REPORT TO THE HISTORIC PRESERVATION COMMISSION

June 28, 2010

SUBJECT: STATUS REPORT ON VIOLATIONS PURSUANT TO FMC 12-1601 ET SEQ. FOR THE HELM HOME (HP#112, 1901) LOCATED AT 1749 L STREET

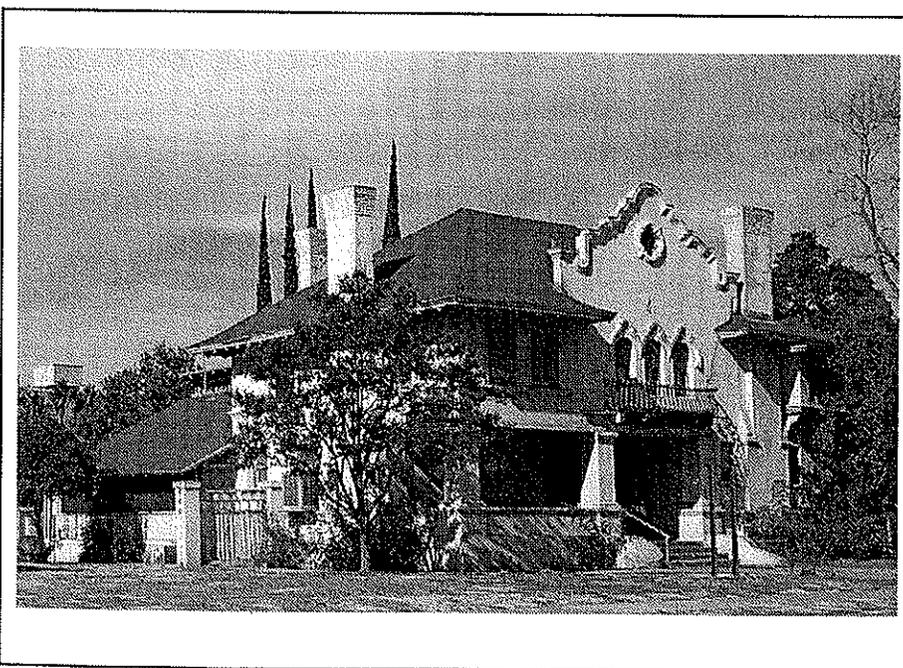
Originally constructed in 1901 as the residence of the Frank Helm family, this house is a rare example of Mission style residential architecture in Fresno. Popularized in California from the 1890s to 1920s, the style was based on the historical interpretation of the Spanish Missions established throughout the southwestern United States (present-day) during Spanish colonization of the area. The style was adopted by the Sante Fe and Southern Pacific Railroad Company's for their respective stations and resort hotels throughout the West, including Fresno's Sante Fe Railroad Depot located at 2650 Tulare Street (built in c.1896). The Helm House at 1749 L Street, commonly referred to as the Alamo House, is comprised of a hipped roof over a central volume with wide unenclosed eaves and a center-set elaborately articulated capped mission-form parapet featuring a quatrefoil window with ornamental surround above three arched single-hung wood sash windows with mission-form drip molding. Designed by the McDougal Brothers architectural firm, the house is asymmetrically composed around the center-set front entrance; with a wide front porch recessed into the left-side of the facade and supported by four square piers atop a solid wall. The northeast corner of the dwelling is punctuated by a north facing second story oriel window. Three corbelled chimneys are located around the perimeter – at the northeast corner, and south and west eave walls. A single-story volume covered by a lean-to roof is sited along the south/southwest corner. Clerestory windows span the upper level rear elevations. The north elevation, fronting Amador Street features several arched openings that have been infilled. A swimming pool and remnants of a garage or carriage house are located in the backyard of the home. This property, although in poor material condition, appears to retain a high degree of integrity.
