REPORT TO THE HISTORIC PRESERVATION COMMISSION

SUBJECT: CONSIDERATION OF APPROVAL OF REQUEST BY THE PROPERTY OWNER TO RESCIND THE DESIGNATION OF THE DR. FLOYD L.R. BURKS HOME (HR#006, 1913) LOCATED AT 2221-2223 STREET AS A HERITAGE PROPERTY AND ADOPTION OF FINDINGS NECESSARY TO SUPPORT RESCINDING THE DESIGNATION, PURSUANT TO 12-1612.

Dr. Floyd L. R. Burks Home, De-listing as a Heritage Property, June 28, 2010

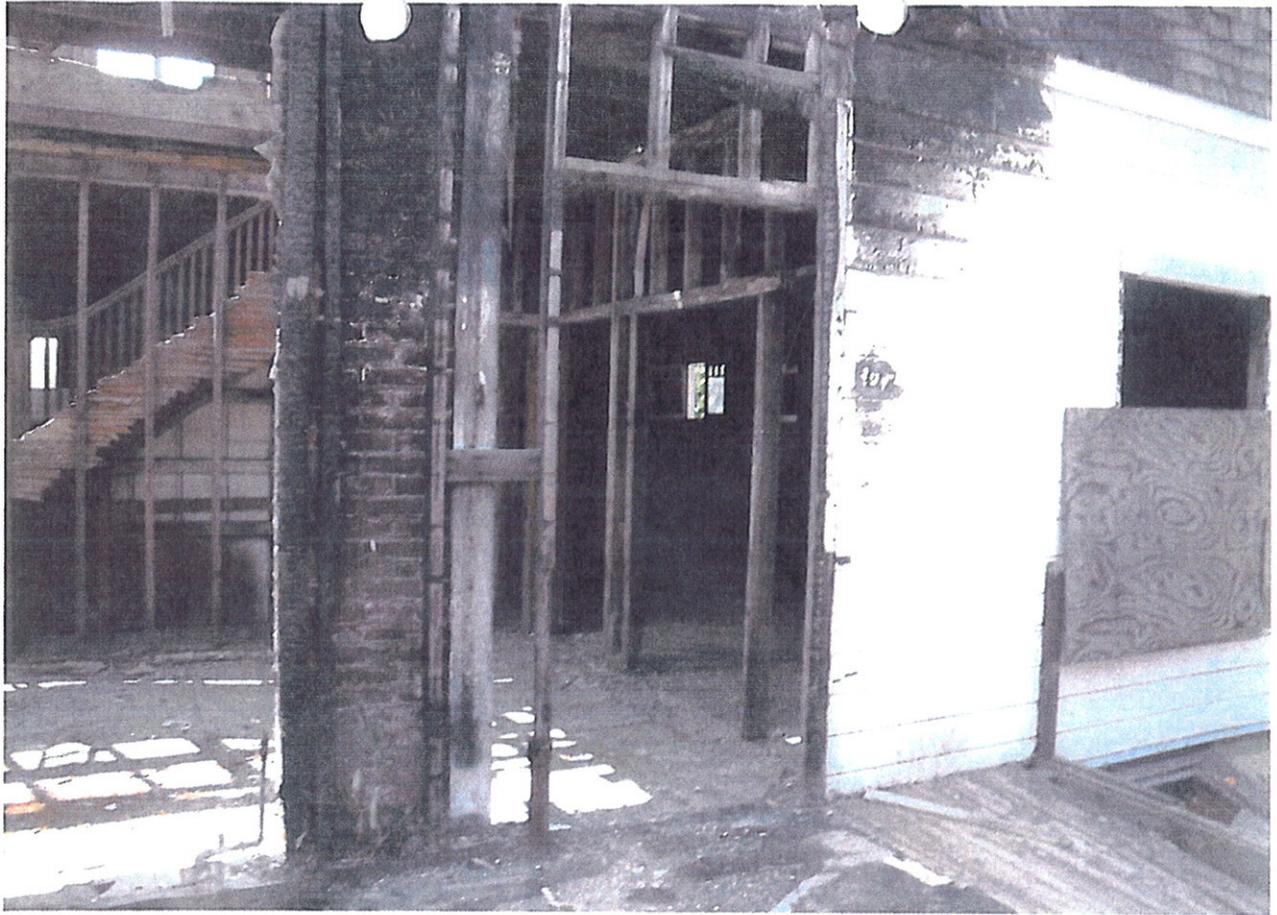
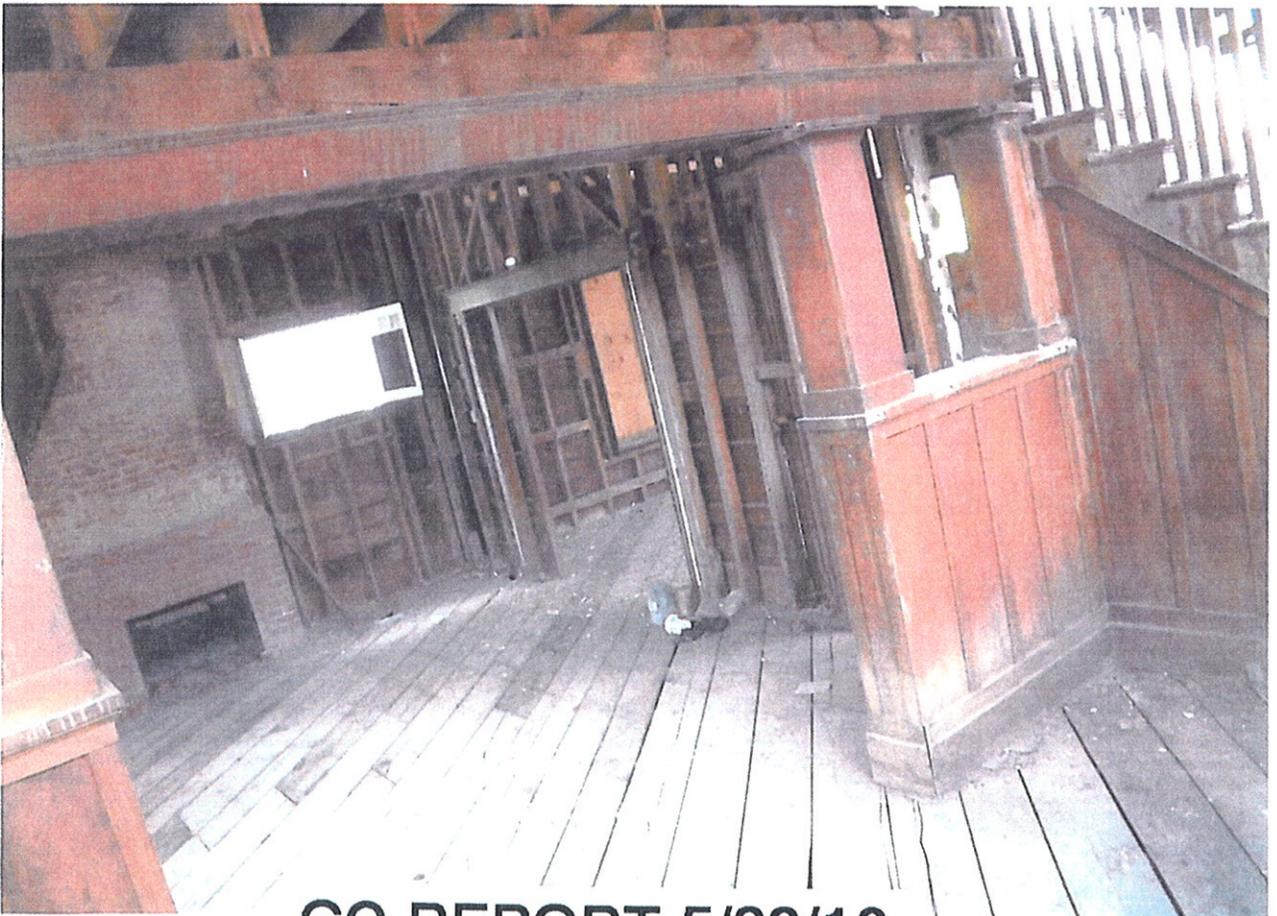
GC REPORT 5/26/10

The August 2006 fire burned the entire second floor and the back addition. The home currently has no roof, no eastern wall covering, and is completely gutted down to the framing. The subfloor is ruined, and the integrity of the remaining lumber is in question. According to the 'Notice and Order to Repair or Demolish Dangerous Building(s)' dated October 5, 2008, by the City of Fresno Code Enforcement Division, there exists 18 Building and Structural Defects, 8 Plumbing Defects and 3 Electrical Defects. Below is a list of a few of the building and structural defects:

- Fire damaged and/or missing window frames throughout
- Fire damage to wall and ceiling framing
- Fire damaged exterior wall framing
- Fire damaged roof covering and structure (rafters and sheathing)

- Fire damaged and dilapidated exterior siding
- Fire damaged and lack of water-tight under-floor access
- Fire damaged and/or unapproved floor support system
- Lack of weather protection at exterior surfaces exposing them to weather damage

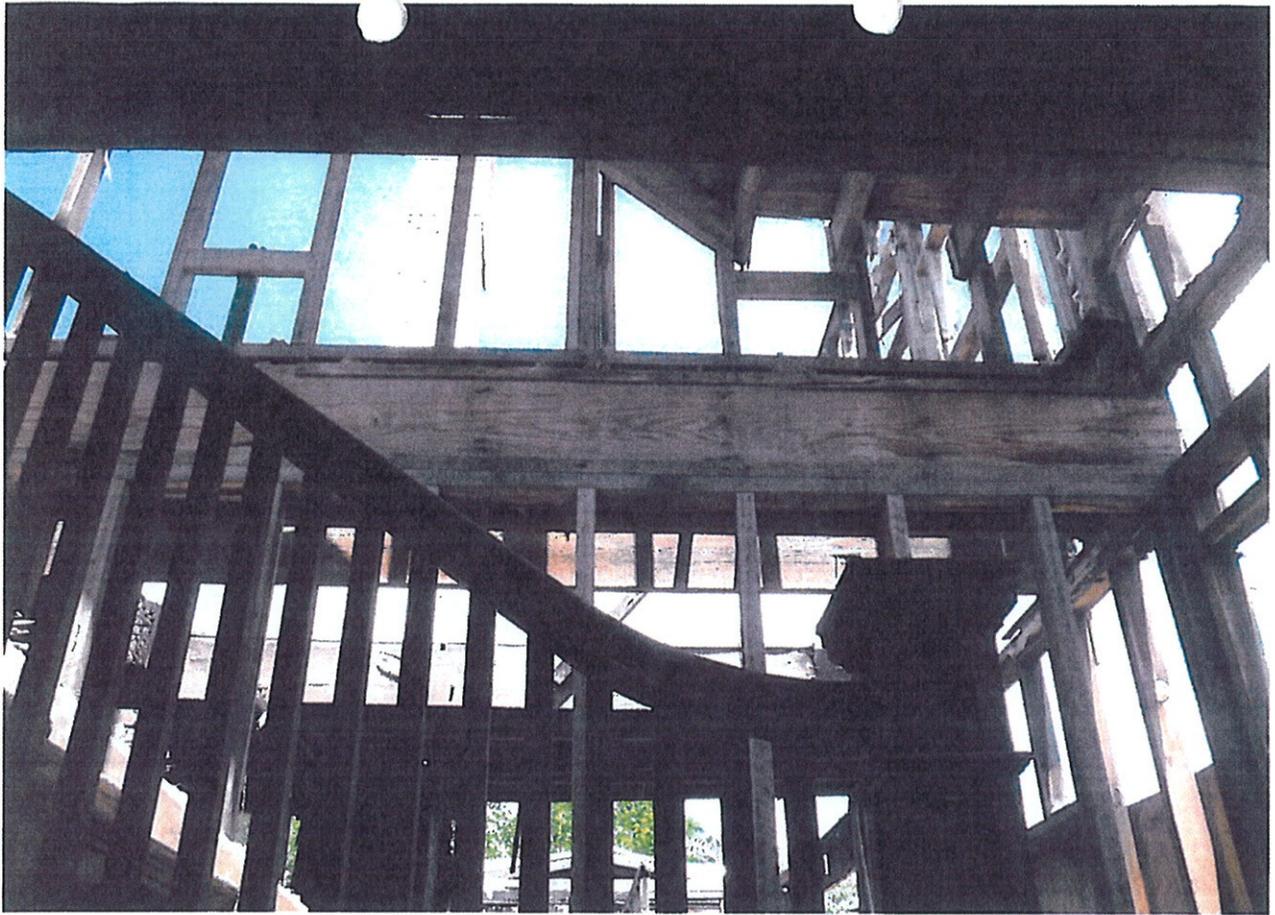
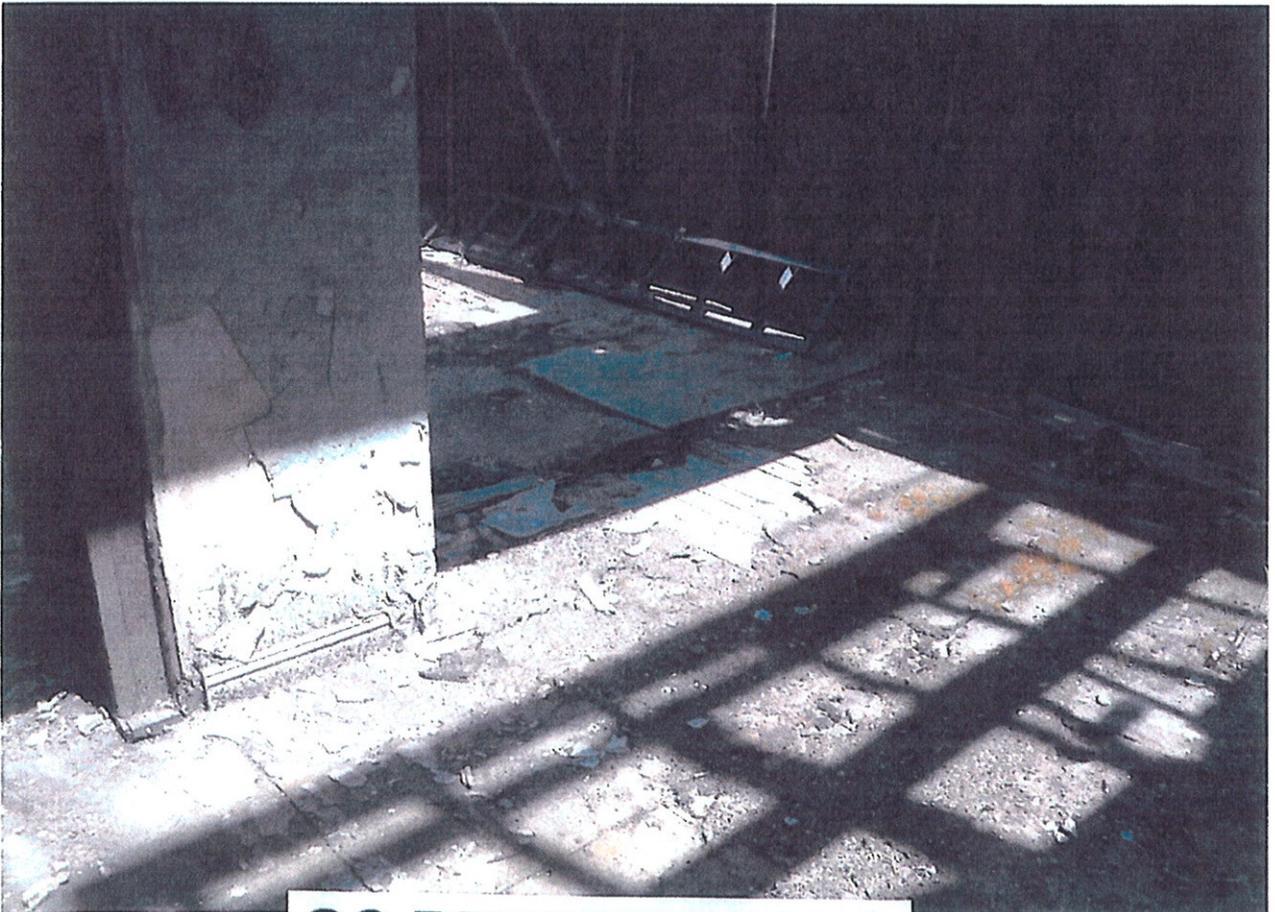
GC REPORT 5/26/10

Since the August 2006 fire, over 34 inches of rainfall has been reported, per the National Weather Service. Since the Notice to Order to Repair was issued in October 2008, over 19 inches of rainfall has been reported, which has caused further water damage to the exposed remaining structure. (See pictures for more details.)
