Community Meeting

Status on Van Ness Boulevard Median Trees

Van Ness Site Assessment

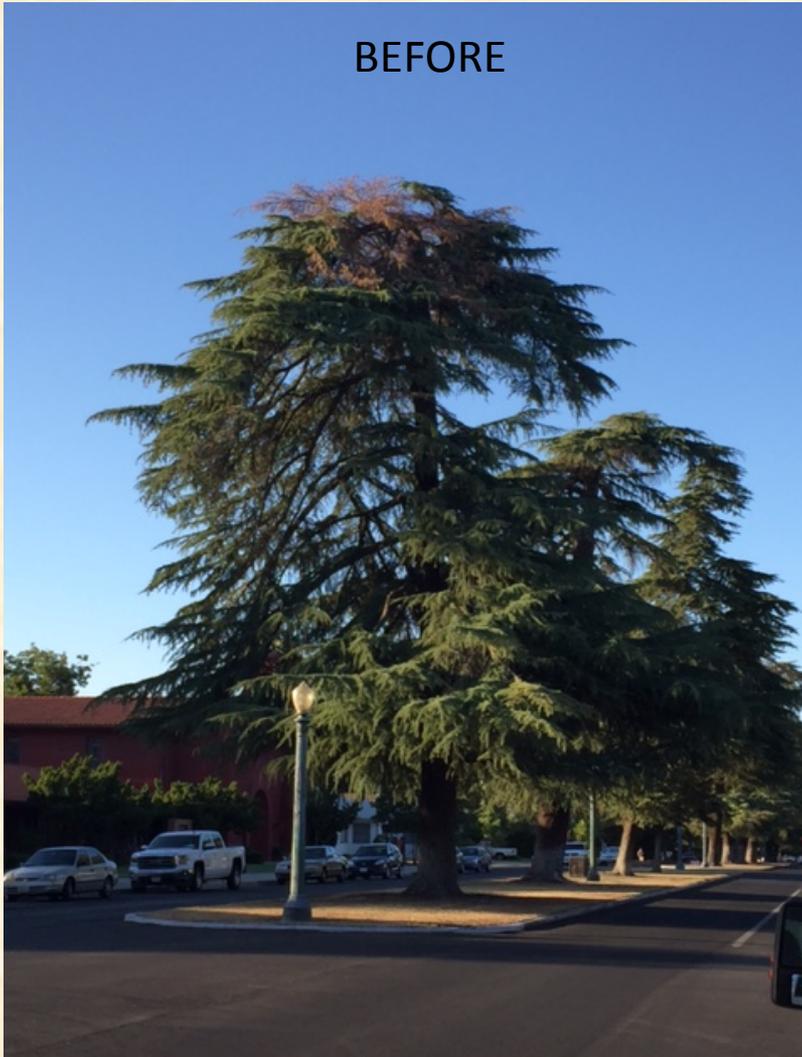
BEFORE

Trimming of Dead Wood 2" and Greater

- Move the present water truck irrigation delivery off of the area around the base of the tree. Try to keep the water delivery in the area between a 3 foot radius from the trees to the drip line of the trees. (Completed)
- Trim any dead branches over 2” diameter out of the remaining trees. Remove no green foliage if possible, as it is what will help the trees resist stress and regrow. (Completed, see attached pictures)
- Make an application of copper fungicide per label instructions to exposed wood areas of the trunks of all the trees to help slow wood decay. (Completed, see attached pictures)
- Keep a 3 foot radius around the trunk of the trees free from turf or weeds by some other means than mowers or string trimmers. (Completed, see attached pictures)
