BROOKS-RANSOM ASSOCIATES

15 September 2016

Subject: Schematic Condition Assessment – 450 E. Belmont Avenue, Fresno CA
North and South Buildings

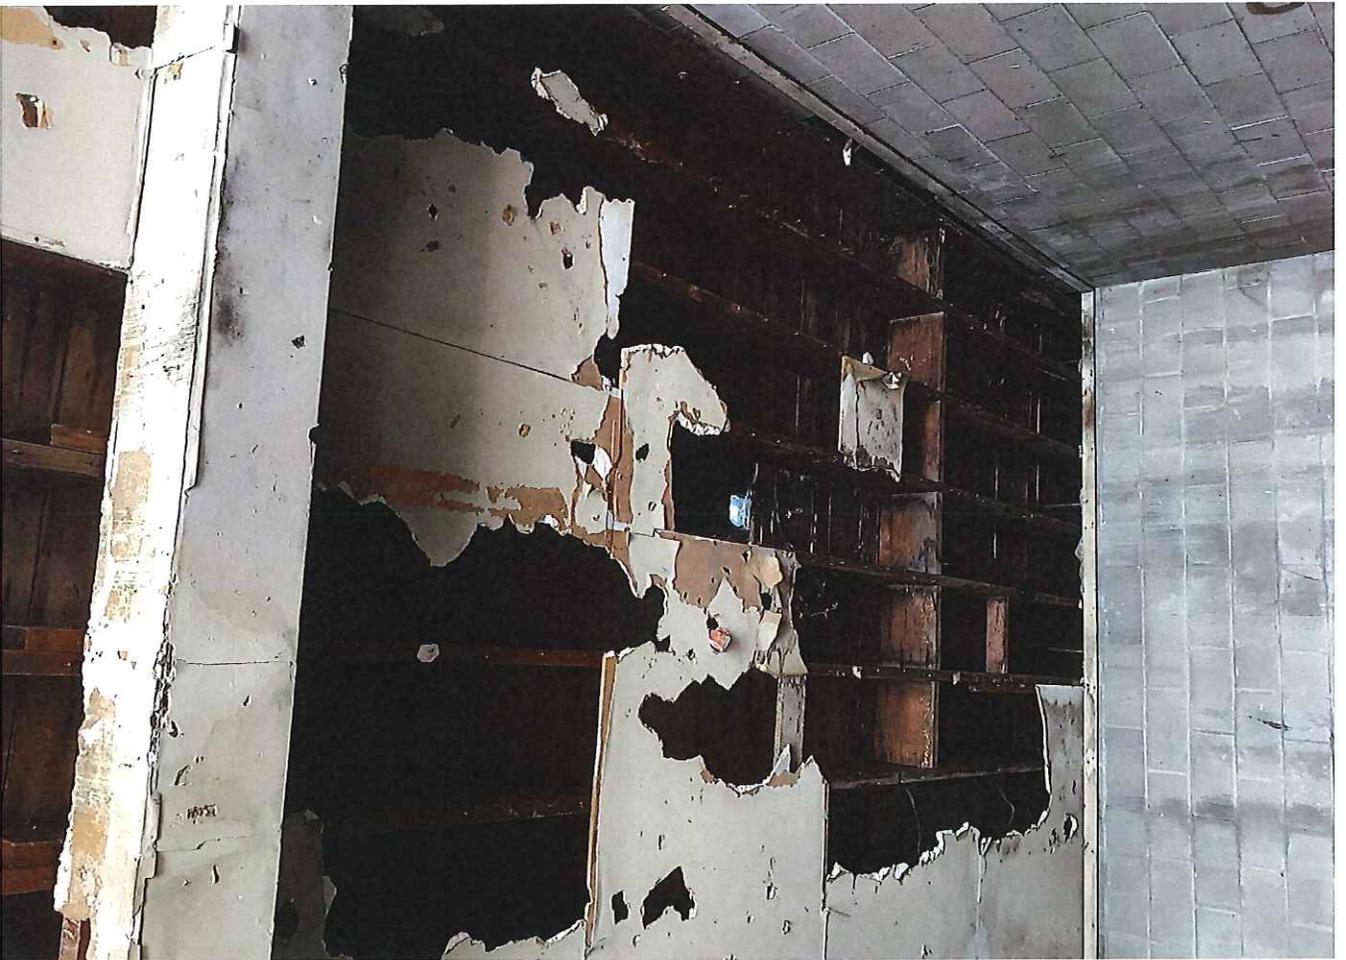
S-2

- Unreinforced Red Brick Walls (Photo S7)
- Nominally reinforced CMU walls (Photo S2)
- Straight board roof sheeting with water damage and rot. (Photo S6)
- Severe water damage to roof framing (Photos S5 & S6)
- Significant impact damage to the west wall. (Photo S7)
- Step cracking in the east wall near the north corner. (Photo S1)
- Deteriorated ceiling sheeting at the east side of the building. (Photo S3)
- No wall ties from perimeter walls to the roof framing. (Photo S5)
- Roof joist embedded directly in the masonry wall. (Photo S5)
- No shear transfer from the roof "diaphragm" to the shear walls. (Photos S5 & S6)

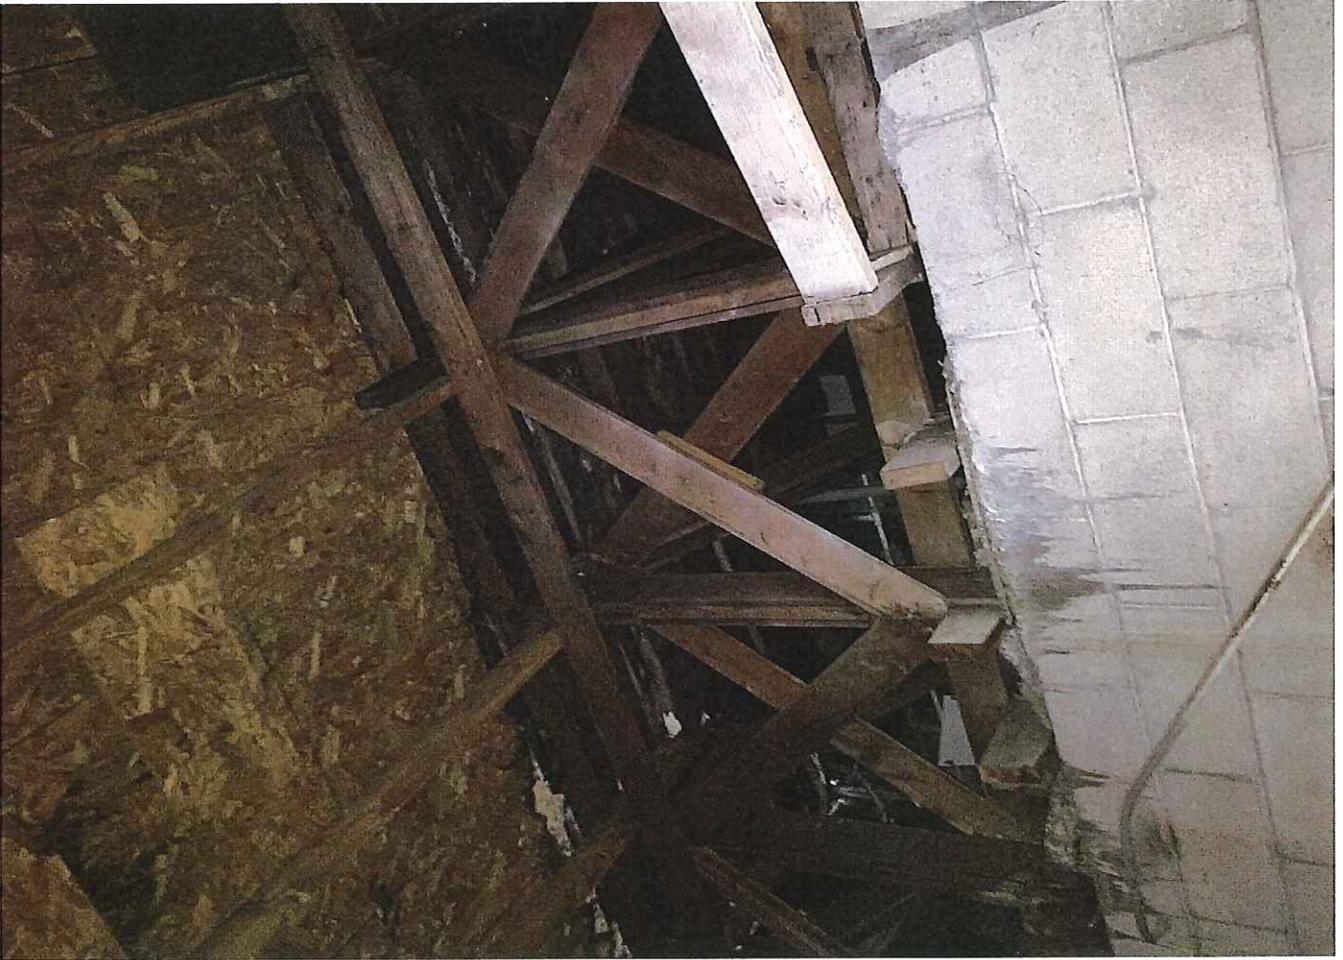
N
22

- Steel moment frames resisting lateral forces in same principal direction as solid masonry walls. (Photo N9)
- Nominally reinforced CMU walls. (Photo N22)

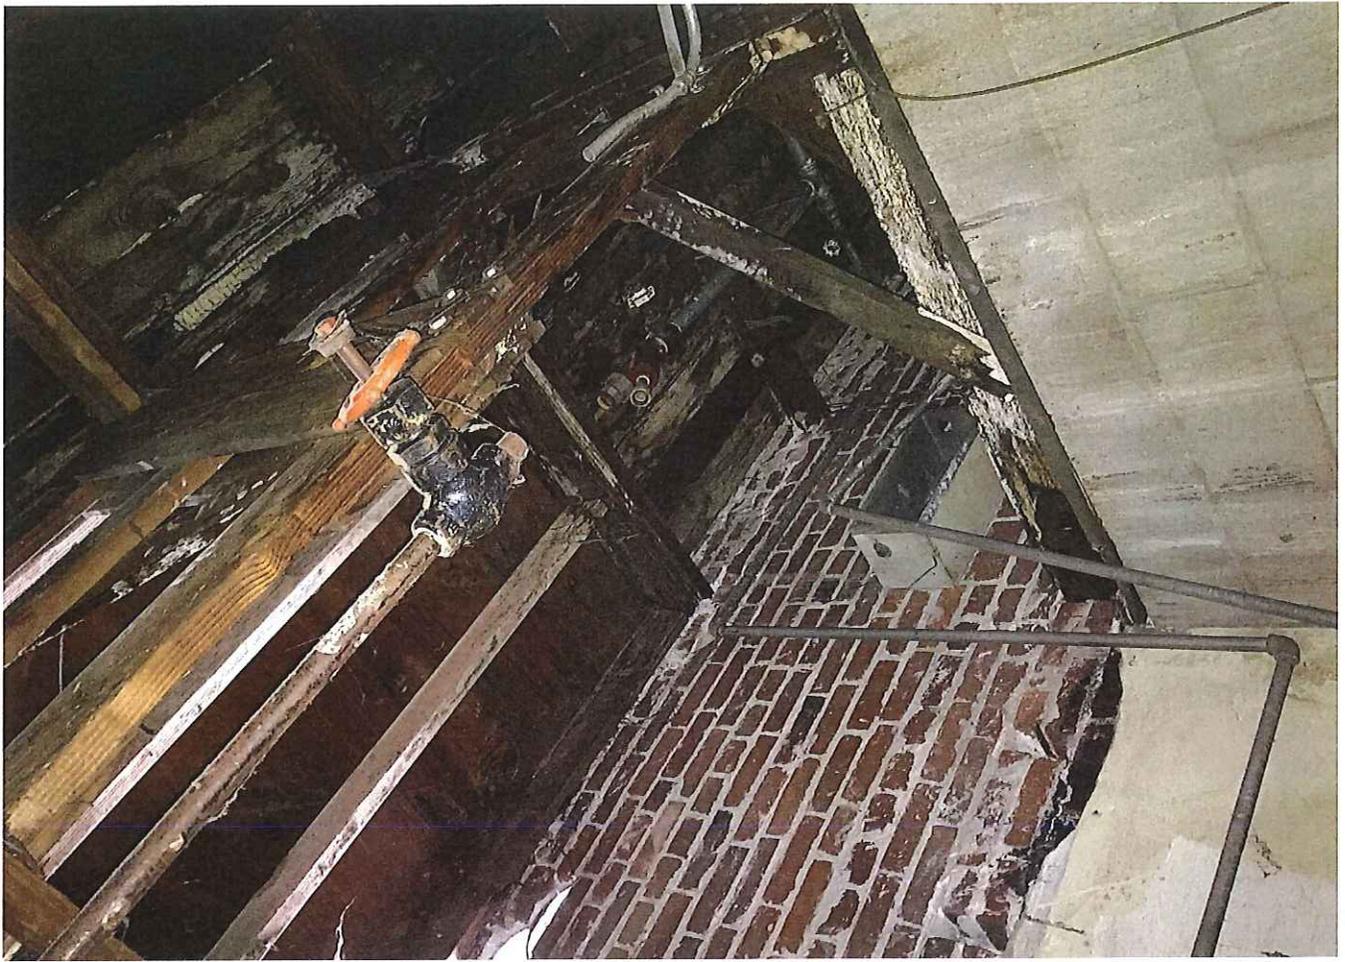
N
25

- West wall above moment frame is a diagonally sheeted wood wall with a plater finish on the outside. (Photo N9)
- Straight wood board diaphragms exist in several areas of the building. (Photo N25)

- Seriously damaged roof sheeting was observed in several areas of the building. (Photo N25)
- There appears to be at least 3 major phases of construction. The nature of these separate phases seem to lack a coordination with the previous construction resulting in a lack in continuity and connection of the subsequent phases so as to provide a total building which will act as a whole during exposure to wind or seismic forces. (Photo N29)

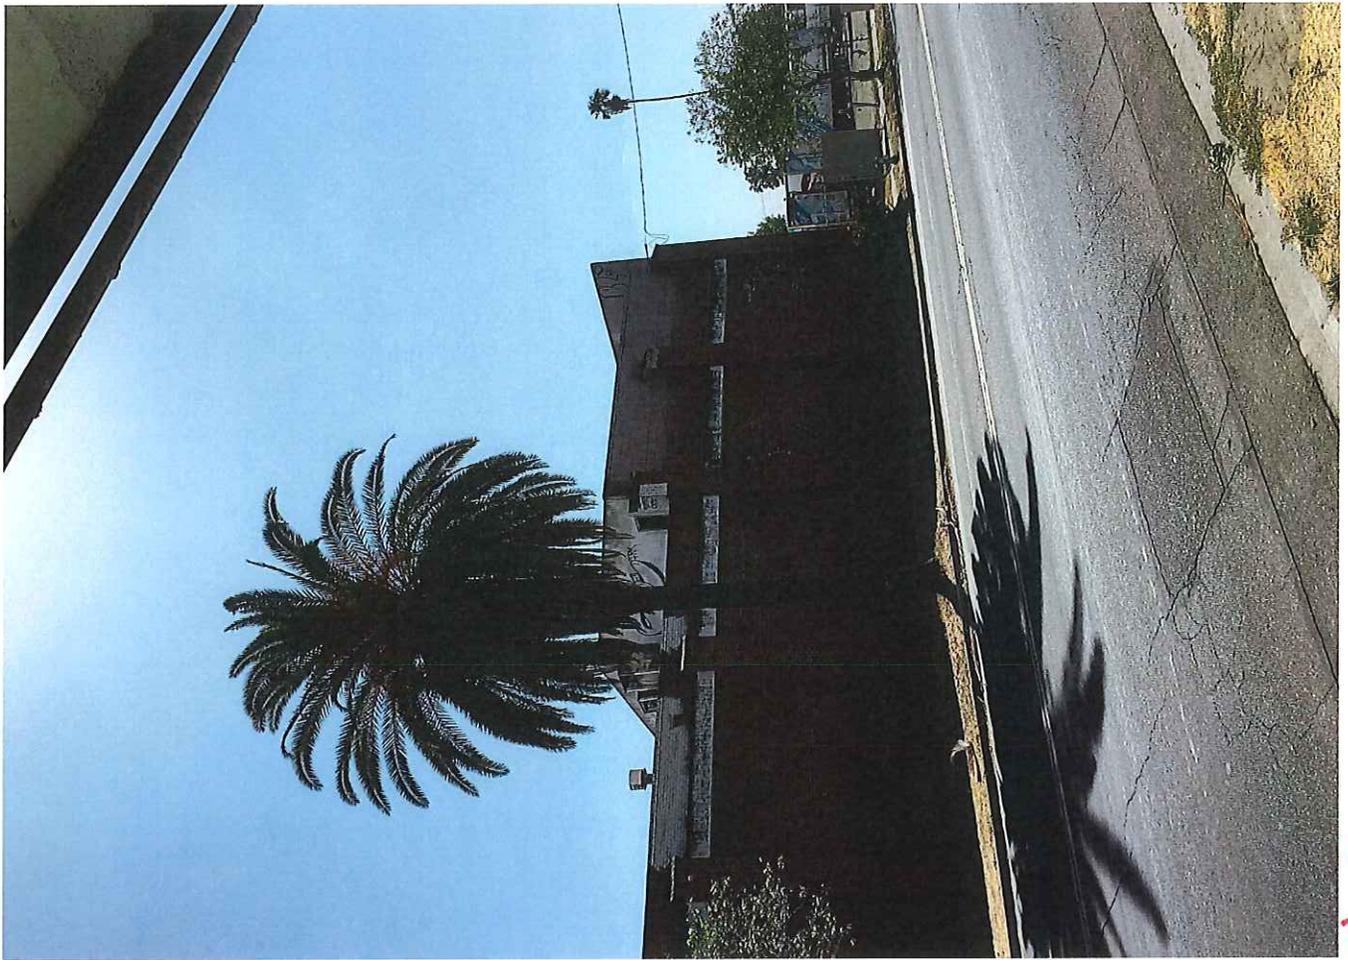
N
37

- A mixture of Unreinforced Red Brick walls, wood stud walls, and light gage metal stud walls apparently all working as shear walls.
- Tall unreinforced red brick perimeter walls (Photo N37)

Being unreinforced red brick walls, the walls must be thoroughly tested to see if they qualify to remain as structural elements in the building, and if they are found to be wanting, they must be heavily reinforced to remain as a part of the structural lateral load resisting system.

If the walls are retained, then the existing diaphragms almost always need to be retrofitted and a new system of shear transfer from the diaphragms to the shear walls must be installed. Finally, the red brick walls must be well tied to the diaphragms to resist the out-of-plane forces to which the wall may be exposed during an earthquake.
