# Fulton Mall Reconstruction

## *Alternatives Analysis Report*

November 13, 2013

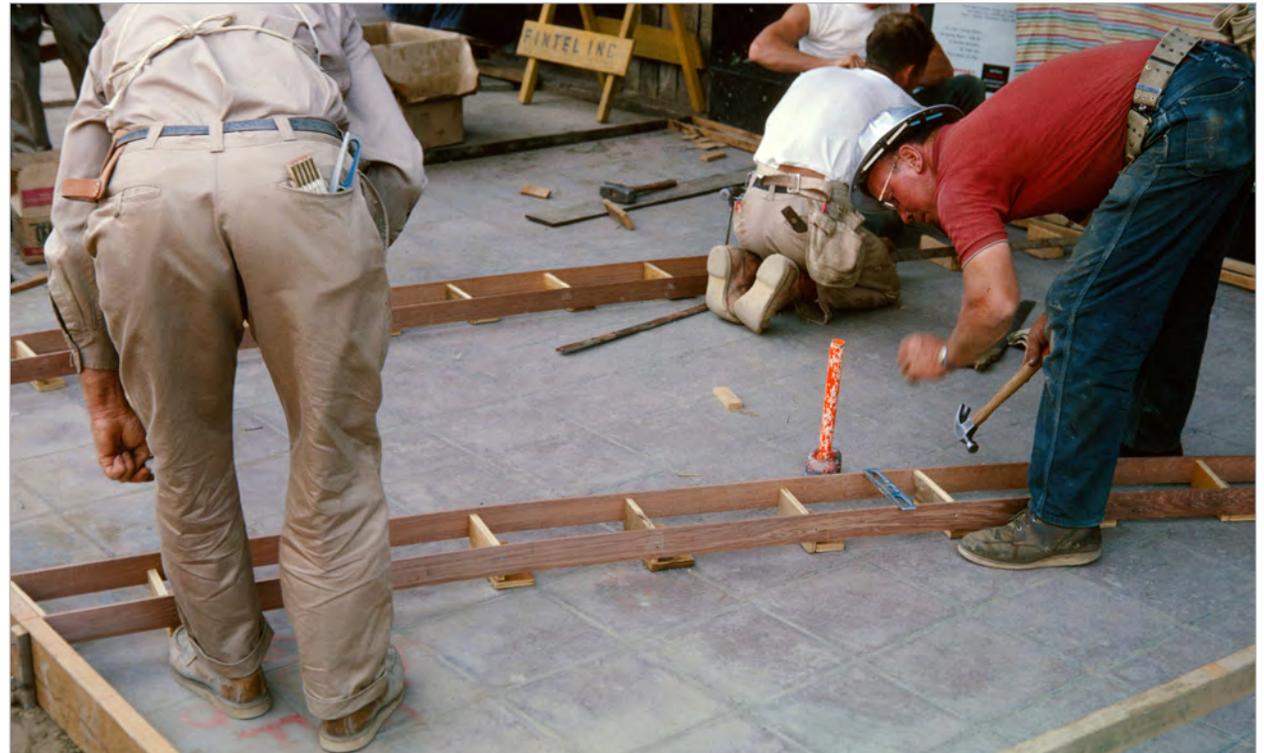
**Figure 28:** Forming for Mall paving on top of basement roof slab is seen in this 1964 photograph of the Fulton Mall construction. *Rich Seyfarth photograph*

This will also require further investigation prior to construction as some existing curbs on side streets appear to occur over basements. In areas where shade is desired, but basements prevent the planting of trees, shade structures such as trellises may be considered. The construction documents will notify the contractor of the possible presence of basements and require that demolition and excavation be done carefully to verify the locations and depths of basements. Where basements are found to not exist, placement of additional trees will be considered.

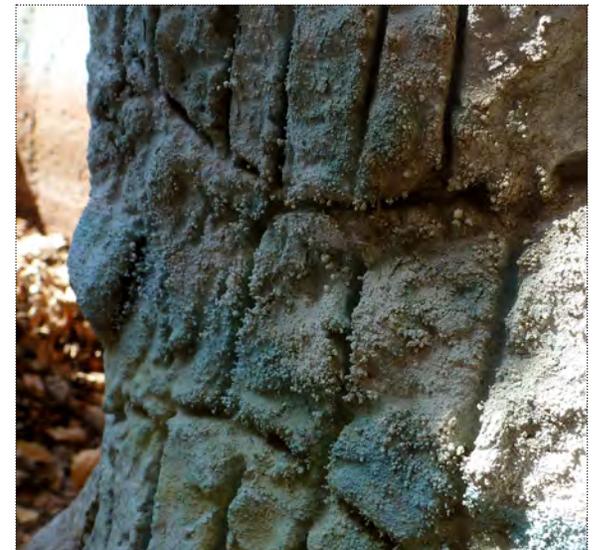
Detail of view of crystallized soluble salts efflorescence on top of white deposits from insoluble salts efflorescence.

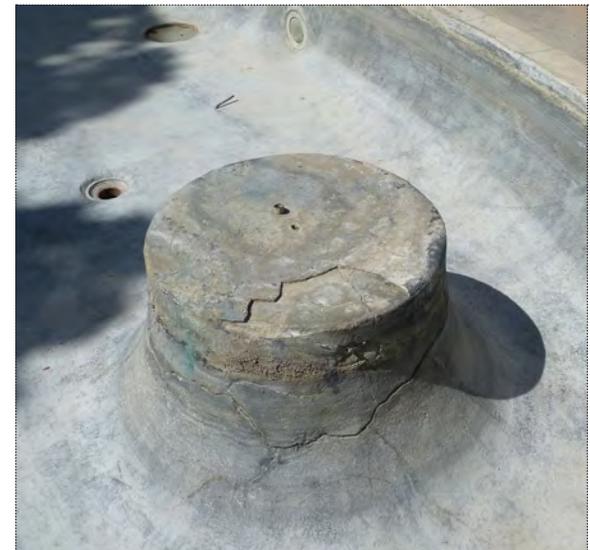
Cracks and surface spalls at empty concrete base for *Leaping Fires*, number 17 on art feature key plan.

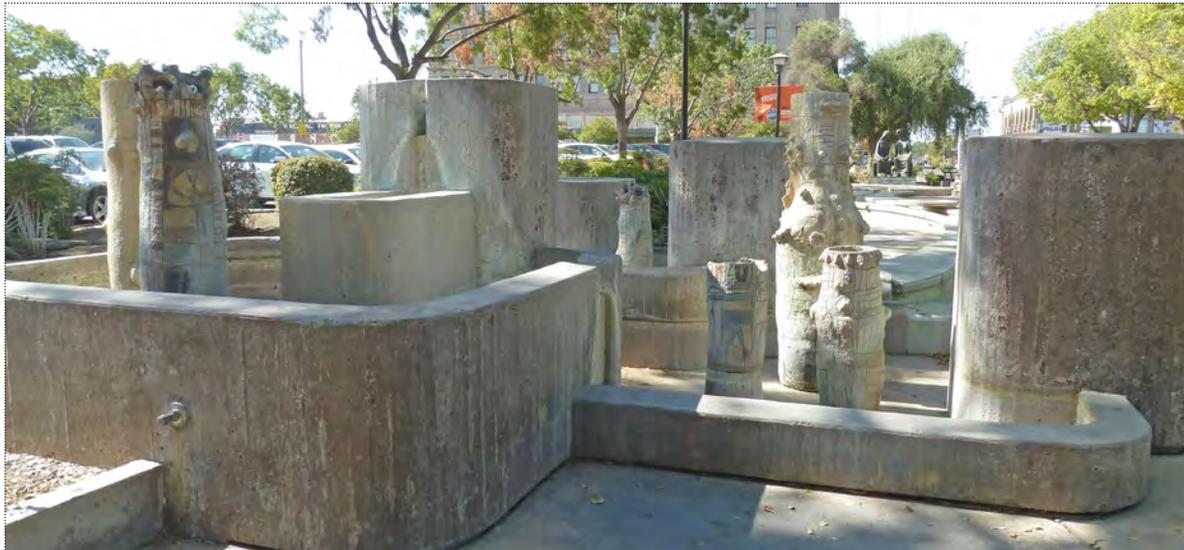
Overall view of clay pipe sculpture and associated concrete fountain labeled as 2A on key plan.

The adjacent concrete fountain materials are in fair condition. The concrete is heavily stained, and ceramic tile at spillover areas are eroded and partially missing. The clay pipes rest on short, concrete pedestals, one of which exhibits a large crack. Cracking at concrete walls is minor, however, and spalling was limited to locations surrounding corroding metal components. One underwater light within the fountain was cracked.

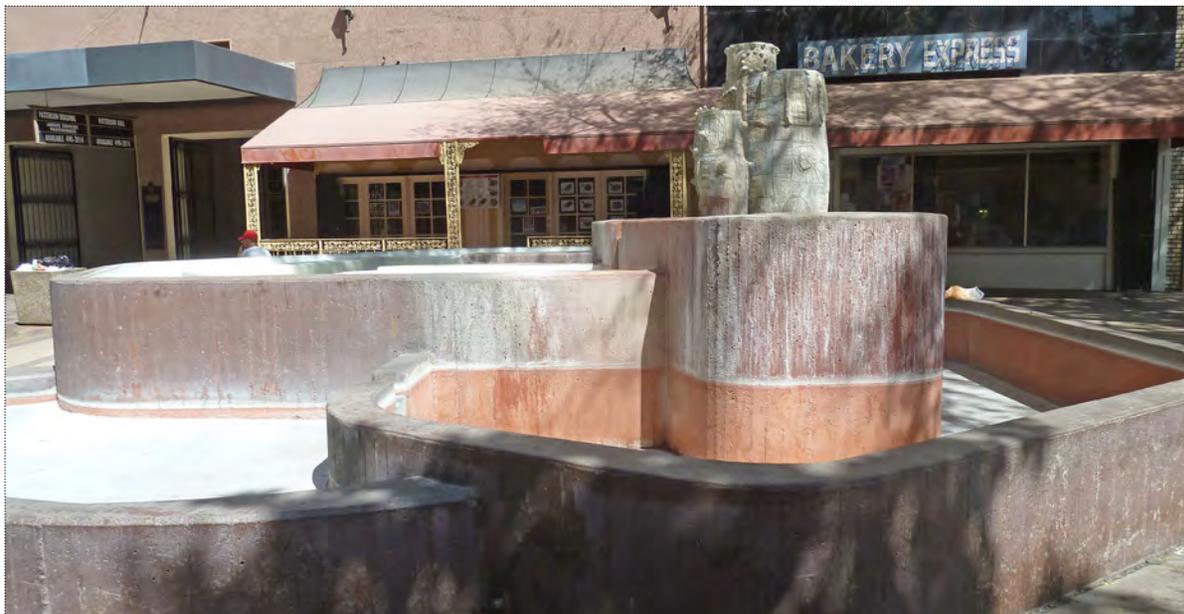
Overall view of clay pipe feature 2C and its location within a larger terraced fountain.

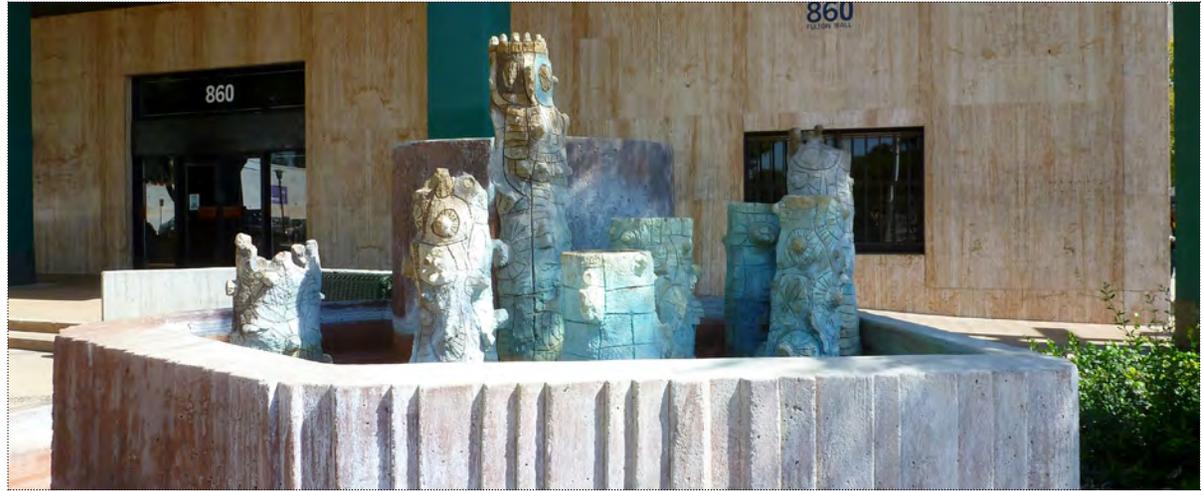
Overall view of clay pipe sculpture and concrete pedestals labeled as 2D on key plan.

locations. Cracks in the concrete walls are small and limited in number. Tree debris has accumulated in the empty basins, and corrosion was visible at all exposed metal fountain components.

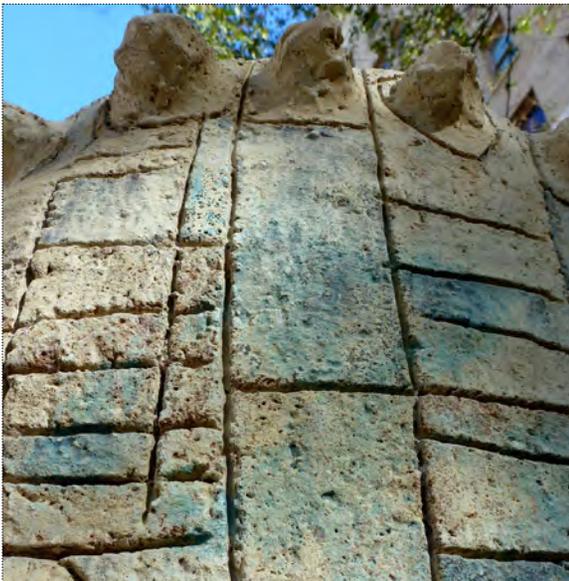
Detail view of efflorescence and staining at clay pipe feature 2C.

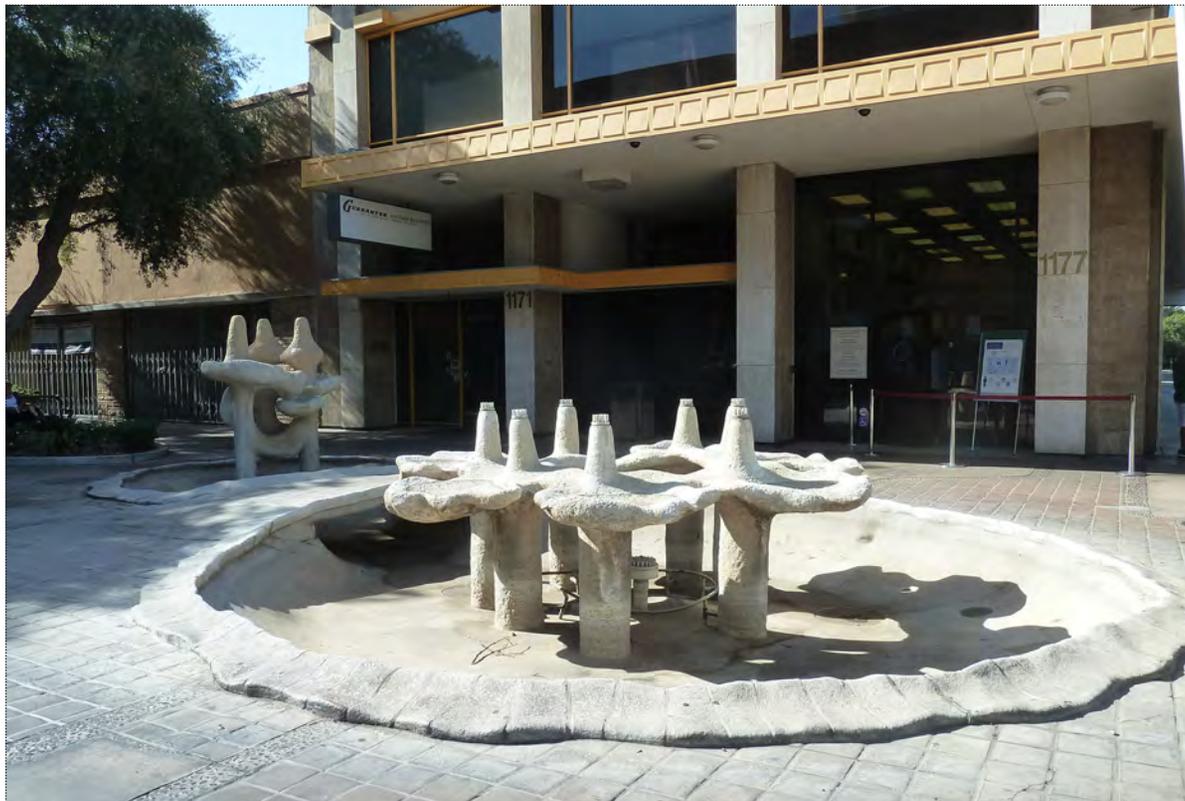
Overall view of cast concrete forms that comprise “Dancing Waters,” sculpture number 07 on the key plan.

survey. Efflorescence caused by insoluble salts completely covers both pieces, disrupting the original appearance of the artwork. Insoluble salts are a consequence of interaction with water when the system was working and water was running through the pieces. Erosion and physical deterioration of the cementitious substrate is visible throughout the pieces, with the most severe conditions appearing at the legs that support the taller elements.

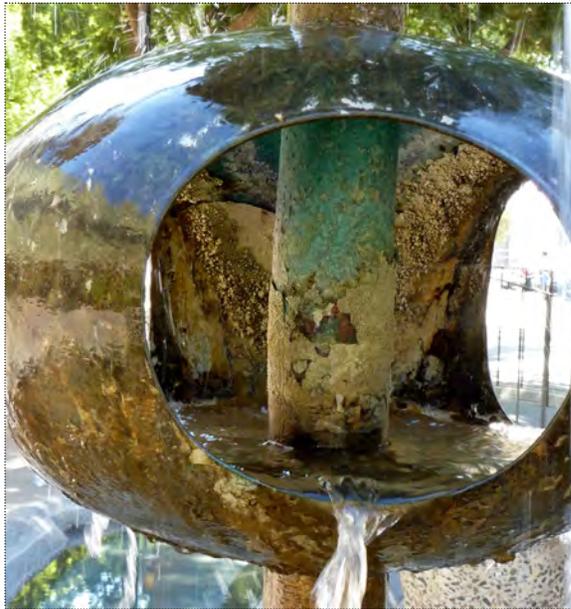
Detail view of green corrosion and white efflorescence on bronze sculpture in direct contact with water.

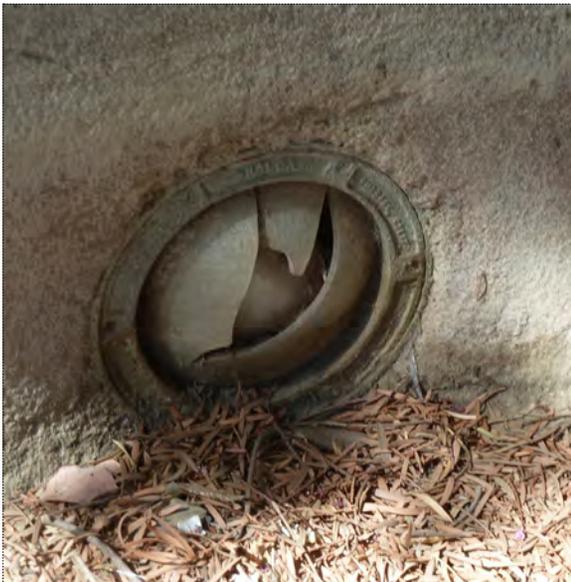
Broken light fixture in empty fountain basin at *Talos*.

The sculpture is in good condition overall. There are minor deposits of dirt and some bird droppings. It has a light colored patina that needs to be re-coated regularly. The pool was empty at the time of the survey, and was filled with tree debris. The concrete pedestal is stained and exhibits minor cracking. An underwater light fixture is cracked and broken.

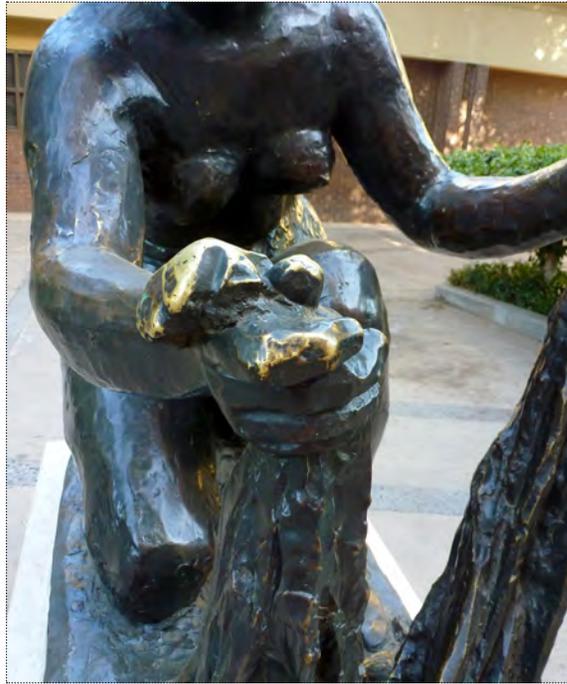
Detail view of minor abrasions at the dark patina.

The sculpture is in overall good condition, with minor deposits of dirt and minor abrasions of the dark patina. Water was found pooling in some areas at the bottom part of the sculpture, contributing to an accumulation of dirt and the beginnings of some corrosion. The travertine base the sculpture rests on is lightly stained and exhibits several cracks at multiple faces.

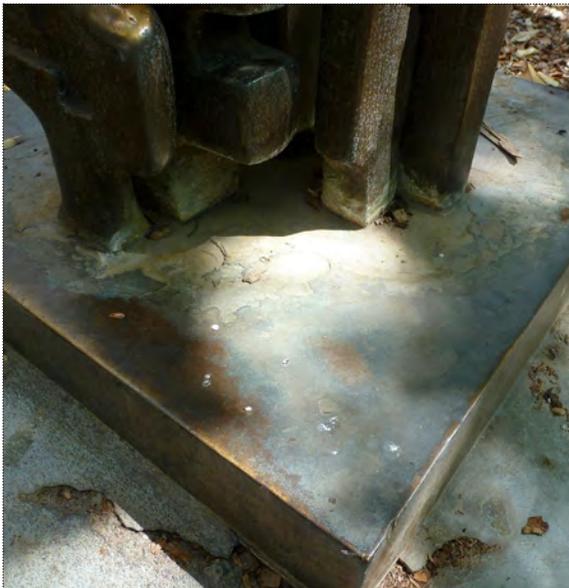
Detail view of deep corrosion on base of Arbre Echelle.

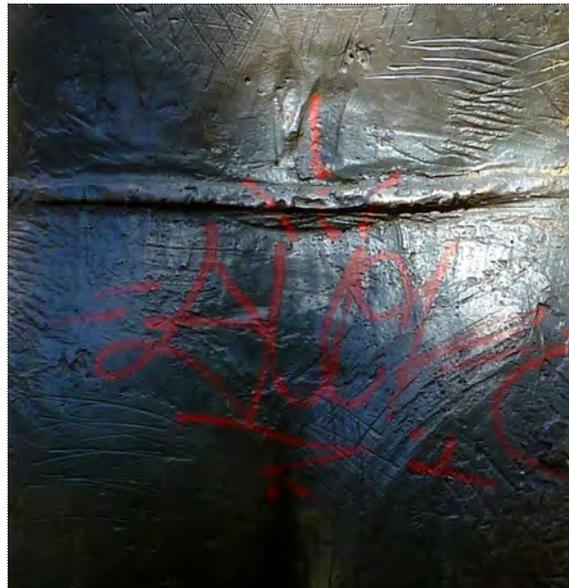
Detail view of graffiti at the back side of Yokuts Indian.

The sculpture is in overall good condition. There are minor deposits of dirt and it has a dark patina that has not been re-coated as recommended. There is red paint graffiti on the front and back sides, near the center. The sculpture is mounted on a rough stone set into a concrete base.

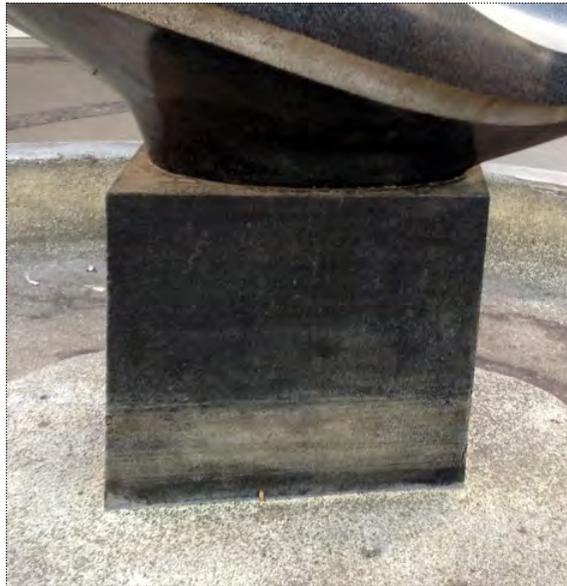
Detail view of staining or water line at Valley Landing.

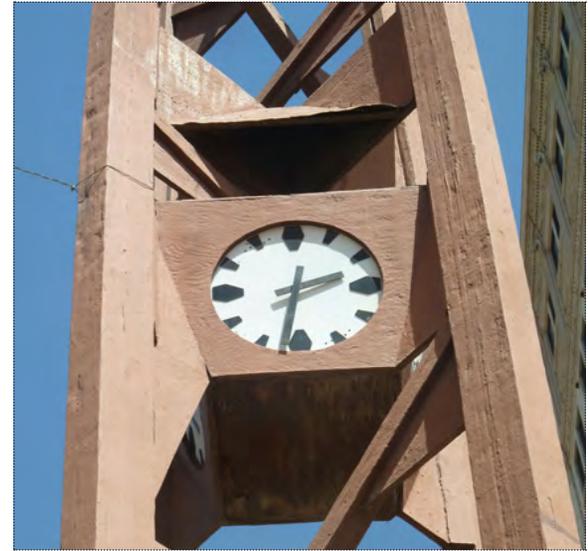
The deteriorated, uneven paint finish and raised grain of weathered wood can be seen at the Clock Tower.

Exposure to sun, wind and moisture has deteriorated the protective finishes covering the wood structure, leaving it exposed to weathering. It appears that the sculpture was originally painted or otherwise coated, but that finish is now degraded and the fiberglass below is deteriorated as well. This leaves the vulnerable, unfinished

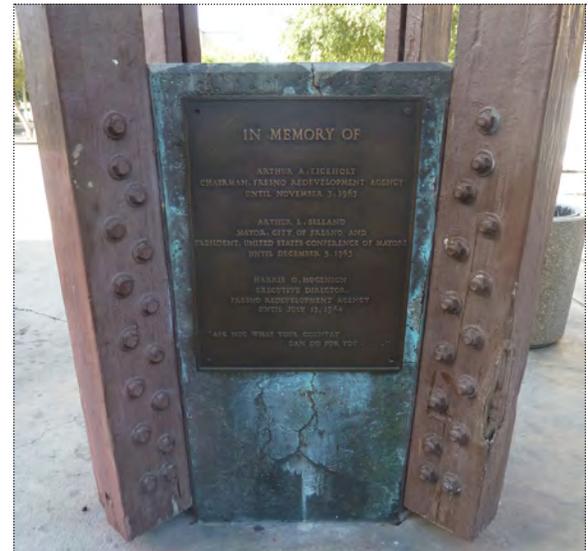
There are multiple large cracks running through the concrete base and staining from the bronze plaques.

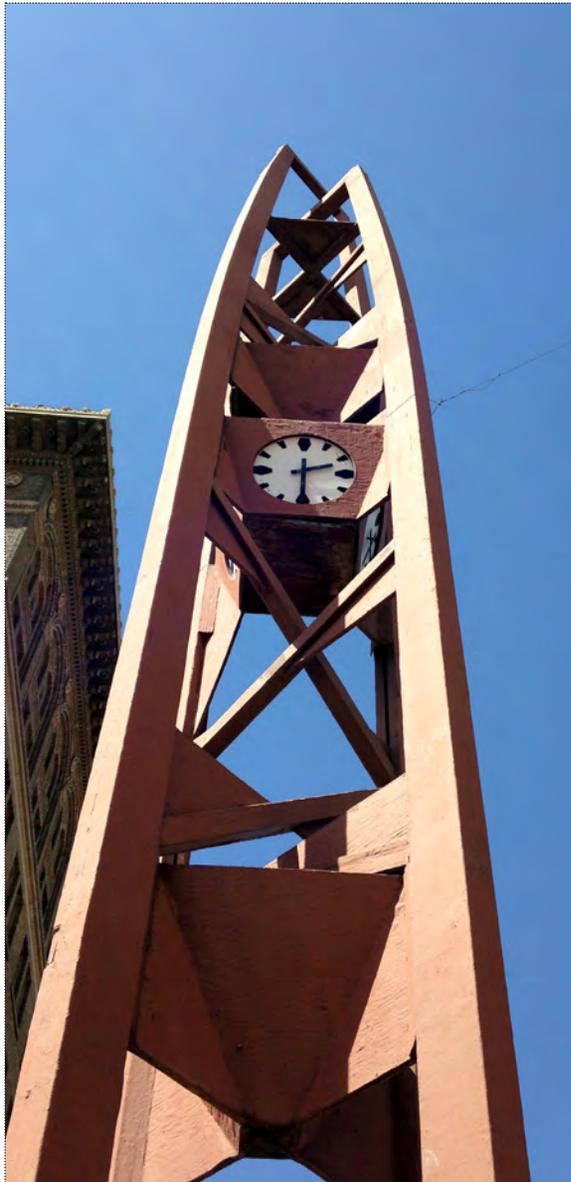
View of upper portion of Clock Tower, with tie-back cable visible at upper right.

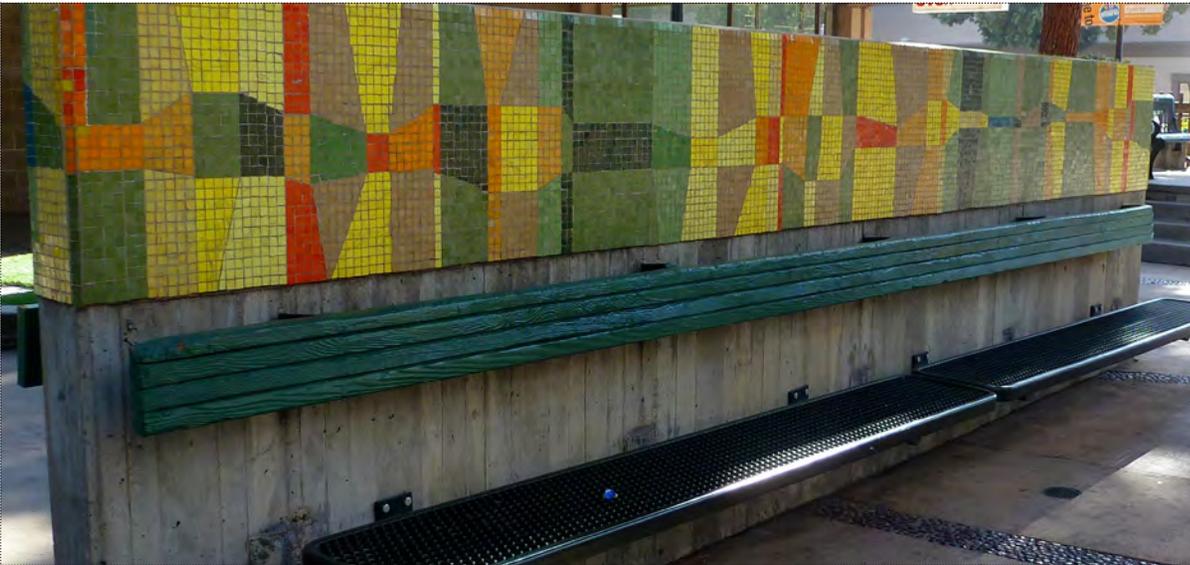
Overall view of mosaic bench, labeled as "A" on art feature key plan. Note patched locations in concrete for previous bench anchors.

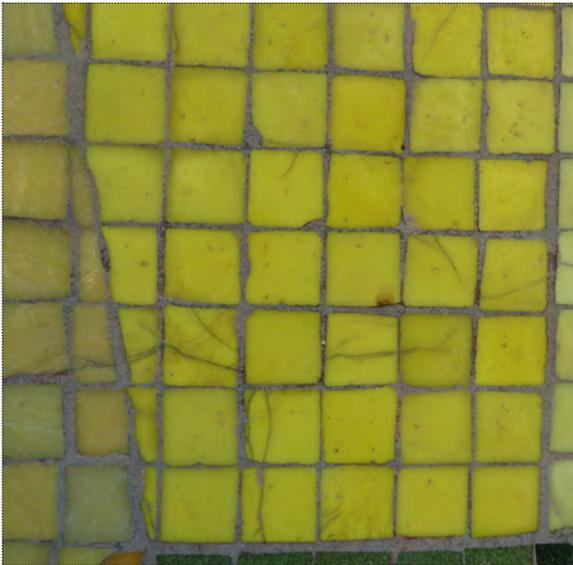
Detail view of minor cracking at tesserae at "A" benches.

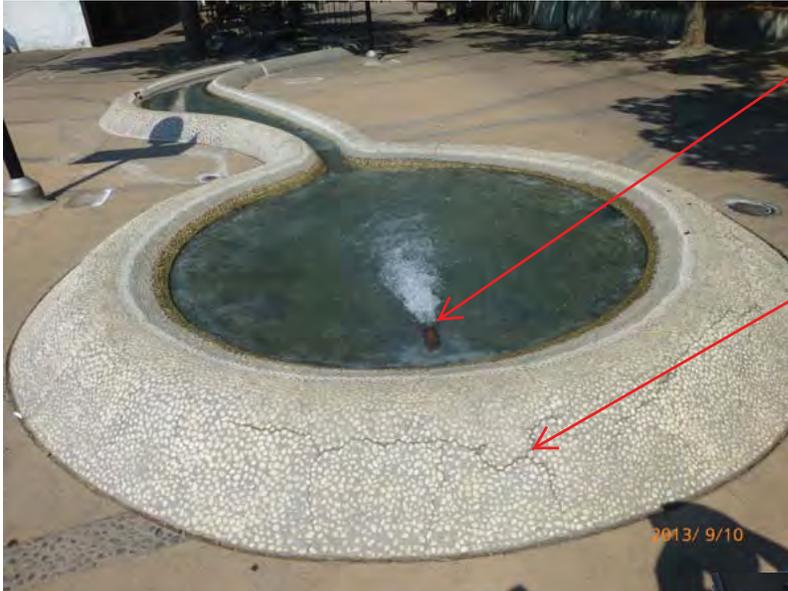
Missing nozzle, typ.

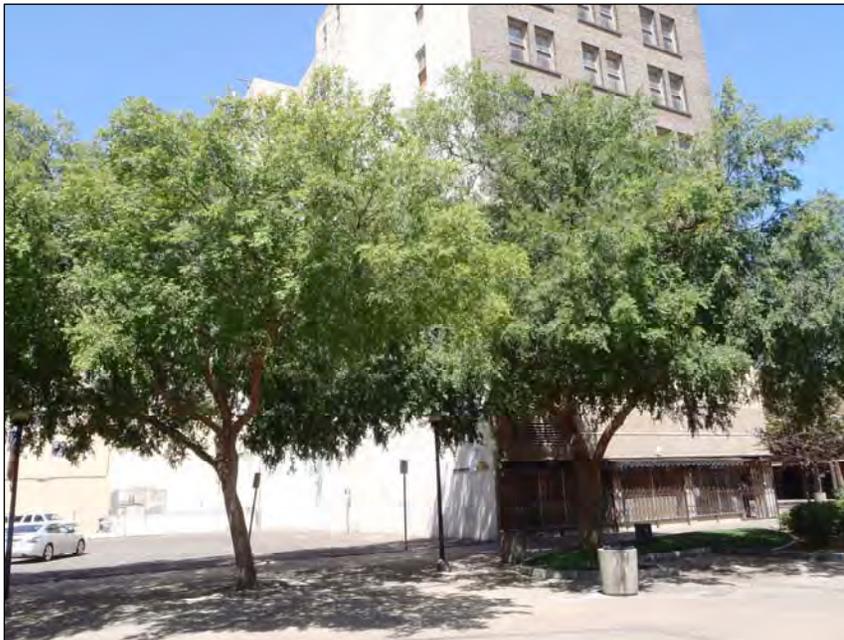
**Photo 1 (Left):** Chinese elms #211 (R) and 212 (L) had broad, full crowns that provided ample shade. The trees performance was typical of the species at the Fulton Mall site.

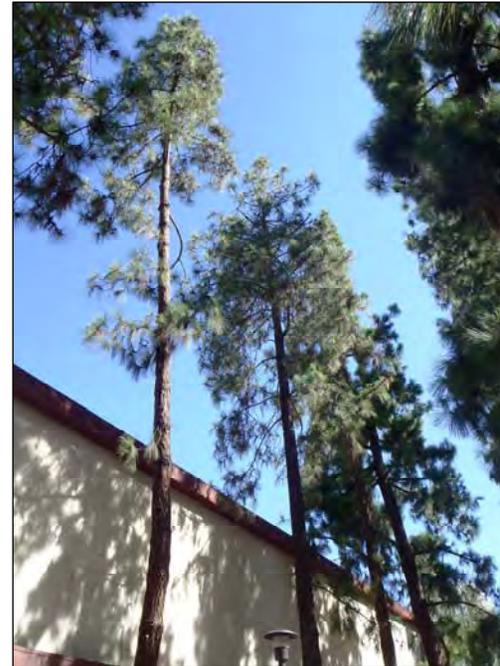
**Photo 3:** Looking east at Canary Island Pines #119-122 (L to R). The trees had the tall, narrow form typical of the species. Canary Island Pine #122 (L) was one of the trees in poor condition, with a small, sparse canopy.

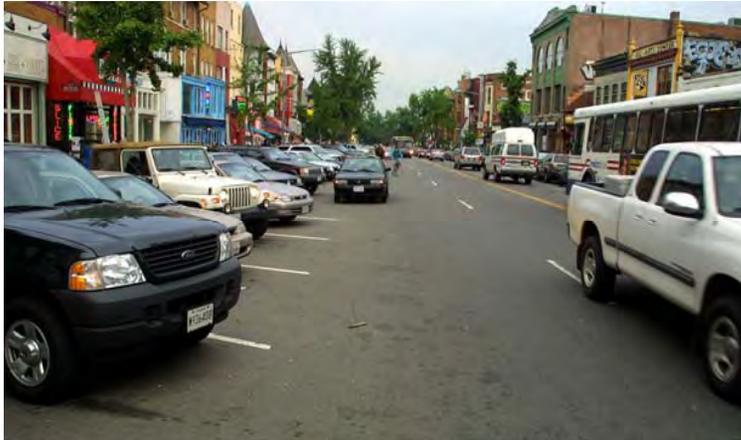
Example of back in angled parking (Washington, DC)

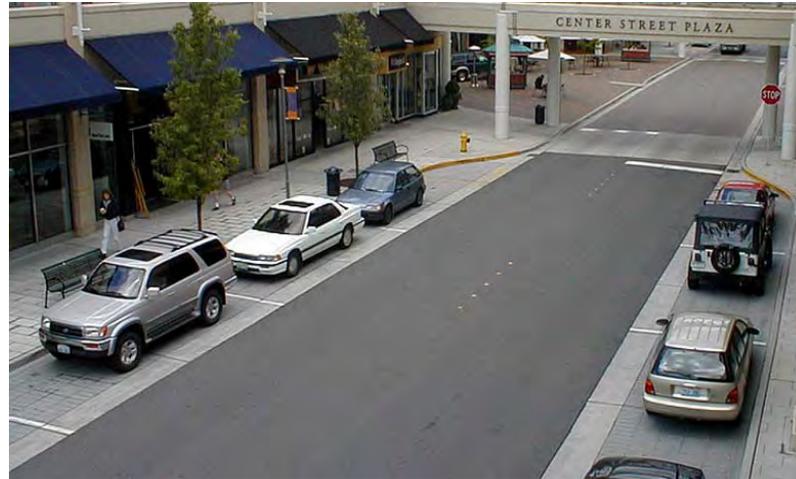
Examples of curb extensions and parking integrated into the pedestrian realm (Cornelius, NC and Redmond, WA)

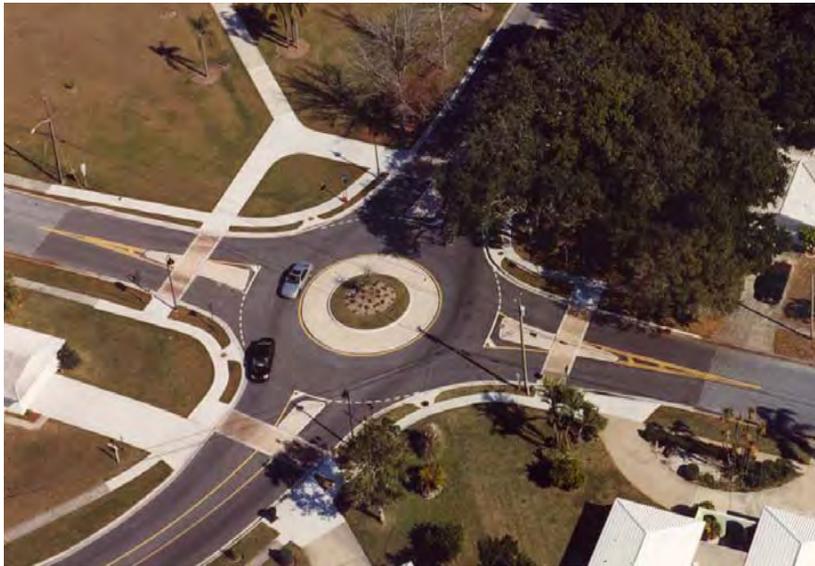
Roundabout with Inscribed Circle Diameter of 85 feet  
(Intersection of Palmetto St. and Casler Ave., Clearwater, FL)
