Drinking Water Infrastructure Renewal and Replacement Plan

**AUGUST 2019
FINAL**

AKEL
ENGINEERING GROUP, INC.

CITY OF FRESNO

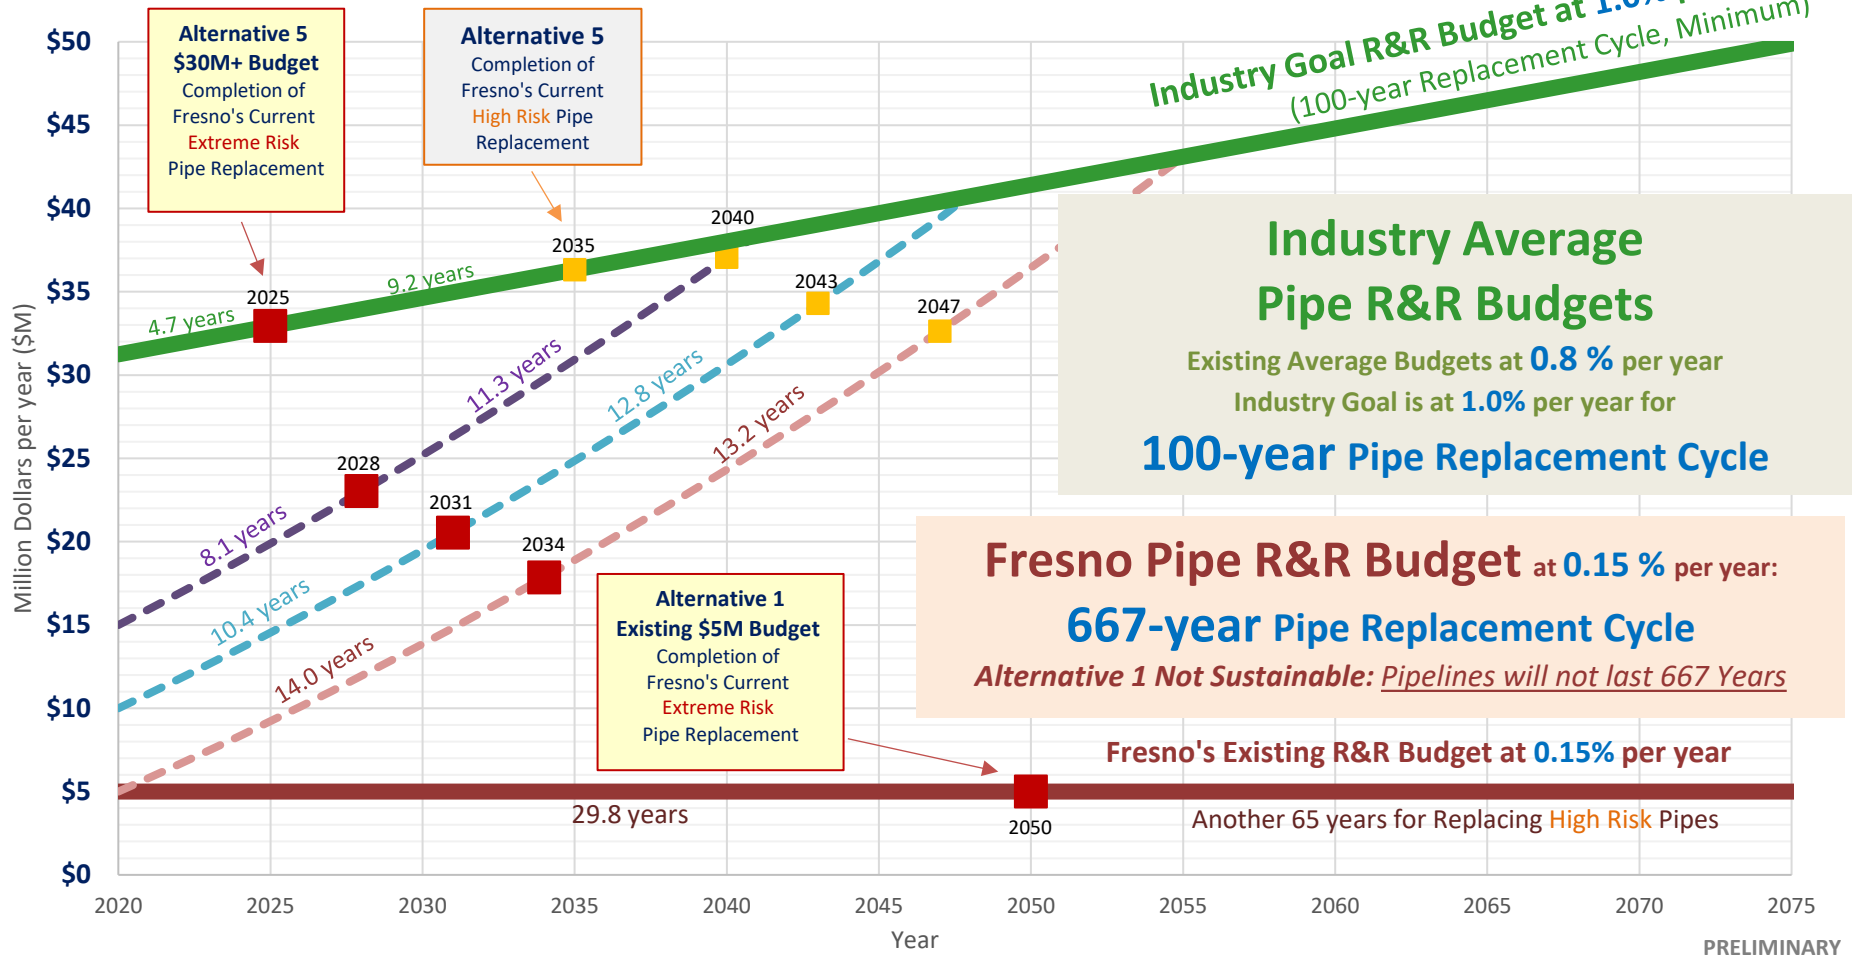
R&R Budget Alternatives

- Alternative 1: Existing Budget (667-year cycle, 0.15% System Replacement)
- - - Alternative 2: Ramp from \$5M (35 Years to Reach 1% System Replacement)
- - - Alternative 3: Ramp from \$10M (28 year to 1% System Replacement)
- - - Alternative 4: Ramp from \$15M (21 years to 1% System Replacement)
- Alternative 5: 1% System Replacement per Year (Industry Goal) (100-year Cycle)

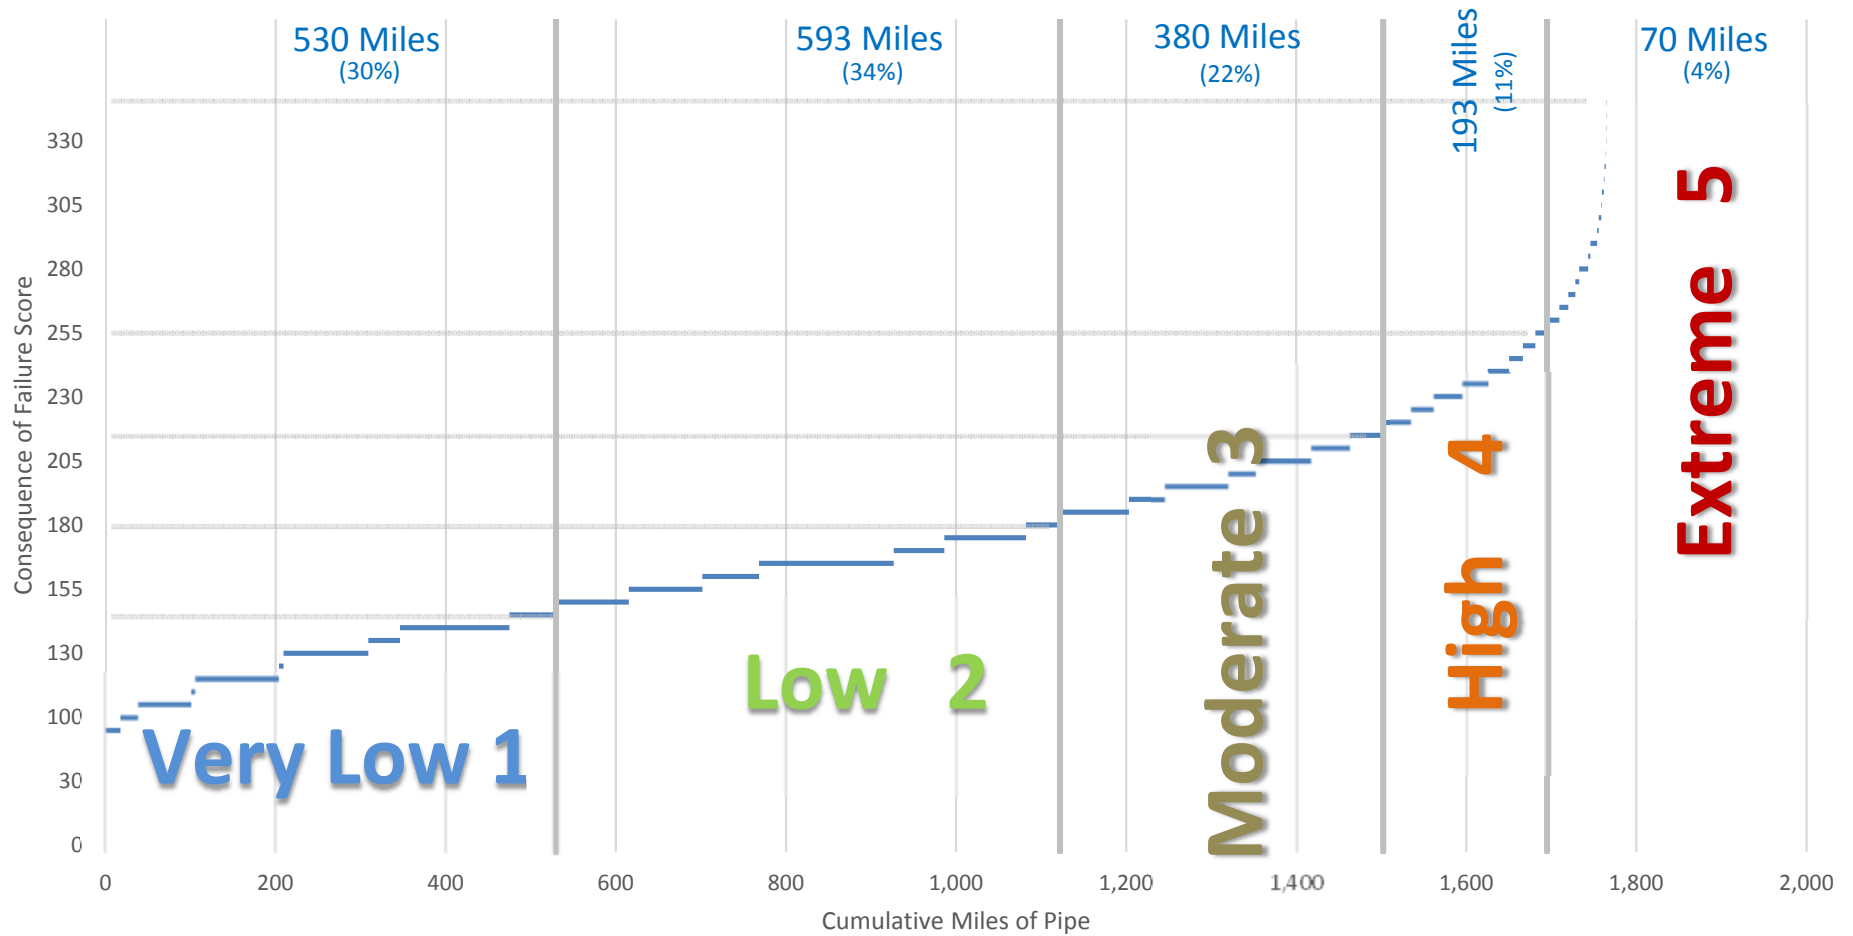
Consequence of Failure

Note: Cumulative miles of pipeline shown represent distribution system and do not include RTMs.

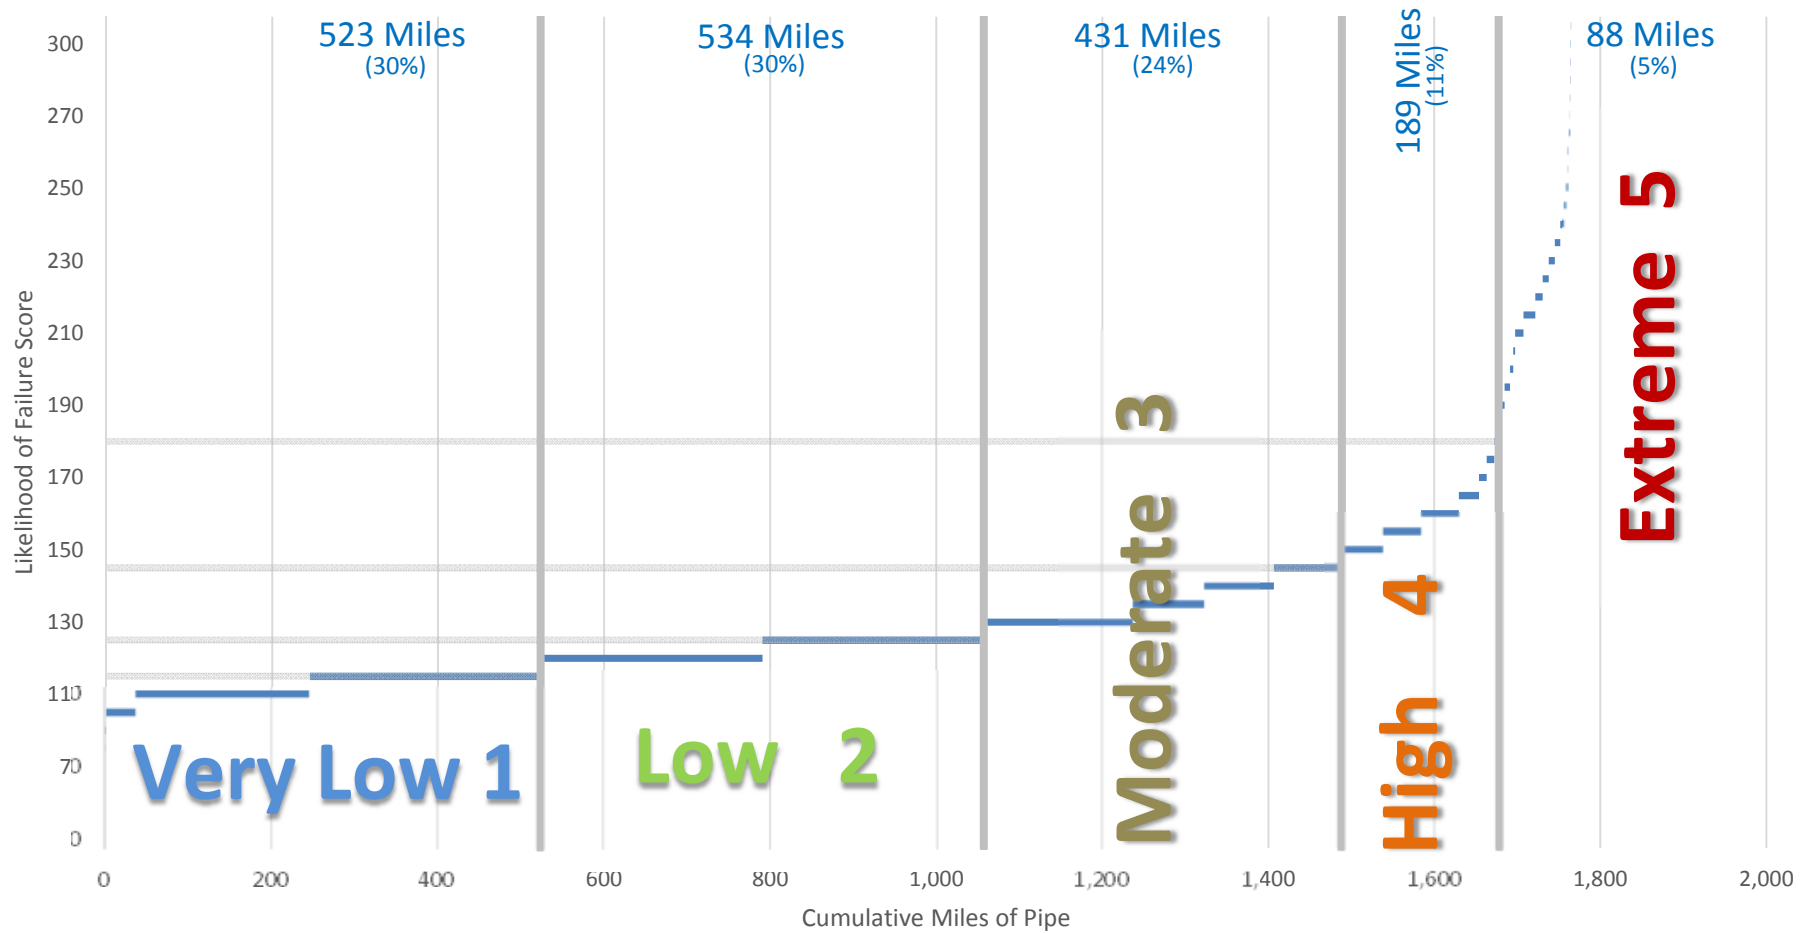
Likelihood of Failure

Note: Cumulative miles of pipeline shown represent distribution system and do not include RTMs.

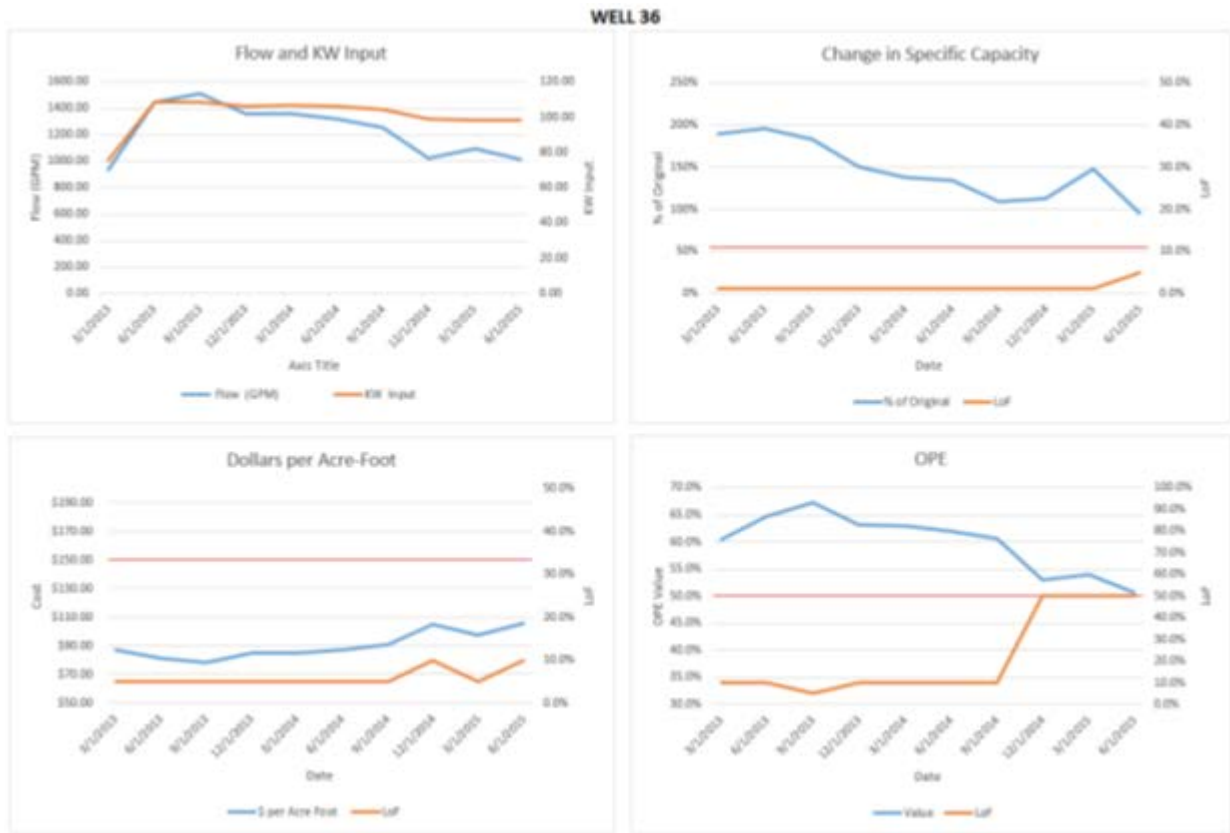
Figure 3.1: Example of KPIs for Energy Use, Specific Capacity, and Change in Efficiency over time for Well 36

During a planning workshop in September 2017, Kleinfelder discussed with the City the use of each of these KPIs as potential metrics for the well assessment. The City agreed on the use of these KPIs to the extent possible given the availability of data. The pilot report is presented in [Appendix C](#).

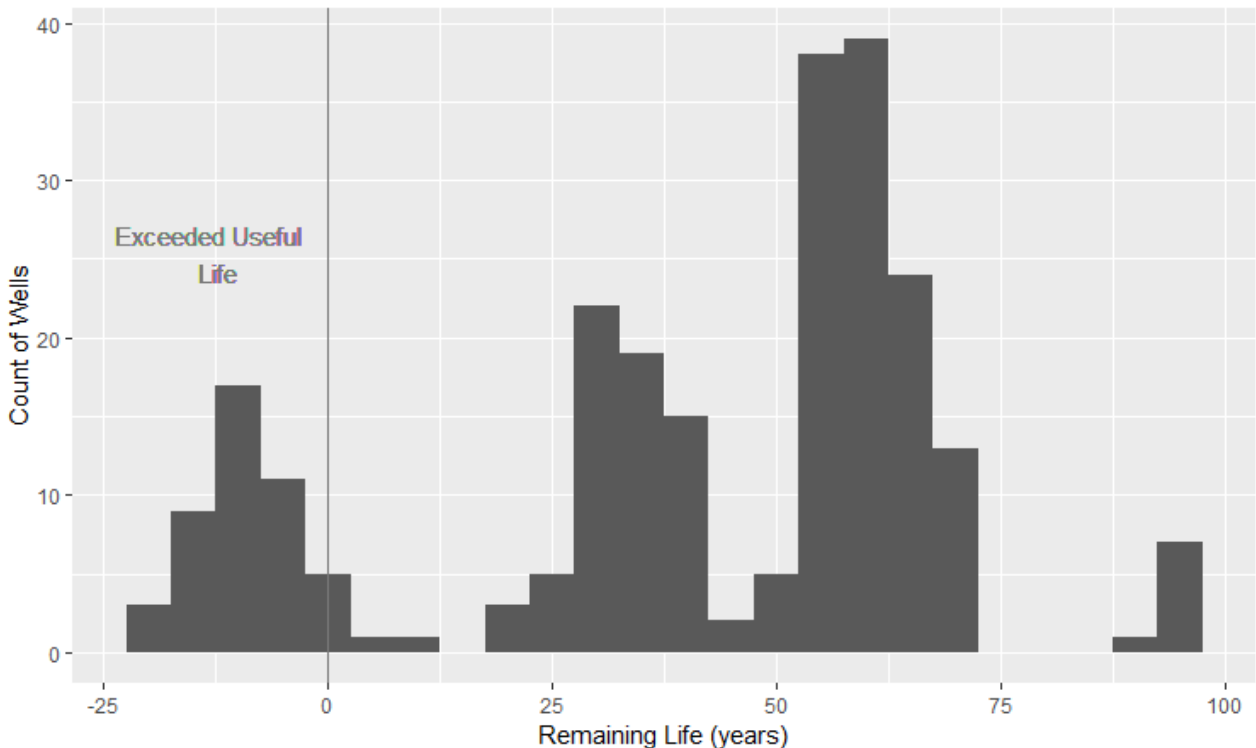
Figure 3.16: Estimated Remaining Useful Life of Wells

In the 2017 O&M Plan, 10 wells were listed as not suitable for rehabilitation due to their extremely poor condition. These wells were excluded from the prioritization process along with the wells excluded from the most valuable well analysis due to operational considerations. Additional wells, 16A and 60, 100-1, 100-2, 105, were added to this list of excluded wells excluded from R&R recommendations with reasoning as listed in [Table 3.29](#).

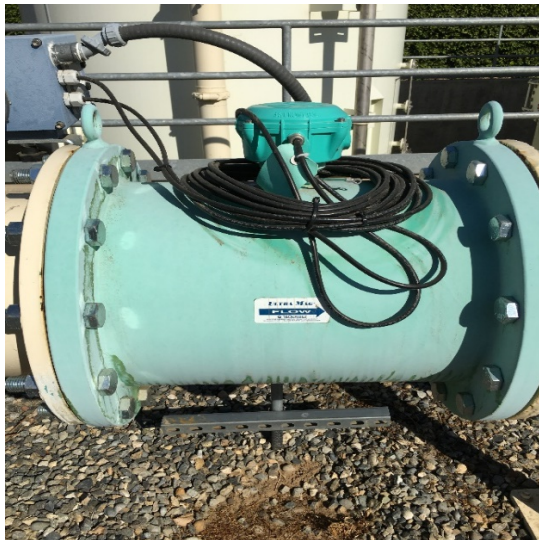
Figure 4.6: Flow Meter No. 1 Nameplate

The influent flow meter is an Ultra Mag magnetic flow meter with 316 stainless steel electrodes and a McCrometer display. The size of the flow meter appears to be 12". All components are above-ground and exposed. **Figure 4.6** shows the Well 354 flow meter and **Figure 4.7** shows the flow meter nameplate.

The components show some signs of deterioration of the coating due to sun light exposure and minor corrosion especially around bolt locations. However, these defects appear to be purely cosmetic.

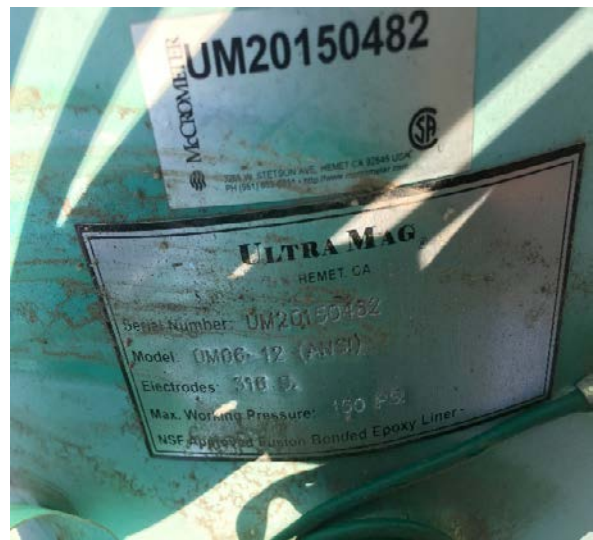
Figure 4.7: Well 354 Flow Meter No. 1

The components have been fully operational without significant shutdowns. The flow meters require calibration every two weeks as part of routine maintenance. The flow meter was recently refurbished in 2013.

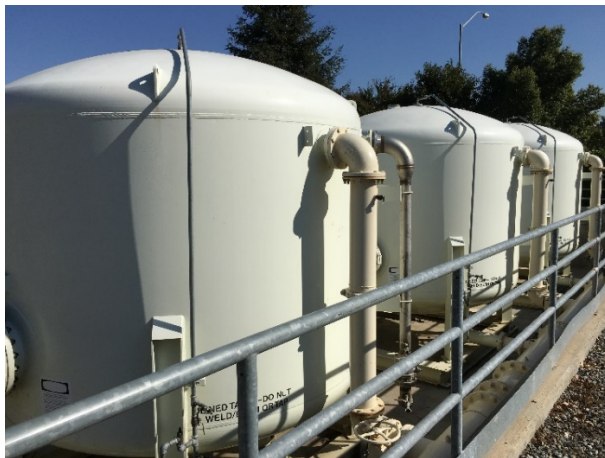
Figure 4.8: GAC Vessels at Wellhead Site 354

Three GAC vessels are located on site to treat extracted groundwater. The GAC vessel is provided by Calgon Carbon Corporation and was certified in 2008. Each GAC vessel is a welded tank of unknown capacity, and includes inlet and outlet piping, three stainless steel injection and sample ports, an outlet valve, and an outlet flow meter. **Figure 4.8** shows the Well 354 GAC vessels and **Figure 4.9** shows the GAC vessel 2 nameplate.

The GAC vessels appear to be in good condition with no signs of major defects.

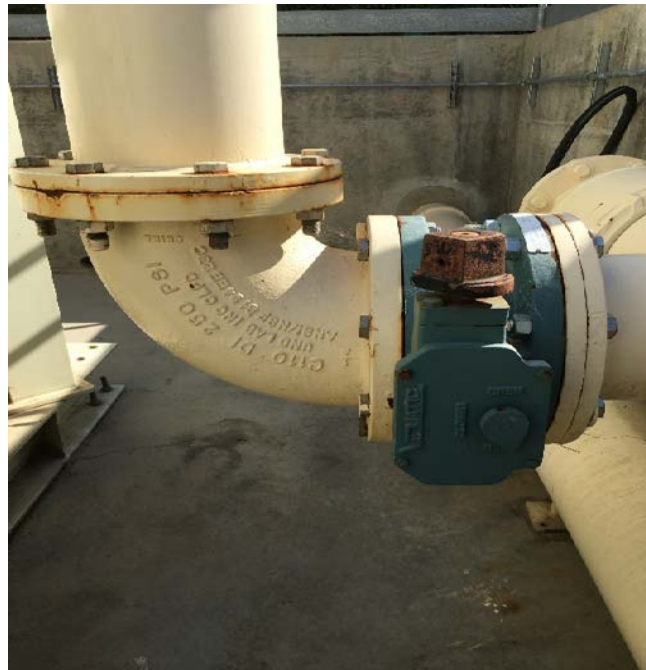
There are signs of minor corrosion in localized areas, particularly around small injection ports. Some signs of oil leaks around valve housings were observed. Flanged connections exhibited some signs of corrosion but were in overall good condition as shown on **Figure 4.10**. No bypass piping was observed within the treatment train at the GAC vessels.

Figure 4.10: Minor Corrosion at GAC Vessel Piping Flanged Connections

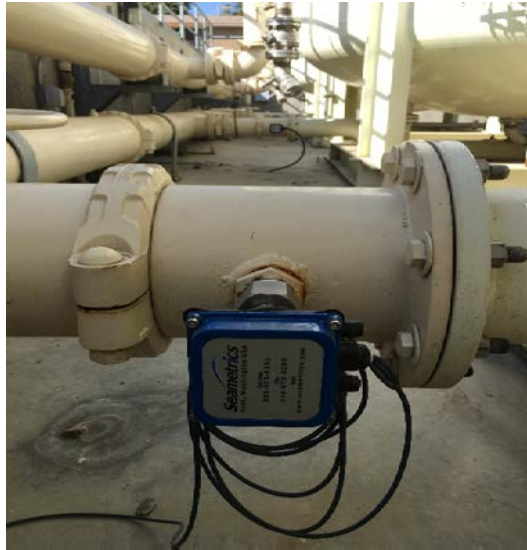
Figure 4.11: GAC Outlet Flow Meter No. 3

The GAC vessel outlet flow meters and sensors are Seametrics Model TX110S insertion turbine flow sensors and have been in operation since 2013. The flow sensors transfer information to flow meters that are in an on-site housing away from the GAC vessels. [Figure 4.11](#) shows the GAC outlet flow meter No. 3.

The flow meters and sensors appeared to be in good condition, with only minor corrosion around the points of injection.

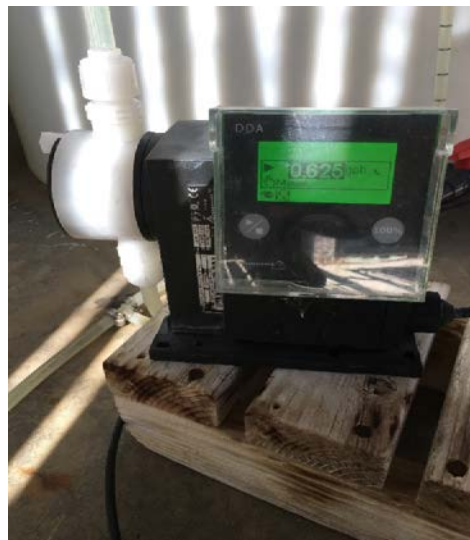
Figure 4.12: Chlorine Dosing Pump at Wellhead Site 354

The chlorine pump is a Grundfos Type DDA 7.5-16 dosing pump that has been in operation since 2011. It regularly doses chlorine from an on-site chlorine storage tank into the treatment stream downstream of the GAC vessels. The pump and storage tank are housed in an on-site, ventilated housing with a locking door. **Figure 4.12** shows the chlorine dosing pump at Well 354.

The dosing tubing inside the pump require frequent replacement as they typically have a short lifespan. Routine and as-needed maintenance are performed. No other issues have been experienced with the pumps.

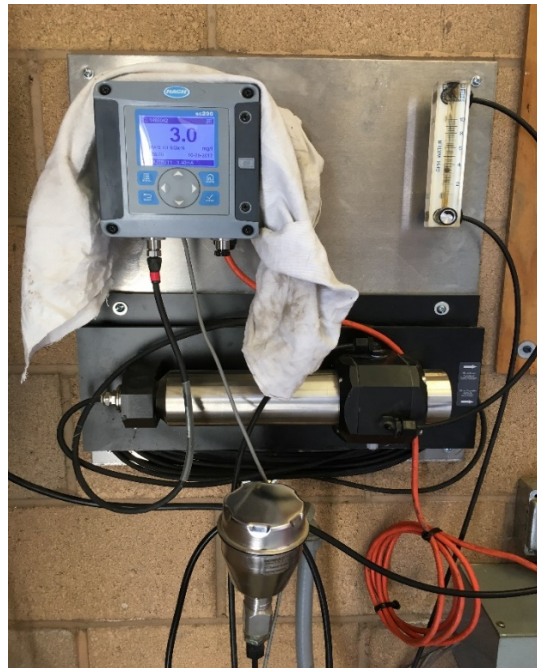
Figure 4.13: Nitrate Analyzer at Wellhead Site 354

The operators had no comments on the nitrate analyzers as they have been operating as intended with no issues.

The analyzers appear to be in good overall working condition with no signs of wear.

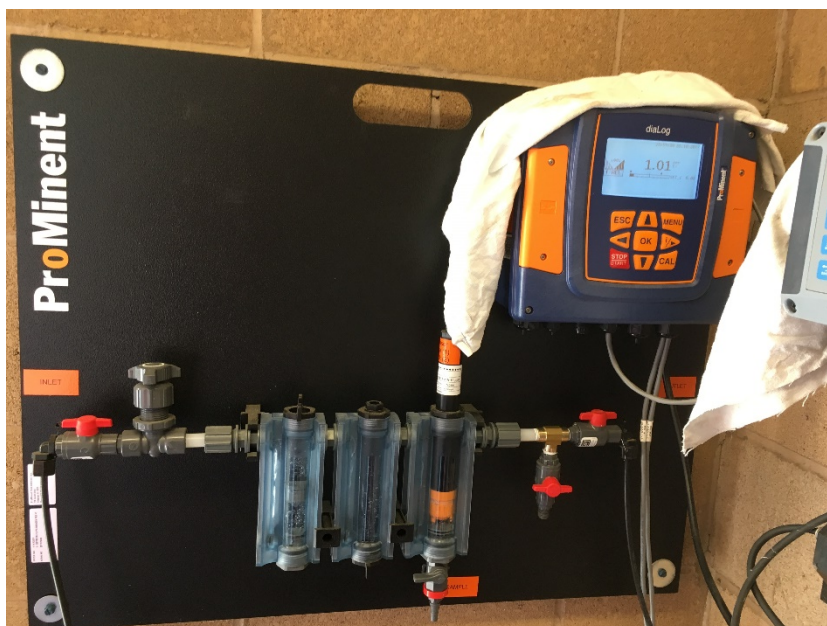
Figure 4.14: Chlorine Analyzing System at Wellhead Site 354

The analyzers appear to be in good overall working condition with no signs of wear.

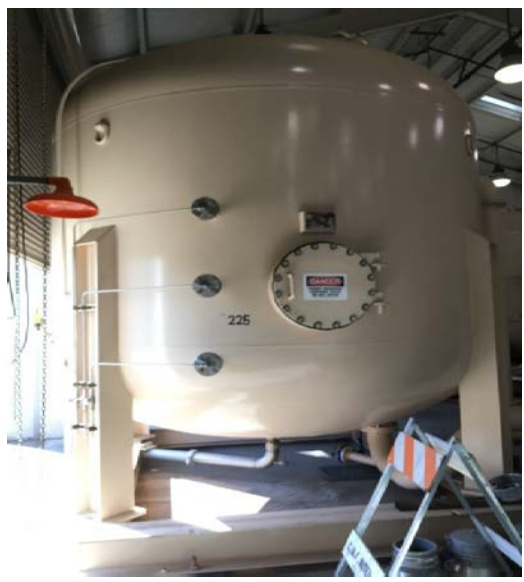
Figure 4.15: GAC Vessel at Wellhead Site 225

The GAC vessel is located on-site to treat the groundwater. The GAC vessel is certified by ITEQ Storage Systems, Inc and was built in the year 2000. The GAC vessel has 7,895-gallon capacity, and includes an inlet and outlet piping, three (3) stainless steel injection and sample ports, an outlet valve, and an outlet flow meter. **Figure 4.15** shows the Well 225 GAC vessels and **Figure 4.16** shows the GAC vessel nameplate.

The operator noted that there are no existing issues with the GAC vessels and associated piping components. Regular maintenance is performed on these components. The GAC is replaced as-needed.

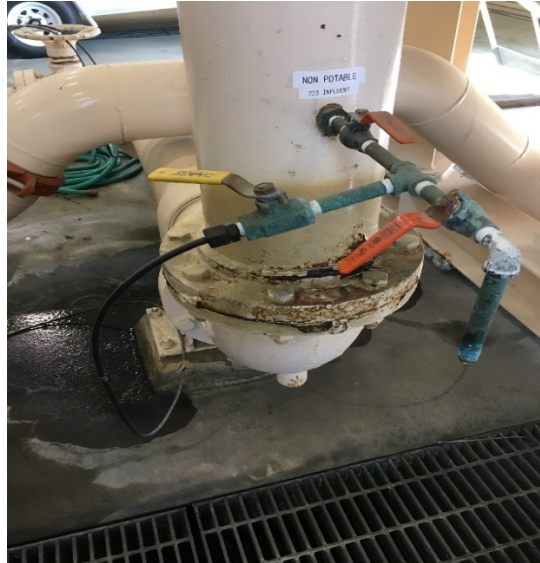
The GAC vessel appears to be in good condition with no signs of major defects. There are signs of corrosion in localized areas, particularly around small injection ports and flanged connections. Some signs of oil leaks around valve housings were observed. Flange connections exhibited some signs of corrosion but were in overall good condition as shown of [Figure 4.17](#). No bypass piping was observed at the location of the vessel.

Figure 4.17: Corrosion at GAC Vessel Outlet Piping

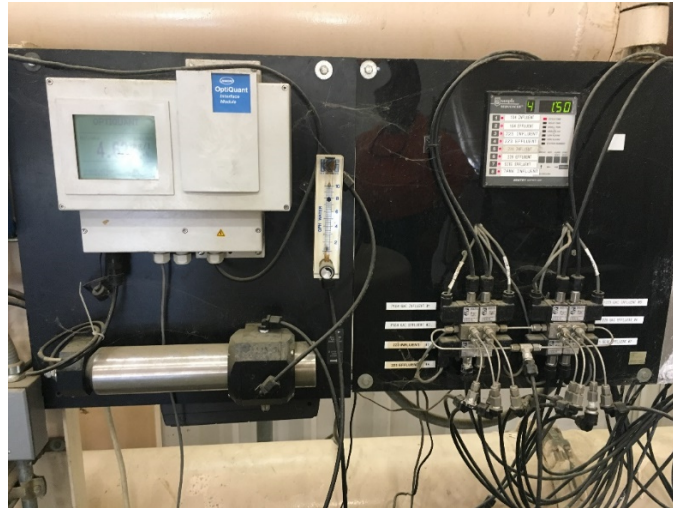
Figure 4.18: Nitrate Analyzing System at Wellhead Site 225

The nitrate analyzing system is comprised of a Hach OptiQuant Interface Module and a Sentry Sample Sequencer. The system was installed in 2010 and is located adjacent to the treatment piping. Nitrate is measured at multiple points throughout the treatment stream, including the influent and effluent of the GAC vessel, effluent of the site, and influent and effluent to the storage tank. The sampler sequences the analysis between the different points. [Figure 4.18](#) shows the Well 225 nitrate analyzing system.

The operators had no comments on the nitrate analyzers as they have been operating as intended with no issues.

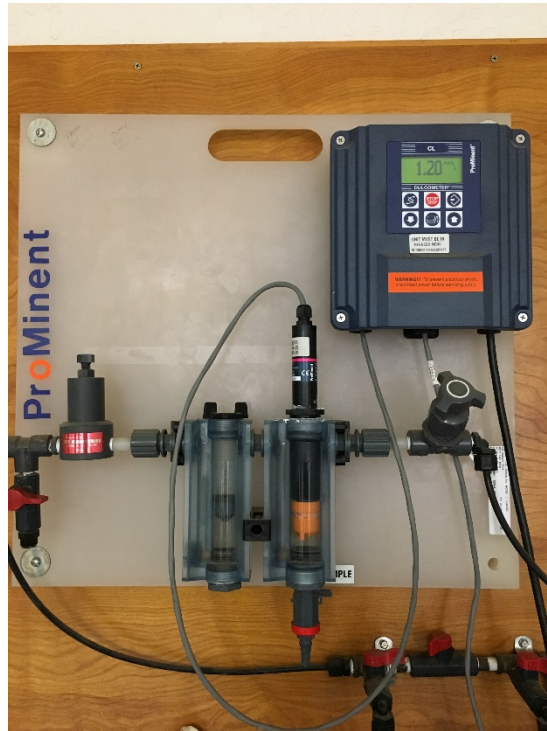
Figure 4.19: Chlorine Analyzing System at Wellhead Site 225

The chlorine analyzing system is a ProMinent Fluid Controls, Inc. analyzing system, with a measuring range of 1-10 PPM that was installed in 2013. Chlorine is measured downstream of the storage tank prior to distribution. **Figure 4.19** shows the Well 225 chlorine analyzing system.

The chlorine analyzers require calibration every two weeks as part of routine maintenance.

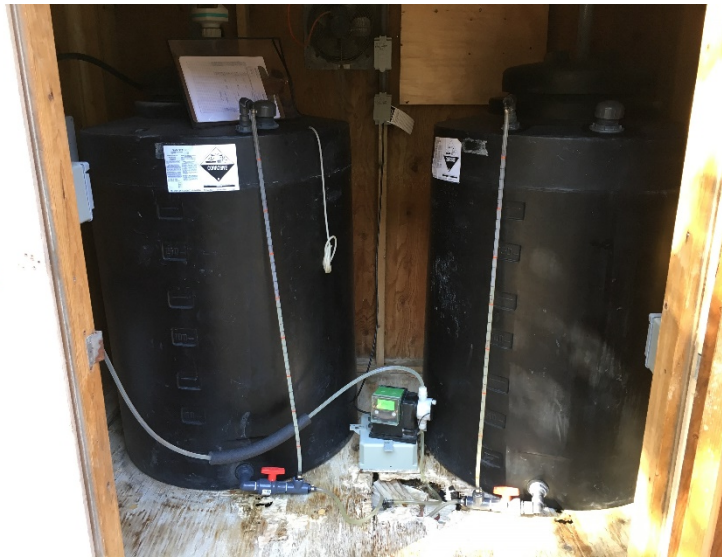
Figure 4.20: Sodium Hypochlorite Tank and Pump at Wellhead Site 225

The chlorine pump is a Grundfos Type DDA 7.5-16 dosing pump and was installed in 2011. It regularly doses chlorine from an on-site chlorine storage tank into the treatment stream downstream of the GAC vessels. The pump and storage tank are housed in an on-site, ventilated housing with a locking door. **Figure 4.20** shows the Well 225 sodium hypochlorite tank and pump.

The dosing tubing inside the pump require frequent replacement as they typically have a short lifespan. Routine and as-needed maintenance are performed. No other issues have been experienced with the pumps.

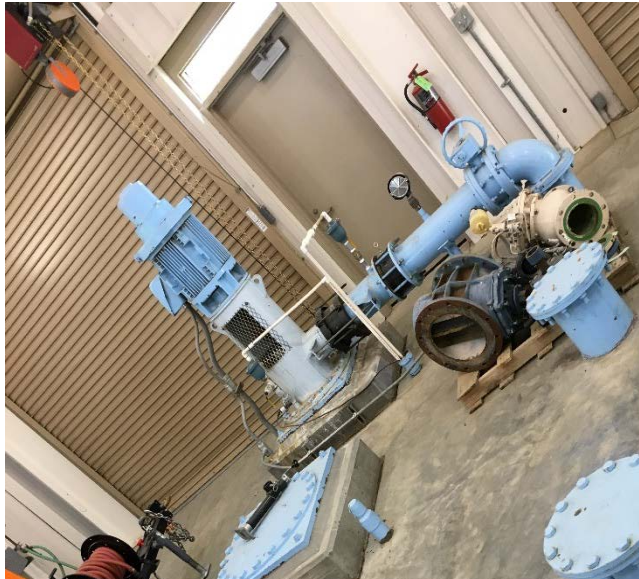
Figure 4.21: Booster Pump #1 at Wellhead Site 225

The booster pumps are Floway vertical turbine pumps with 50 HP General Electric vertical motors and were installed in 1996. There are four (4) pumps, with space for two (2) additional pumps. [Figure 4.21](#) shows the Well 225 booster pump No. 1 and [Figure 4.22](#) shows the booster pump motor No. 1 nameplate.

The operator noted that the pumps worked well with no major issues. The pumps are regularly maintained for upkeep of their operation.

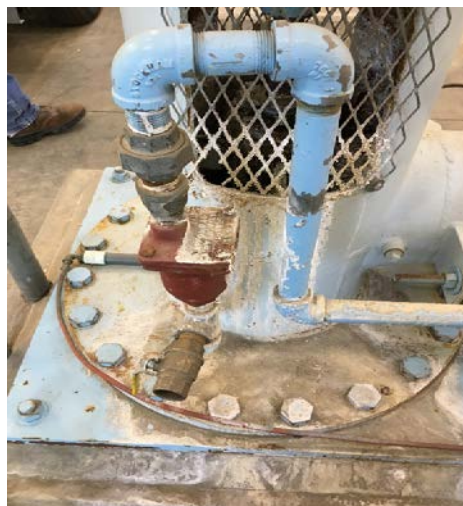
The pumps exhibited some corrosion and buildup at ports and bolt locations as shown on [Figure 4.23](#). The pumps did not turn on at the time of observation.

Figure 4.23: Corrosion at Boost Pump #1

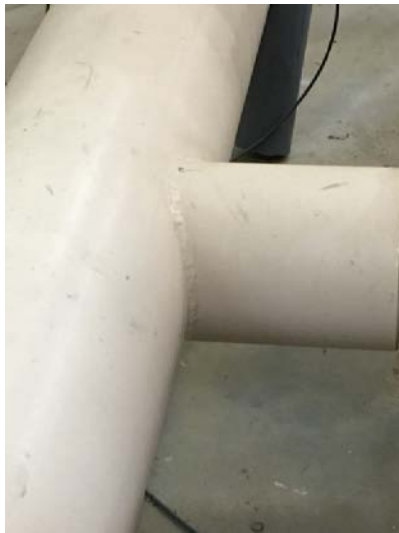
**Figure 4.24: Welded Tee Connection
Between Wells 184 & 225**

Treated water from Wells 225 and 184 blends at Wellhead site 225. The connection consists of a welded-tee connection shown on [Figure 4.24](#), of Well 184 effluent into Well 225 effluent, and control valves on both lines as shown on [Figure 4.25](#).

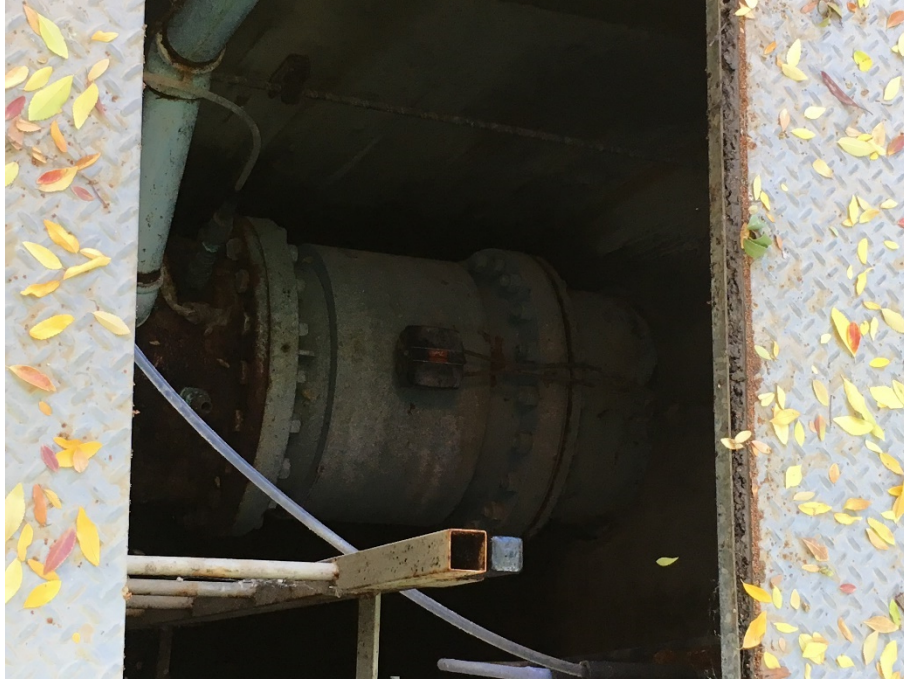
Figure 4.26: Flow Meter No. 2 at Wellhead Site 225

Flow meter no. 2 at wellhead site 225 measures the flow of the effluent water from the site. It was installed in 2000 and is located in a deep vault on the outside perimeter of the site. This valve was visually seen from the ground level, but its physical condition could not be observed. [Figure 4.26](#) shows the Well 225 flow meter No. 2.

This flow meter is not frequently accessed since it is buried. Frequent failures are experienced with SCADA communication between the flow meter and the receiving equipment.

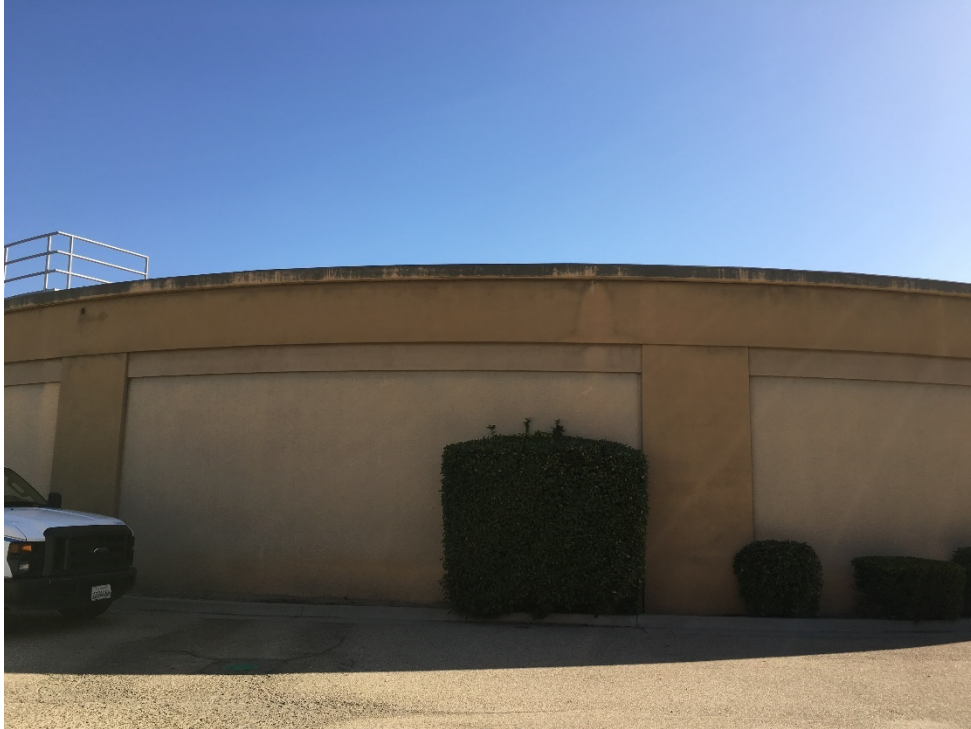
Figure 4.27: 2-MG Storage Tank at Wellhead Site 225

The 2-MG tank on-site is served to store treated water blended from wellhead sites 184, 225 and 223-3. It is a cylindrical, partially-buried prestressed concrete tank. **Figure 4.27** shows the 2 MG storage tank.

The inside of the tank is serviced and cleaned every two years to clean out sediment buildup. The tank and components are in maintained in very good condition.

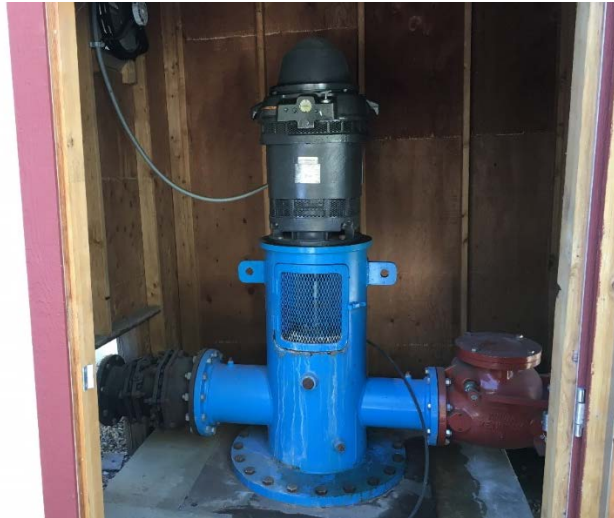
Figure 4.28: Booster Pump and Motor at Wellhead Site 143

The booster pump boosts pump from the extracted groundwater within the well. The pump type is unknown as no nameplate was visible. The motor is a 40 HP Emerson motor. The Well 143 booster pump and motor are shown on [Figure 4.28](#). The pump and motor are housed in a separate, ventilated enclosure with a locking door.

No known major issues. The pump and motor go under routine maintenance.

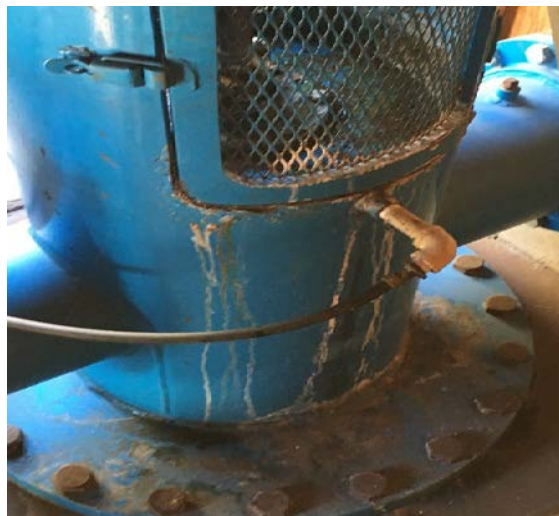
The pump exhibited some oil leaking, corrosion, and buildup from the shaft as shown on **Figure 4.29**. The pump was in overall good condition.

Figure 4.29: Corrosion at Booster Pump

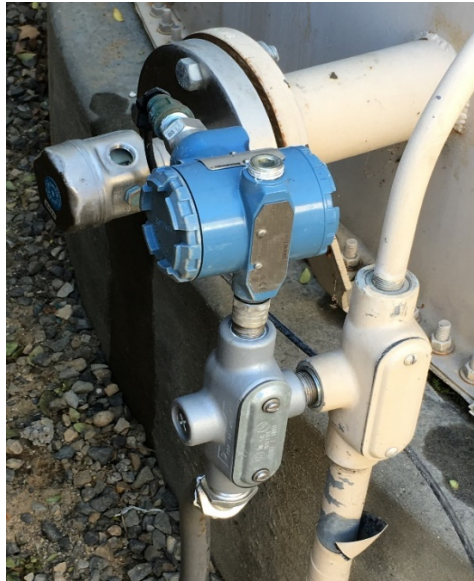
Figure 4.30: Degassing Tank Level Instrument at Wellhead Site 143

The degassing tank on site contains a Rosemount pressure analyzer that detects the water level inside the tank. **Figure 4.30** shows the Well 143 degassing tank level instrument and **Figure 4.31** shows the level instrument nameplate.

This component is fairly new.

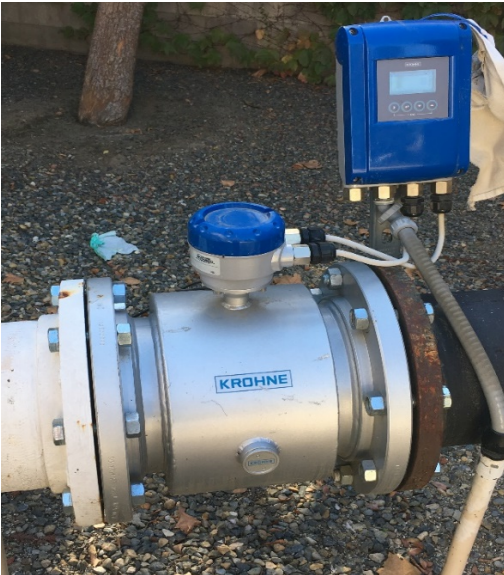
Figure 4.32: Flow Meter No. 1 at Wellhead Site 143

The influent flow meter is a Krohne Enviromag 2000 F CSA electromagnetic flow meter with a Krohne KFC 100W display. The size of the flow meter appears to be 8". All components are above-ground and exposed. **Figure 4.32** shows Well 143 flow meter No. 1 and **Figure 4.33** shows the flow meter No. 1 nameplate.

The components have been fully operational without significant shutdowns. The flow meters require calibration every two weeks as part of routine maintenance.

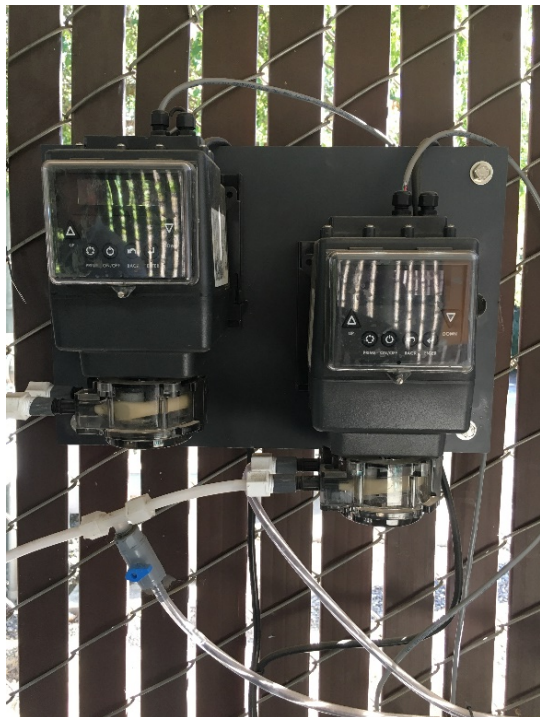
Figure 4.34: Chlorine & Dosing Pump at Wellhead Site 143

The chlorine pump is a Stenner S3007 dosing pump. The pump and storage tank are housed in an on-site, ventilated housing with a locking door. [Figure 4.34](#) shows the Well 143 chlorine and dosing pump and [Figure 4.35](#) shows the chlorine dosing pump nameplate.

The dosing tubing inside the pump require frequent replacement as they typically have a short lifespan. Routine and as-needed maintenance are performed. No other issues have been experienced with the pumps.

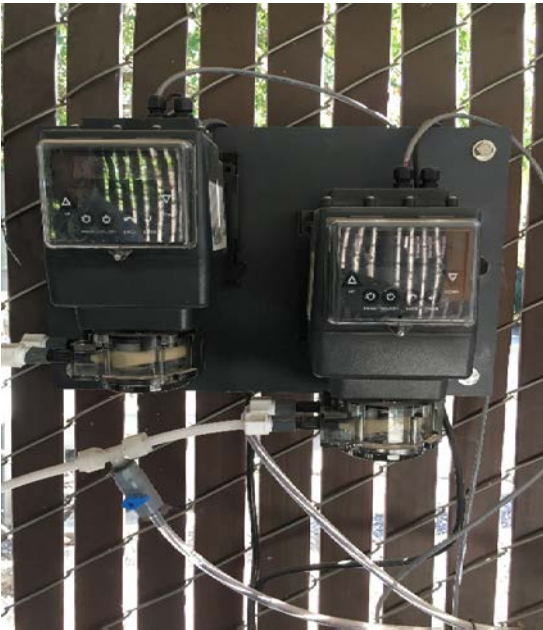
Figure 4.36: Chlorine & Orthopolyphosphate Dosing Pump at Wellhead Site 143

The orthophosphate pump is a Stenner S3007 dosing pump. The pump and storage tank are housed in an on-site, ventilated housing with a locking door. [Figure 4.36](#) shows the Well 143 chlorine and Orthopolyphosphate pump and [Figure 4.37](#) shows the dosing pump nameplate.

The dosing tubing inside the pump require frequent replacement as they typically have a short lifespan. Routine and as-needed maintenance are performed. No other issues have been experienced with the pumps.

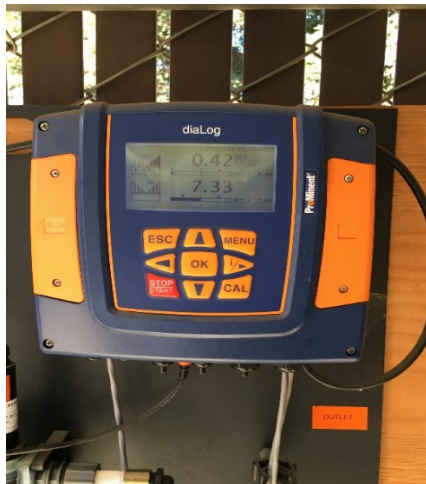
Figure 4.40: pH Analyzer at Wellhead Site 143

The pH is analyzed using a ProMinent Fluid Controls, Inc. pH analyzing system. The system is located in a ventilated enclosure with a locking door. The distribution water is measured for pH. All sites in north-east Fresno with Orthopolyphosphate include pH probes. **Figure 4.40** shows Well 143 pH analyzer and **Figure 4.41** shows the pH analyzer nameplate.

The operators had no comments on the pH analyzers as they have been operating as intended with no issues.

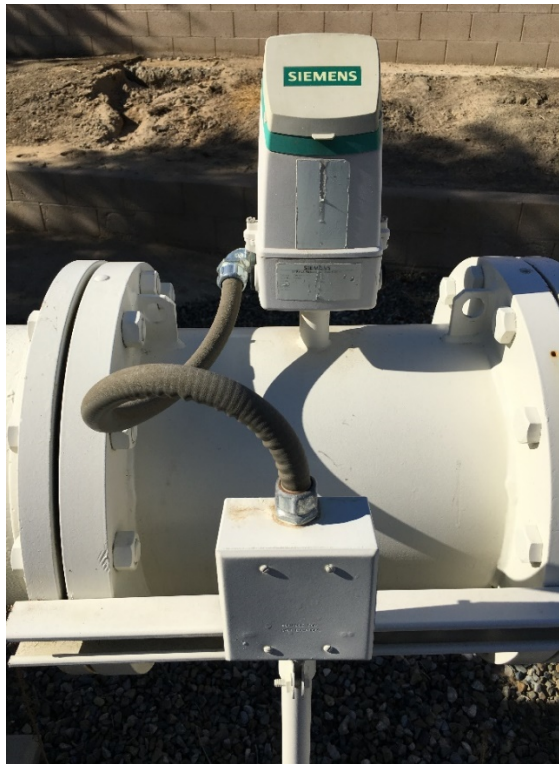
Figure 4.42: Flow Meter No. 1 at Wellhead Site 330

The influent flow meter is a Siemens magnetic flow meter with 316 stainless steel electrodes. The size of the flow meter appears to be 12". All components are above-ground and exposed. **Figure 4.42** shows Well 330 flow meter No. 1 and **Figure 4.43** shows the flow meter No. 1 nameplate.

The components have been fully operational without significant shutdowns. The flow meters require calibration every two weeks as part of routine maintenance.

The components show some signs of deterioration of the coating due to sun light exposure and minor corrosion especially around bolt locations. However, these defects appear to be purely cosmetic.

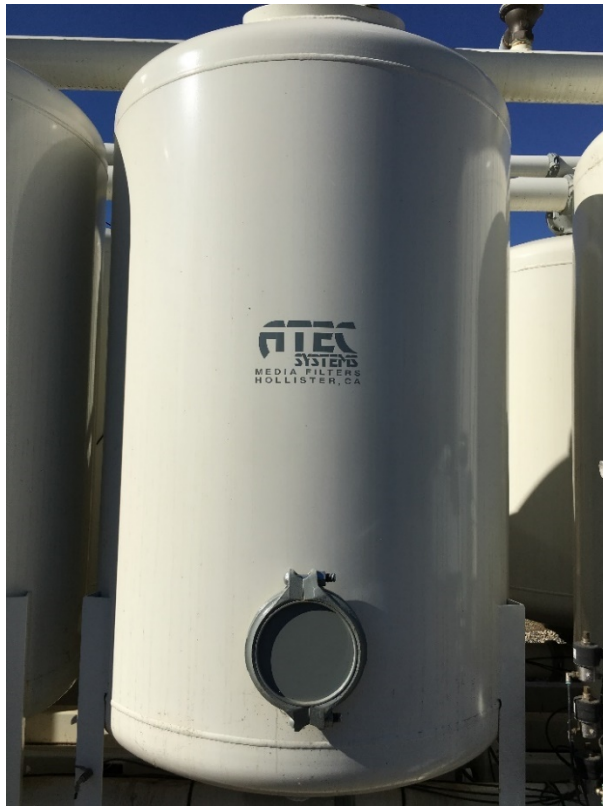
Figure 4.44: Filter Vessel at Wellhead Site 143

Systems media filters. There are eight (8) filters in series. An Alex-Tronix control panel is located on site. **Figure 4.44** shows the Well 330 filter vessel and **Figure 4.45** shows the filter control panel.

The operator noted that there are no existing issues with the filter vessels and associated piping components. However, some operational issues arise when the filters are being backwashed. Backwash cycles frequently go out of sync to due manual input of backwash volume by the operators. This volume needs to run against production volume, which varies by season.

The filter vessels and associated components appear to be in good condition with no signs of major defects.

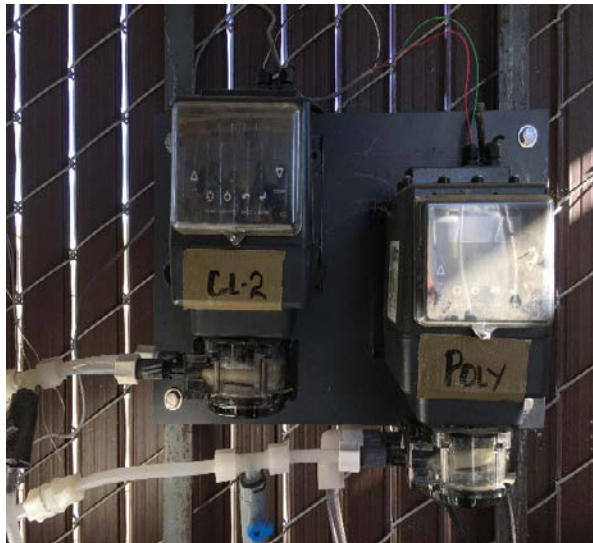
Figure 4.46: Chlorine & Orthopolyphosphate Dosing Pump

The chlorine pump is a Stenner S3007 dosing pump. The pump and storage tank are housed in an on-site, ventilated housing with a locking door. [Figure 4.46](#) shows the Well 330 Orthophosphate Dosing Pump and [Figure 4.47](#) shows the dosing pump nameplate.

The dosing tubing inside the pump require frequent replacement as they typically have a short lifespan. Routine and as-needed maintenance are performed. No other issues have been experienced with the pumps.

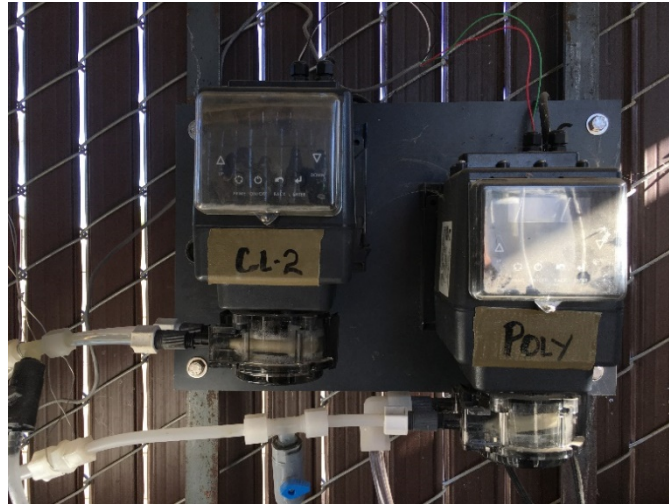
Figure 4.48: Chlorine & Orthopolyphosphate Dosing Pump

The pump appeared to be in good condition, with no signs of wear or corrosion as shown on [Figure 4.48](#).

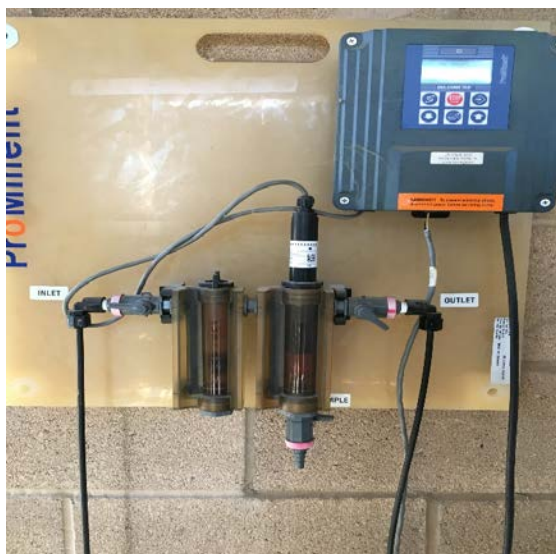
Figure 4.49: Chlorine Analyzing System at Wellhead Site 330

The chlorine analyzing system is a ProMinent Fluid Controls, Inc. analyzing system, with a measuring range of 1-10 PPM. Chlorine is measured pre- and post-filtration. **Figure 4.49** shows the Well 330 chlorine analyzing system and **Figure 4.50** shows the chlorine analyzer nameplate.

The influent chlorine analyzing chamber is darkly discolored due to the high levels of manganese experienced at this well site. High levels of manganese also cause issues with chlorine analysis. The chlorine analyzers require calibration every two weeks as part of routine maintenance.

The analyzers appear to be in good overall working condition with no signs of wear.

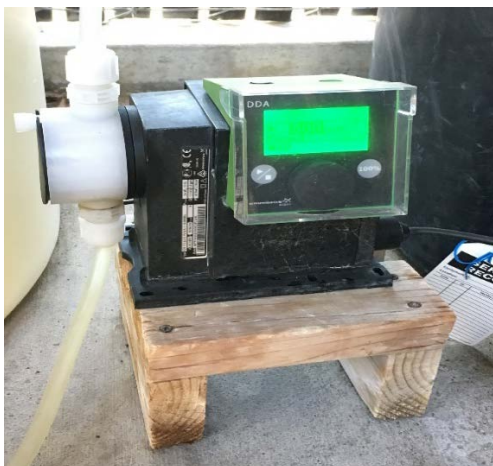
Figure 4.51: Chlorine Dosing Pump at Wellhead Site 70

The chlorine pump is a Grundfos Type DDA 7.5-16 dosing pump. It regularly doses chlorine from an on-site chlorine storage tank into the treatment stream at the head of the treatment process. The pump and storage tank are housed in an on-site, ventilated housing with a locking door. **Figure 4.51** shows the Well 70 chlorine dosing pump and **Figure 4.52** shows the pre-chlorine pump nameplate.

The dosing tubing inside the pump require frequent replacement as they typically have a short lifespan. Routine and as-needed maintenance are performed. No other issues have been experienced with the pumps.

The pump appeared to be in good condition, with no signs of wear or corrosion.
