Drinking Water Infrastructure Renewal and Replacement Plan

**AUGUST 2019
FINAL**

AKEL
ENGINEERING GROUP, INC.

CITY OF FRESNO

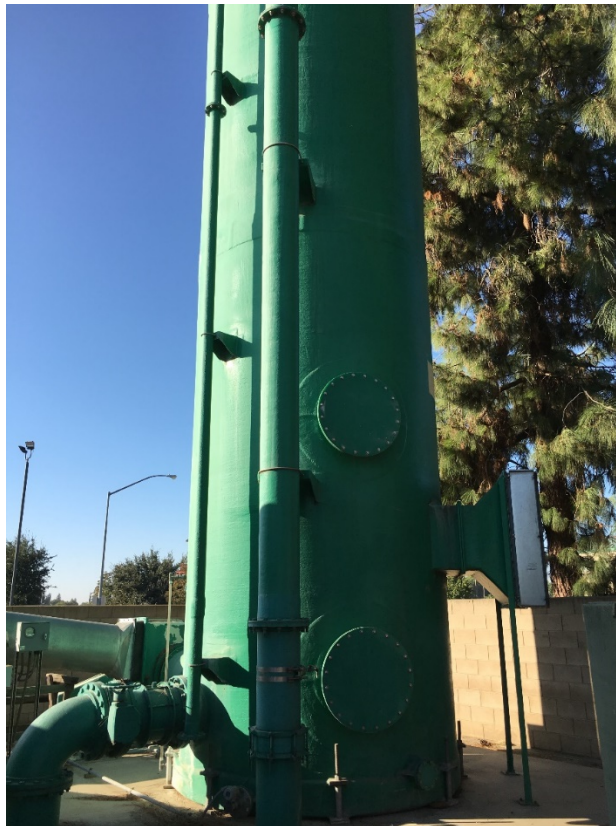
Figure 4.53: Packed Tower at Well 70

The packed tower is located on site to treat extracted groundwater. No information regarding the manufacturer and type of packed tower is known. **Figure 4.53** shows the Well 70 packed tower.

Operation's staff noted that the geodesic balls within the packed tower had been recently changed. The tower undergoes routine maintenance. No known issues are experienced with the packed tower.

No conditional comments regarding the packed tower.

- *Packed Tower: Risk score 6.67; recommended on-site refurbishment – add bypass*
- *GAC Vessel: Risk score 6.00; regular maintenance recommended*
- *Chlorine analyzer: Risk score 5.00; recommended to add an on-shelf spare*

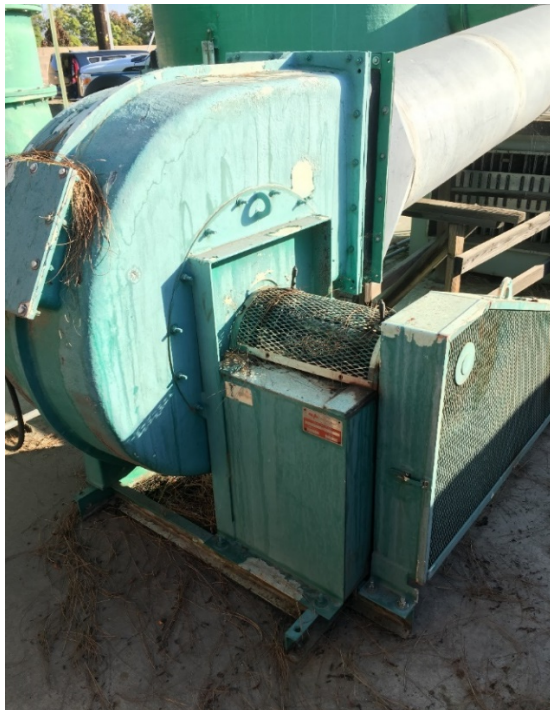
Figure 4.54: Air Blower at Wellhead Site 70

The air blower is located upstream of the packed tower. It is a 24-inch New York Blower Company fume exhauster. **Figure 4.54** shows the Well 70 air blower and **Figure 4.55** shows the air blower nameplate.

The air blower undergoes routine maintenance. No other known issues are experienced.

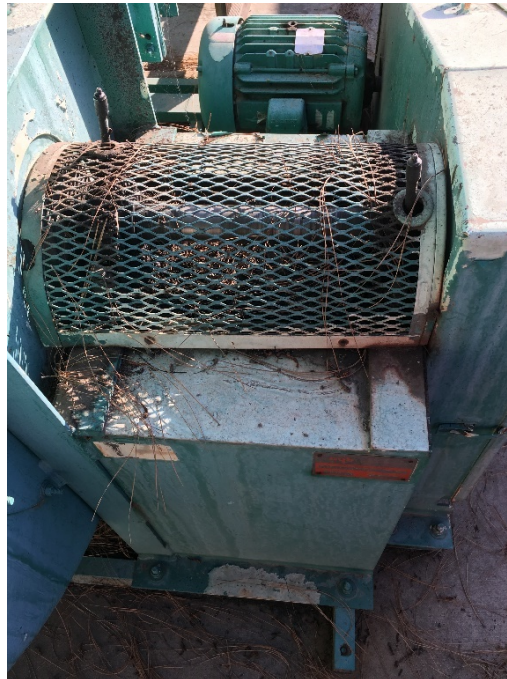
Figure 4.56: Corrosion and Chipping Paint at Air Blower

Minor corrosion, chipping paint, and oil drippings are exhibited around the housing as shown on [Figure 4.56](#).

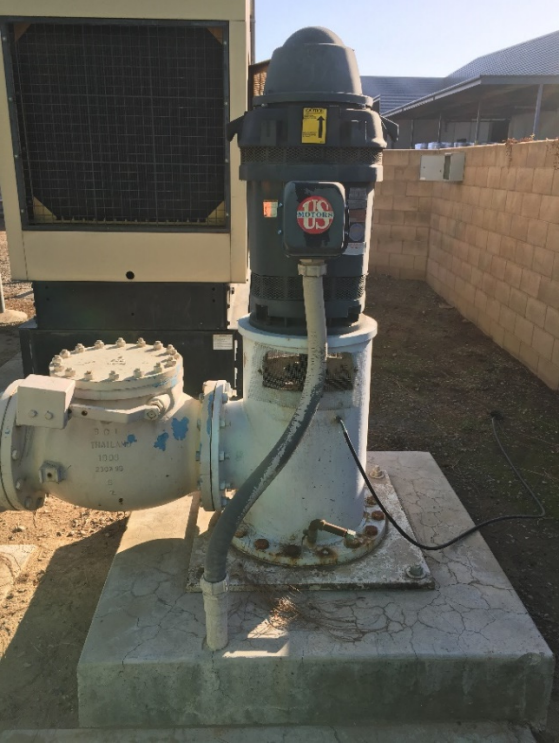
Figure 4.57: Booster Pump at Wellhead Site 70

The booster pump is a vertical turbine pumps with 75 HP US Motors vertical motor. [Figure 4.57](#) shows the Well 70 booster pump and [Figure 4.58](#) shows the booster pump motor nameplate.

The pumps exhibited some corrosion and buildup at ports and bolt locations. The pump did not run at the time of observation

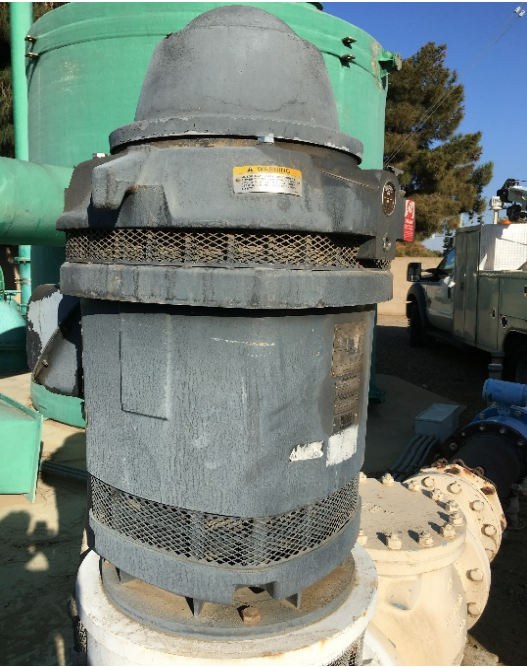
Figure 4.59: Minor Corrosion of Motor

The operator noted that the pumps worked well with no major issues as shown on [Figure 4.59](#). The pump is regularly maintained for upkeep.

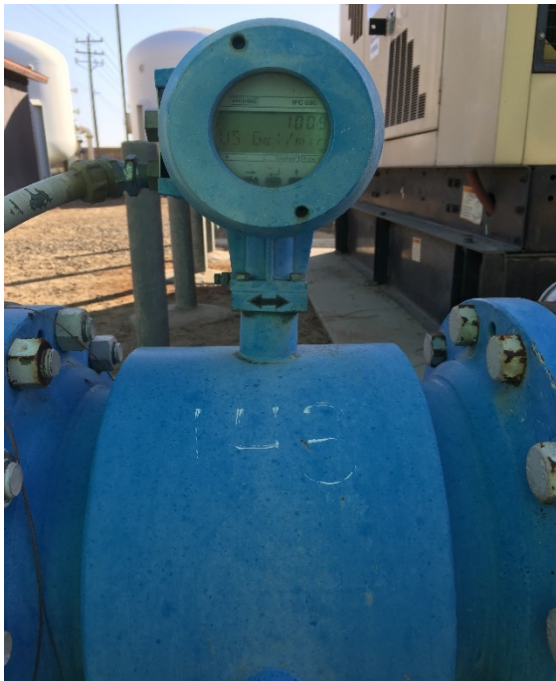
Figure 4.60: Flow Meter No. 1 at Wellhead Site 70

The influent flow meter is an Altometer K480 10-inch magnetic flow meter with a Krohne digital display. All components are above-ground and exposed. **Figure 4.60** shows the Well 70 flow meter No. 1 and **Figure 4.61** shows the flow meter No. 1 nameplate.

The components show some signs of deterioration of the coating due to sun light exposure and minor corrosion especially around bolt locations. However, these defects appear to be purely cosmetic.

- *Pre-chlorination pump: Risk score 4.00; regular maintenance recommended*
- *Post-chlorination pump: Risk score 4.00; regular maintenance recommended*
- *Flow meter: Risk score 4.00; recommended to add bypass*
- *Air blower: Risk score 3.33; recommended to replace once past useful service life*
- *GAC vessel pressure reducing valve: Risk score 1.67; regular maintenance recommended*

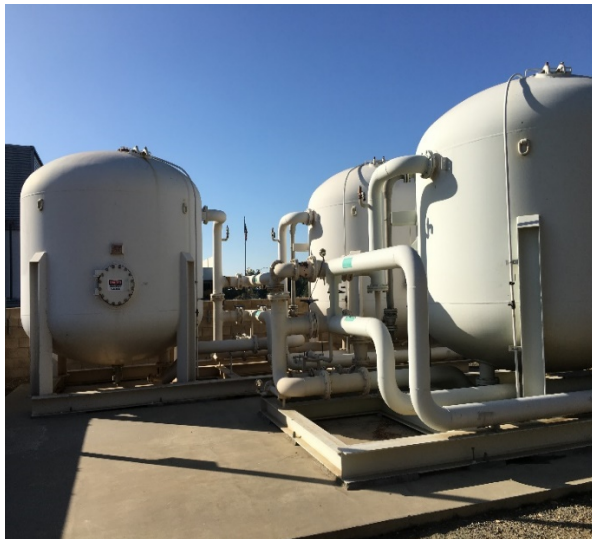
Figure 4.62: GAC Vessels at Wellhead Site 70

Three GAC vessels are located on site to treat extracted groundwater. The GAC vessels are certified by Trusco Tank Inc. Each GAC vessel is a 7,895-gallon welded tank, and includes inlet and outlet piping, three stainless steel injection and sample ports, an outlet valve, and an outlet flow meter. **Figure 4.62** shows the Well 70 GAC vessels and **Figure 4.63** shows the GAC vessel 2 nameplate.

Operation's staff noted that there are no existing issues with the GAC vessels and associated piping components. Regular maintenance is performed on these components. The GAC is replaced regularly. One issue is that the GAC vessels are vandalized as the site is trespassed on by transients frequently.

The GAC vessels appear to be in good condition with no signs of major defects. There are signs of minor corrosion in localized areas, particularly around small injection ports. Some signs of oil leaks around valve housings were observed. Flanged connections exhibited some signs of corrosion but were in overall good condition as shown on **Figure 4.64**.

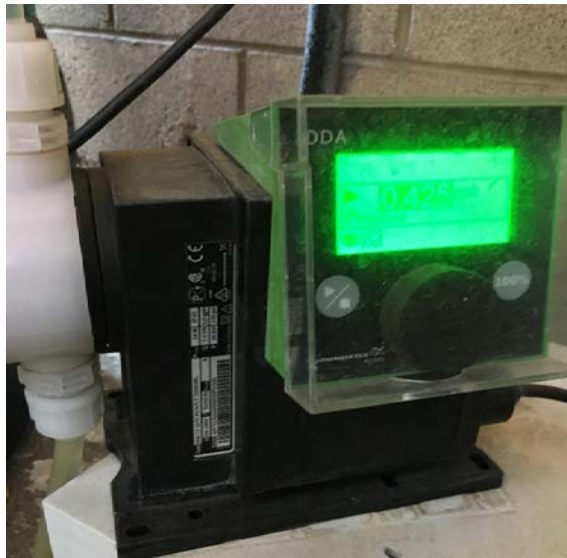
Figure 4.67: Post-Chlorine Dosing Pump at Wellhead Site 70

The chlorine pump is a Grundfos Type DDA 7.5-16 dosing pump. It regularly doses chlorine from an on-site chlorine storage tank into the treatment stream downstream of the GAC vessels. The pump and storage tank are housed in an on-site, ventilated housing with a locking door. **Figure 4.67** shows the Well 70 post-chlorine dosing pump and **Figure 4.68** shows the post-chlorine pump nameplate.

The dosing tubing inside the pump require frequent replacement as they typically have a short lifespan. Routine and as-needed maintenance are performed. No other issues have been experienced with the pumps.

The pump appeared to be in good condition, with no signs of wear or corrosion.

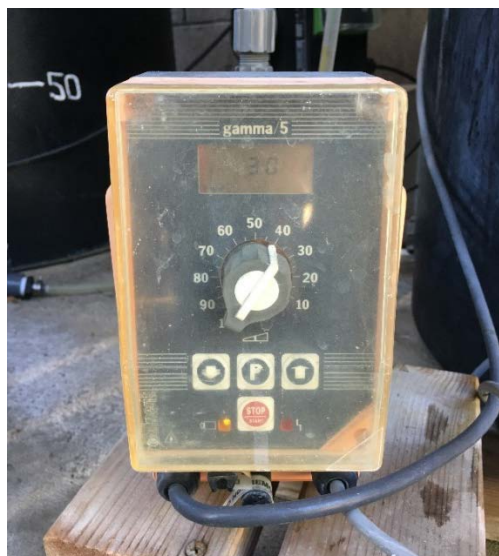
Figure 4.69: Orthopolyphosphate Dosing Pump at Wellhead Site 70

The chlorine pump is a ProMinent Gamma/5 dosing pump. It regularly doses orthopolyphosphate from an on-site storage tank into the treatment stream downstream of the packed tower aeration. The pump and storage tank are housed in an on-site, ventilated housing with a locking door. **Figure 4.69** shows the Well 70 ortopolyphosphate dosing pump and **Figure 4.70** shows the orthopolyphosphate pump nameplate.

The dosing tubing inside the pump require frequent replacement as they typically have a short lifespan. Routine and as-needed maintenance are performed. No other issues have been experienced with the pumps.

The pump appeared to be aged, however exhibiting signs of abnormal wear and corrosion.

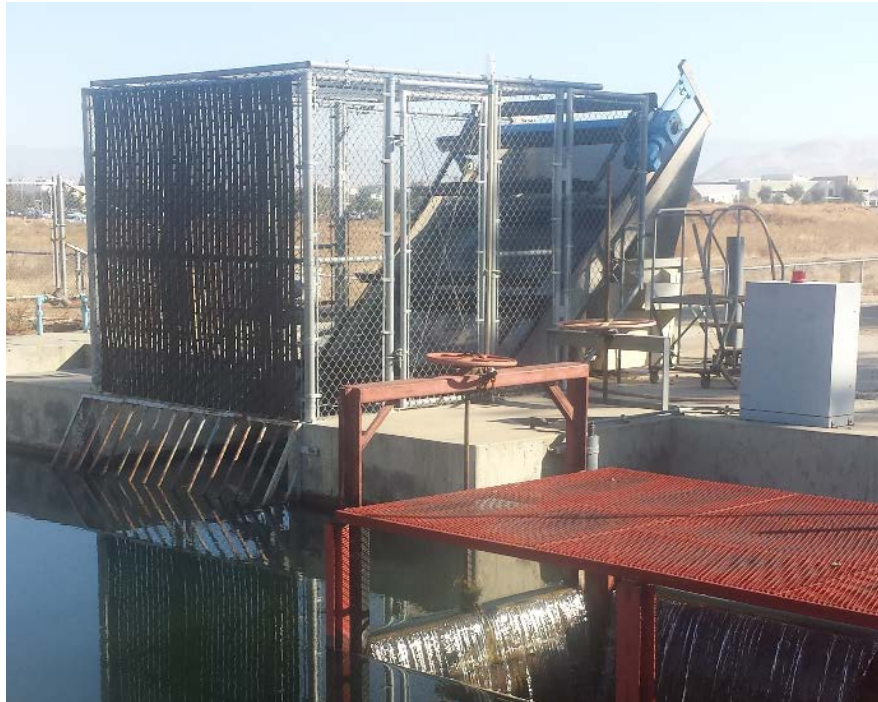
Figure 5.2: General View of Water Inlet Process

The water intake system includes a travelling screen, inlet gate, and a diversion gate. These are located on the northern central part of the property adjacent to North Chestnut Road. The water intake system is shown in [Figure 5.2](#).

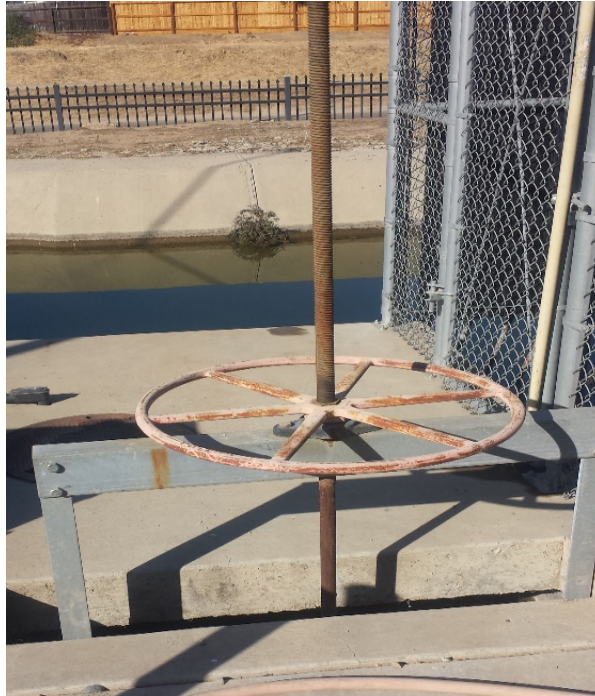
Figure 5.4: Inlet Gate Top View

The inlet gate is adjacent and located south of the travelling screen. It is manually operated by a hand-wheel to regulate the inlet flow, see [Figure 5.4](#). The inlet gate is normally completely open except during plant shut-downs.

The inlet gate has not presented any major issues.

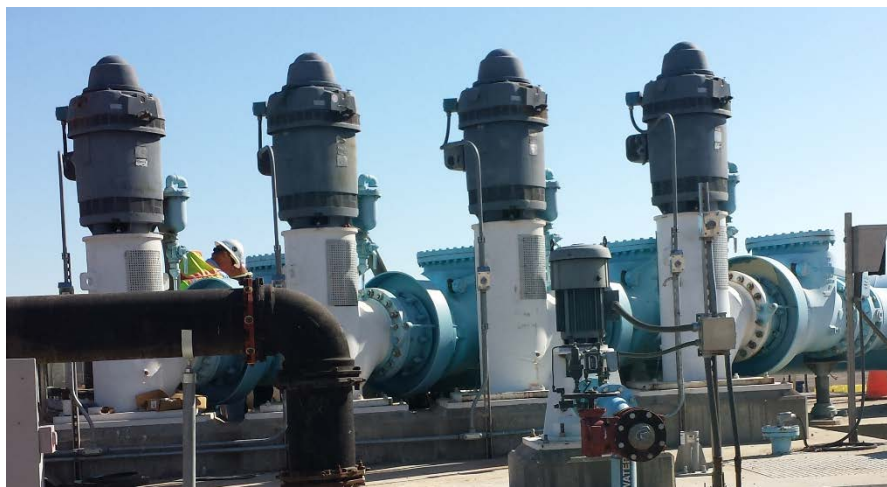
Figure 5.7: Raw Water Pumps

The raw water pumps were identified by the field tags 1-P-11, 1-P-12, 1-P-13, and 1-P-14. At the time of the site investigation only 1-P-12 and 1-P-13 were operating. The pumps appear to be in overall good condition as shown in [Figure 5.7](#).

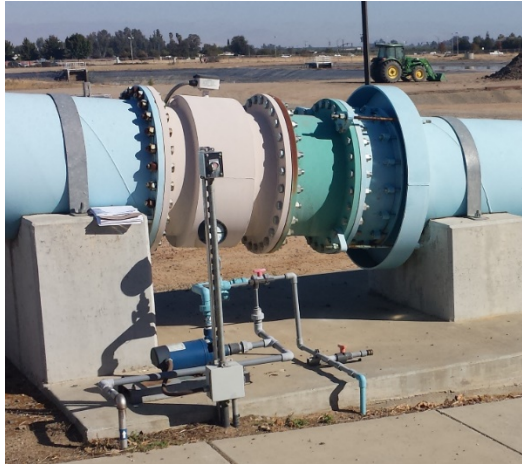
Figure 5.9: Plant Influent Flow Meter

The Influent Flow Meter measures the Plant's influent flow pumped by the Raw Water Pump Station through a 36-inch pipeline. The flow meter is a magnetic flow meter manufactured by Siemens. The tag number identified on the as-built drawings is FE/FIT-001, however no field tag number was found. **Figure 5.9** shows the Plant Influent Flow Meter and **Figure 5.10** shows the flow meter nameplate.

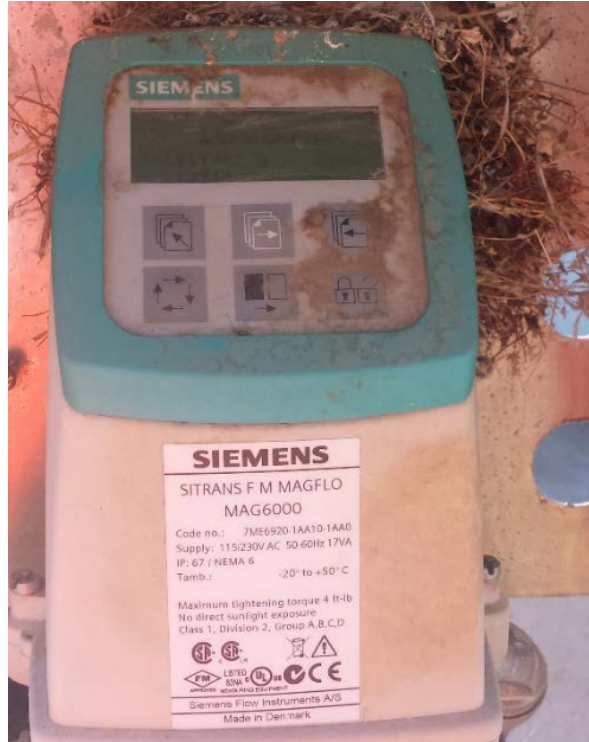
Figure 5.11: Flow Meter Control panel

The influent flow meters appear to be in overall good condition. A bird nest was observed on the flow meter control panel as shown in [Figure 5.11](#).

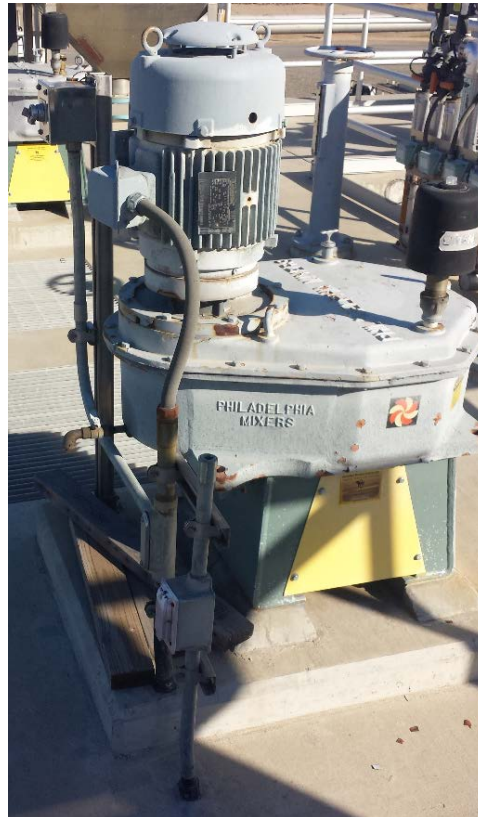
Figure 5.16: Coagulation Mixer Electric Motor and Gear box

The mixers were submerged at the time of the inspection and were not able to be observed. The equipment above the top deck appeared to be in good condition. There was some chipped paint on top and around the electric motor and gear box. **Figure 5.16** shows a photo of one motor and gearbox.

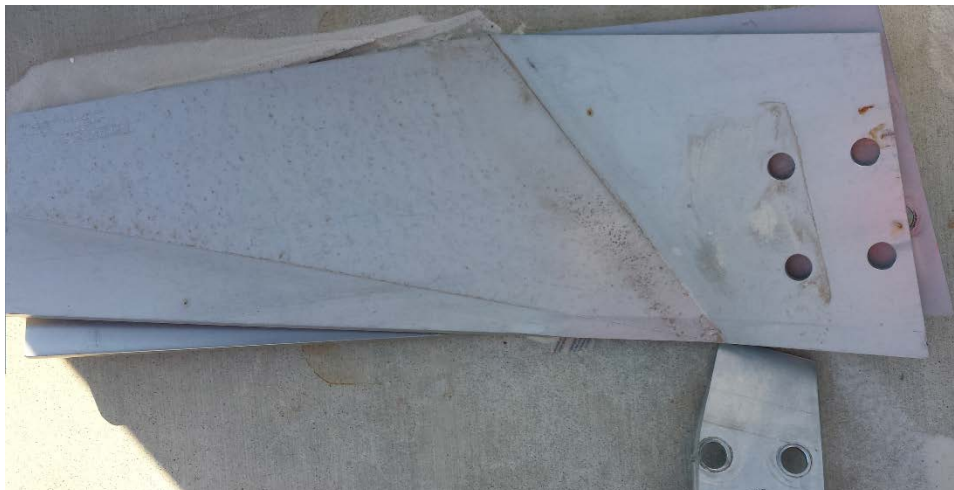
Figure 5.18: Example of the Injection Mixer Broken Blades

The plant operator reported that the blades of the injection mixers have broken multiple times. The rupture of the blades appears to occur at the same location on the blade – close to the shaft where the blades are bolted to the shaft as shown in [Figure 5.18](#). The Plant staff has attempted to reach out to Philadelphia and Actiflo. The plant operator reported representatives from Actiflo noted this event is unique to the NESWTF and has not yet been reported by other facilities. This issue has not been resolved. The blades were most recently replaced in 2016.

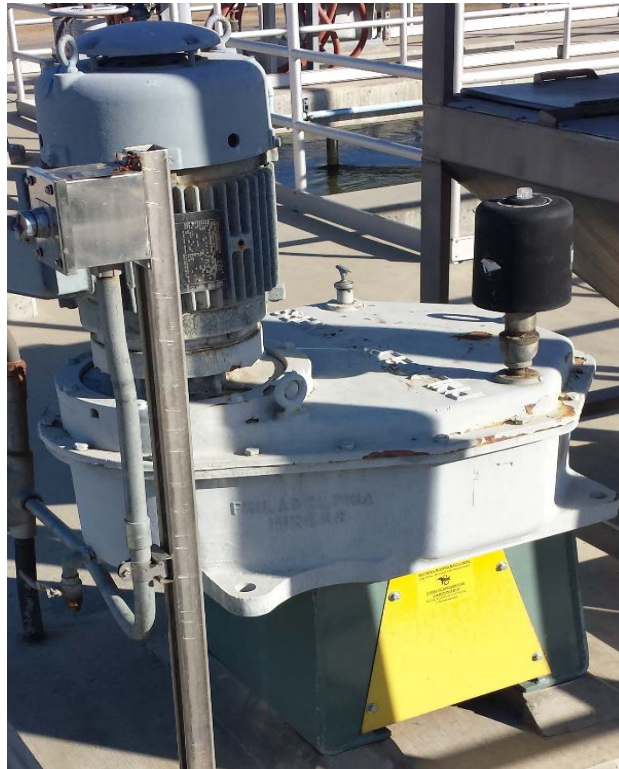
Figure 5.19: Injection Mixer Motor and Gear Box

The equipment is in overall good condition. Some chipping paint was observed on top and around the electric motor and gear box as shown in [Figure 5.19](#). The mixer was submerged at the time of the inspection. The motor was running properly at the time of the inspection and no sounds were heard.

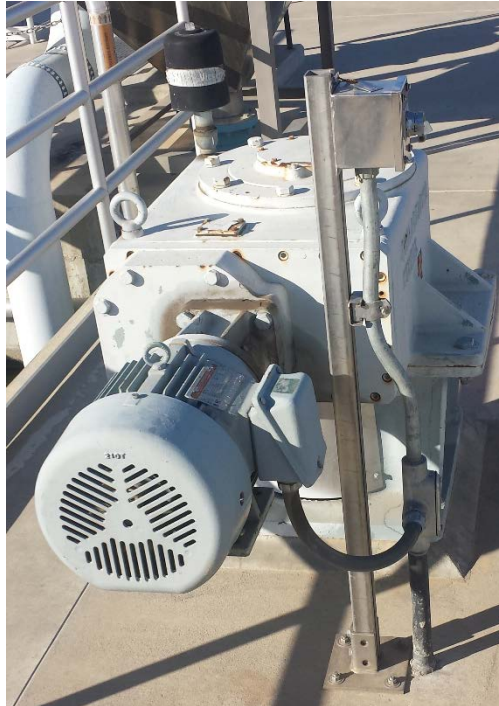
Figure 5.22: Flocculation Mixer Electrical Components at Clarifier Deck

The mixer was submerged at the time of the inspection. The equipment is in good condition, see [Figure 5.22](#). The motor was running properly at the time of the inspection and no particular sounds were heard.

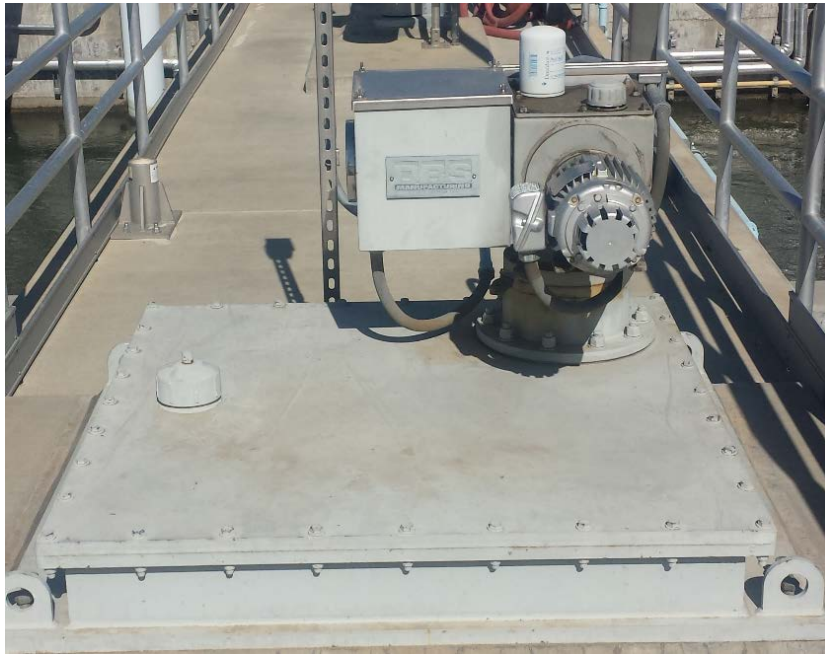
Figure 5.24: Sludge Scraper Electric Components at the Clarifier Deck

The electric motor and gear box of the sludge scraper at the Clarifier Deck were inspected as the scraper blades were submerged at the time of the inspection. The equipment observed appears to be in overall good condition as shown in [Figure 5.24](#). The sludge scrapers were running at the time of the inspection.

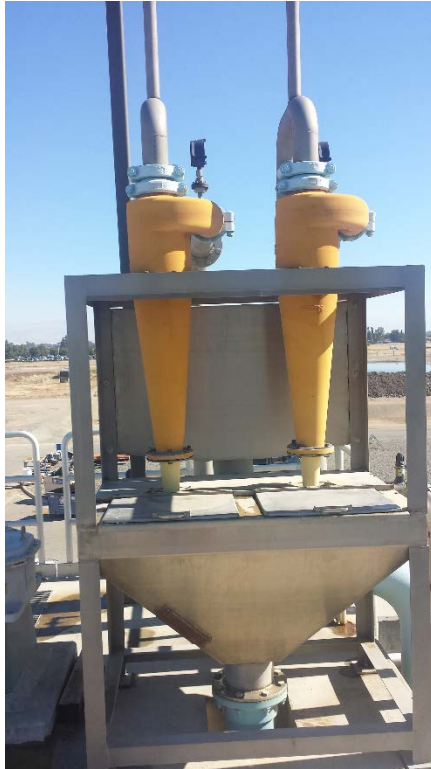
Figure 5.25: Hydrocyclones at Actiflo No. 1

There are two hydrocyclones units for each Actiflo. The units were not identified by a field tag number. Each unit is composed of two Krebbs cyclones, one on duty and one stand-by. The record drawings show eight hydrocyclone units, four for each Actiflo unit, identified as 3-ME-15, 3-ME-16, 3-ME-17, 3-ME-18 and 3-ME-25, 3-ME-26, 3-ME-27, 3-ME-28. [Figure 5.25](#) shows two of the hydrocyclones.

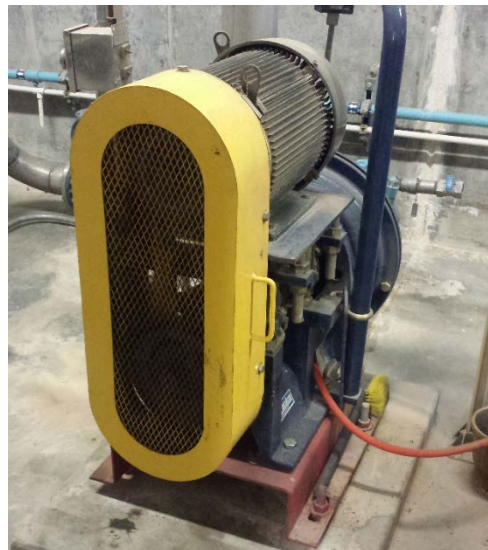
Figure 5.27: Solids Pump and Electric Motor

The pump was off at the time of the field investigation. All connected supporting equipment is functional and well kept. Connections and fittings are in good condition as seen in [Figure 5.27](#). No leak stains or traces of corrosion have been observed. Some oil stains were found around the motor, which is likely attributed to maintenance activities.

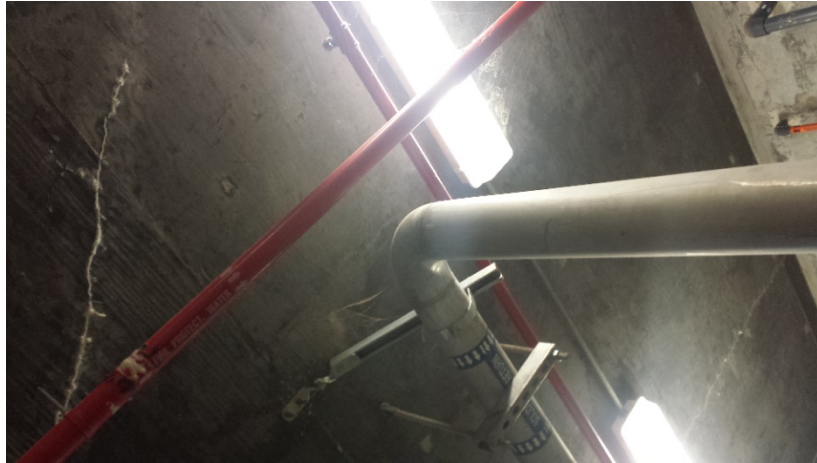
Figure 5.28: Ceiling of Solids Pump Room

Cracks in the concrete walls and ceilings of the room where the Solids Pumps are located were observed as shown in [Figure 5.28](#). A structural condition assessment is recommended by a

licensed structural engineer as structural inspections are out of the scope of this condition assessment report.

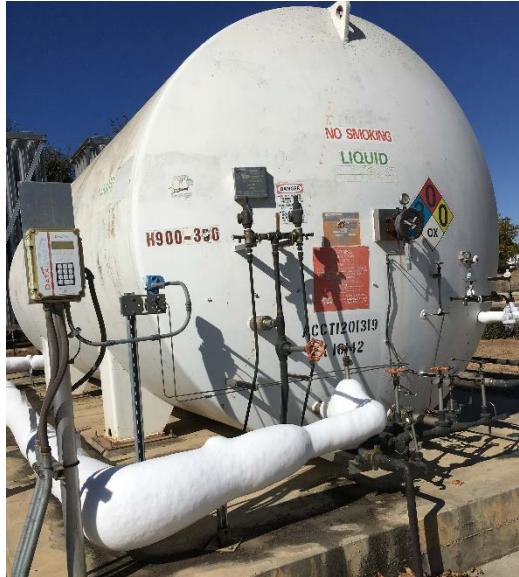
Figure 5.33: LOX Storage Tank with Ice Build-up on the Pipe

The LOX storage tank is in overall good physical conditions, the connection and fittings are also in good condition. It was noticed that during operation, when liquid oxygen passes throughout the exposed pipeline that connect to the vaporizer unit, water from the atmosphere condensates on the metal surface of the pipe building up a significant layer of ice. **Figure 5.33** shows the ice build-up around the pipe where liquid oxygen is flowing.

Adjacent pipes that were not operation during the site visit, and thus did not have ice build-up, did not show signs of damage and were in overall good condition. Ice build-up may increase the weight of the pipe and may cause damage to the piping, fittings, and connected appurtenances.

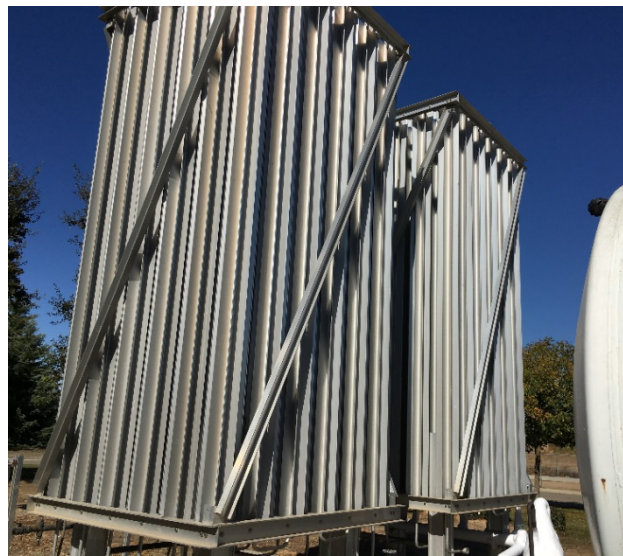
Figure 5.35: Vaporizer Units

The exteriors of both vaporizers are in good condition and do not present visible signs of physical wear or corrosion. Components connections and gaskets are observed to be in good overall physical conditions. **Figure 5.35** shows a general view of both vaporizer units.

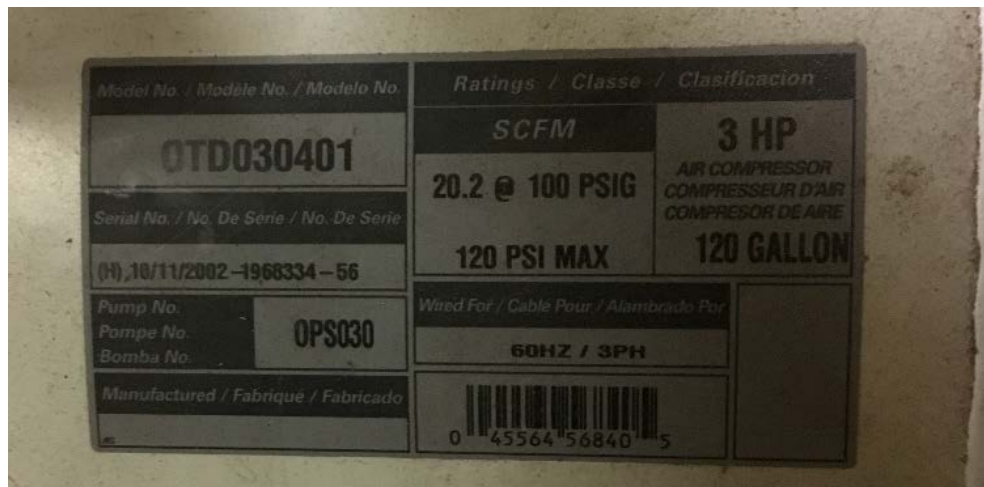
Figure 5.36: Air Compressor Nameplate

The air compressor units are both located together with the other ozone system components in a room in the maintenance building below the offices. Only one of the two units is regularly operated, while the second unit is on standby. The air compressor units are operated by a 5 HP Baldor Reliance electrical motor. The units were not identified by a field tag number, however per the record drawings they are reported as 4-ME-23 and 4-ME-24. **Figure 5.36** shows the air compressor nameplate.

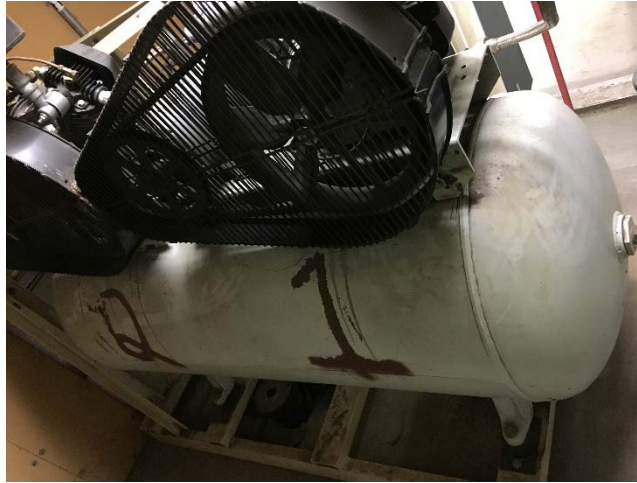
Figure 5.37: Air Compressor

Both units were observed to be in very good conditions, only one of the two was operating at the time of the site visit. Vibration appeared to be normal. **Figure 5.37** shows the air compressor unit that was operating at the time of the site visit.

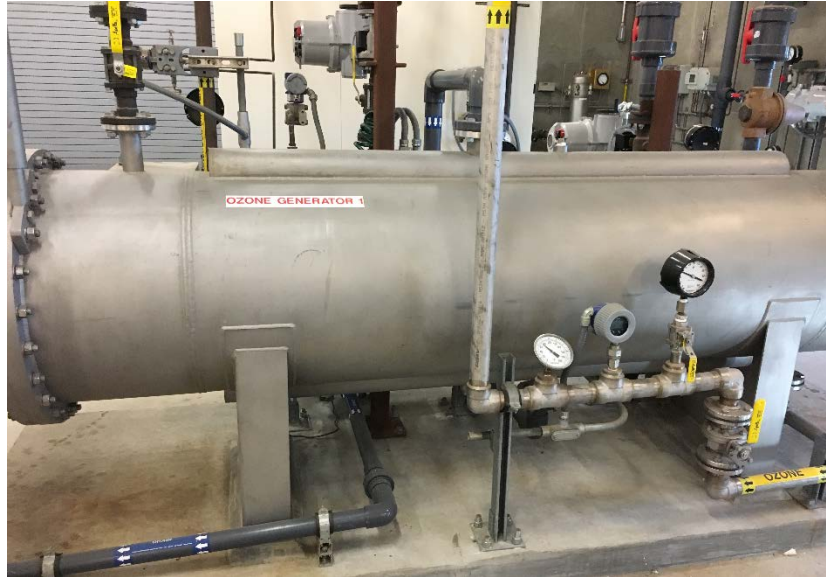
Figure 5.40: Ozone Generator Unit No. 1

The ozone generator unit and their related components and connections appear to be in good condition as shown in **Figure 5.40**. Only one of the two units was operating during the site visit.

- *Ozone generators: Risk score 7.50; refurbishment of internal components recommended*
- *LOX Vaporizers: Risk score 5.83; refurbishment of internal components recommended*
- *Particulate filters: Risk score 5.00; refurbishment recommended*

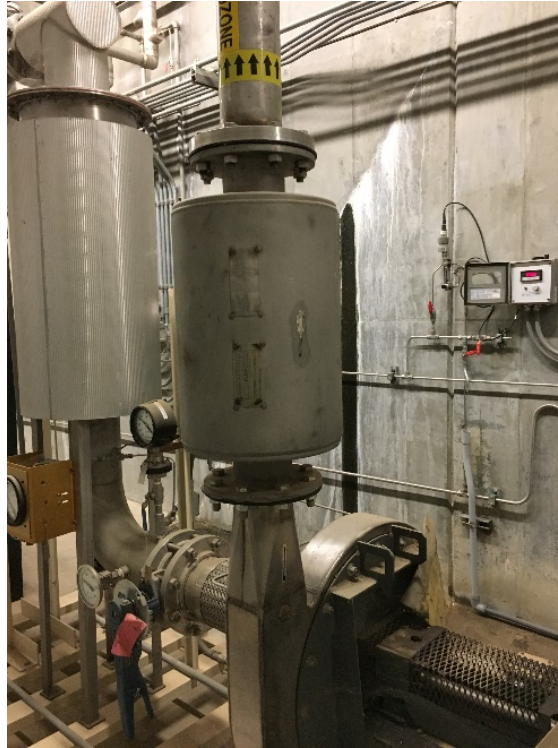
Figure 5.41: Ozone Destruct Unit No. 1

Only unit 4-ME-61 was operational during the site visit. Unit 4-ME-62 was covered in dust and appeared to be out of service. [Figure 5.41](#) shows Ozone Destruct Unit No. 1 and [Figure 5.42](#) shows the exhaust blower.

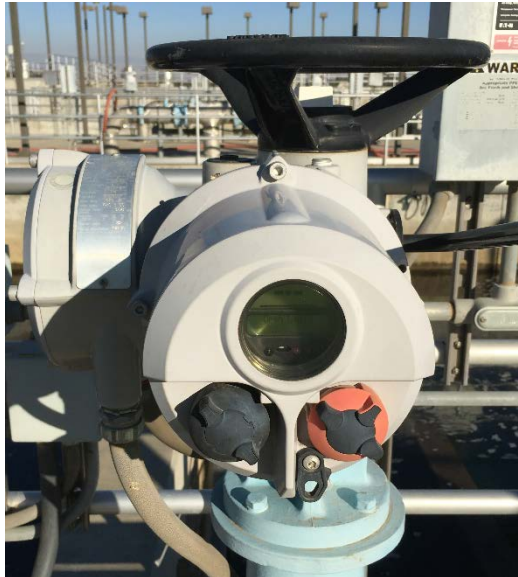
Figure 5.43: Influent Valve Actuator

There are six 10-inch DeZurik influent valves, operated by a Rotork IQFM actuator, identified by the field tags 5-MOV-11, 5-MOV-21, 5-MOV-31, 5-MOV-41, 5-MOV-51, and 5-MOV-61. **Figure 5.43** shows a typical influent valve actuator.

General comments: Valves have been refurbished several years ago to replace worn gaskets and seats. Media screens at the bottom of the filter beds have come loose and allowed carbon and sand to enter the tanks.

Deterioration of plastic components on the actuator housing from sun exposure and minor corrosion was observed. All valves were submerged at the time of field visit so visual inspection was not possible.

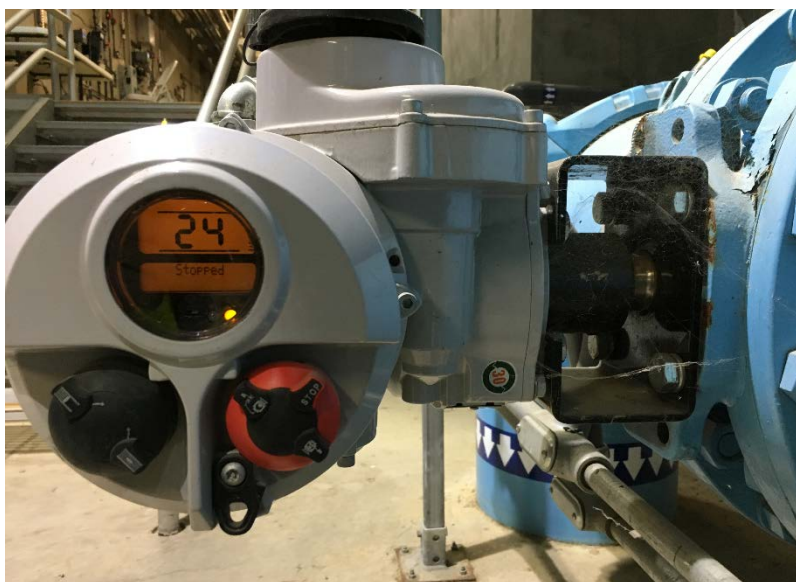
Figure 5.44: Filter Water Valve and Actuator

All valves housings appeared to be in good physical condition, with some minor corrosion. **Figure 5.44** shows a typical filter water valve actuator.

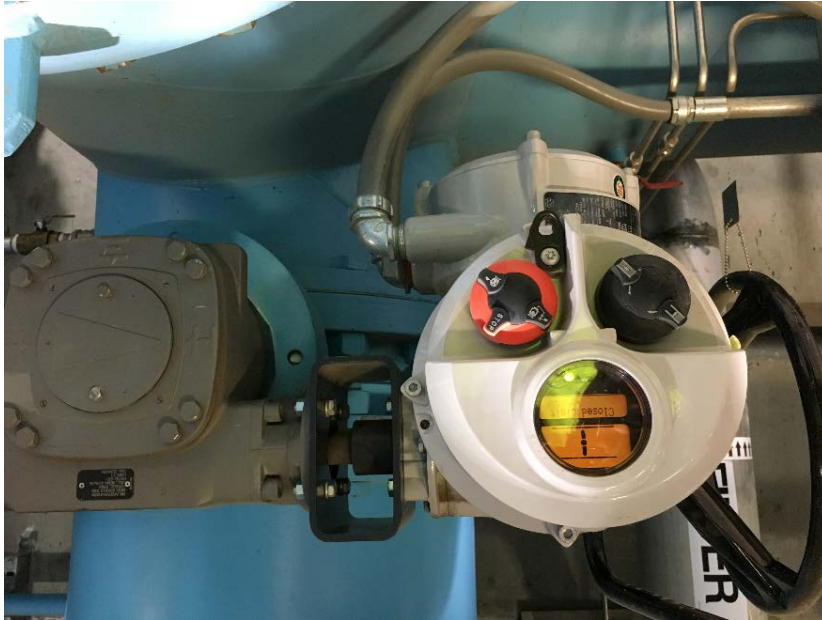
Figure 5.45: Backwash Valve and Actuator

All MOV housings seem to be in good physical condition, without major physical defects. **Figure 5.45** shows a typical backwash valve and actuator.

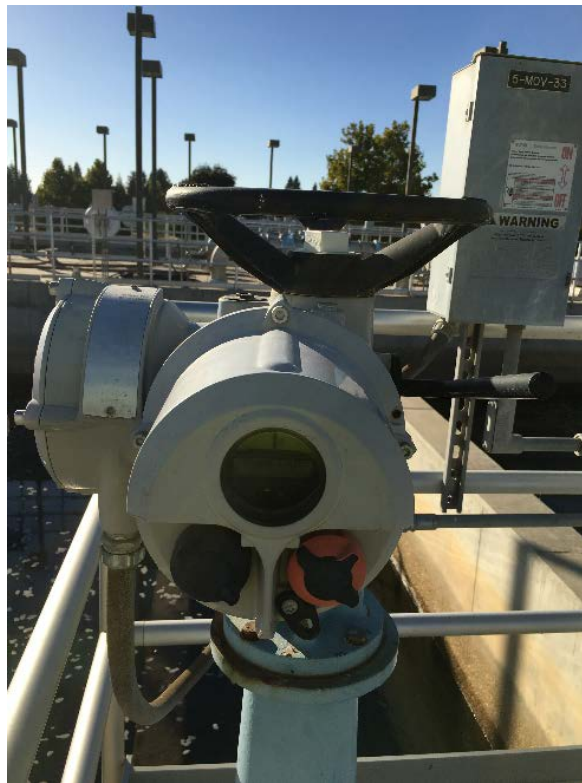
Figure 5.46: Drain Valve Actuator

Deterioration of plastic components on the actuator housing from sun exposure and minor corrosion was observed. All valves were submerged at the time of field visit so visual inspection was not possible. **Figure 5.46** shows the valve actuator with some corrosion around the actuator connection to the valve stem housing.

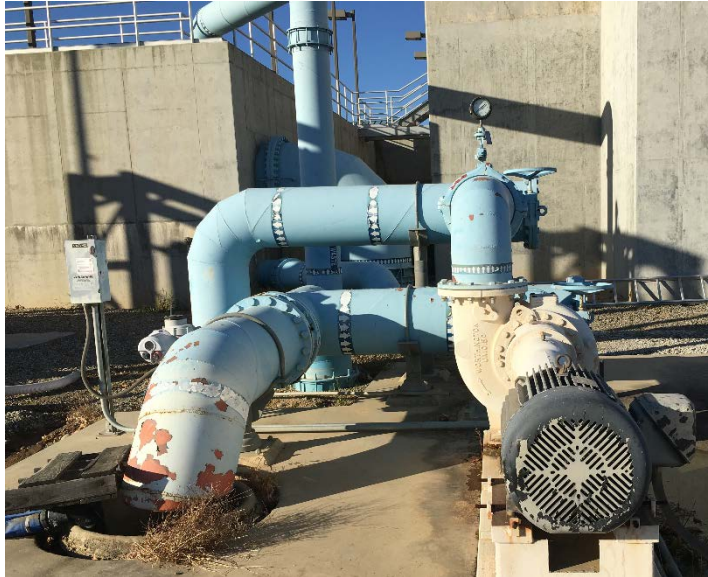
Figure 5.48: Filter Waste Pump Actuator and Valve

Filter waste pump, actuator and valve are located south of the filter tanks. The pump is a 20 HP Flowserve centrifugal pump with a rated capacity of 3,550 GPM at 13 feet of TDH and an operating speed of 845 RPM. The pump is driven by a 20HP motor manufactured by US Electric Motors. The valve is a 14-inch DeZurik 14. **Figure 5.48** shows the entire pump, actuator, and valve system.

Some corrosion and chipping paint were observed throughout, with some signs of leaks.

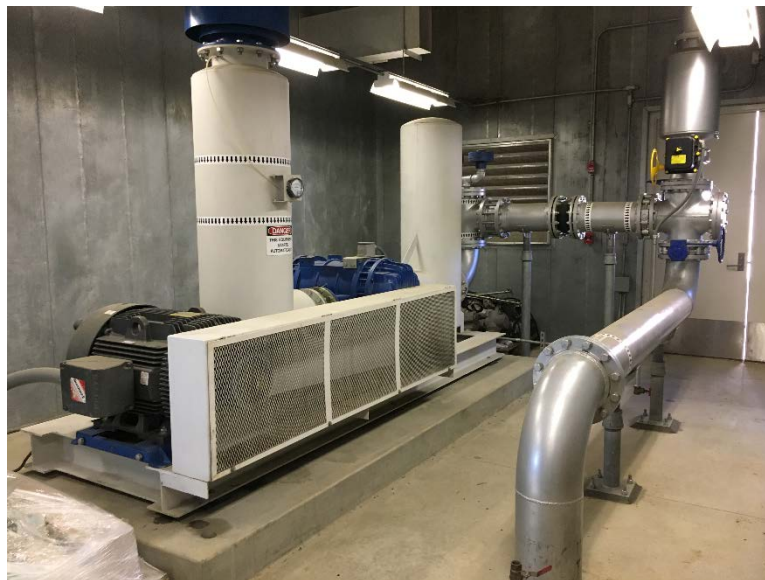
Figure 5.50: Air Scour Blower

The air scour blower was not in operation during the site visit. All components appeared to be in good physical condition as showed in **Figure 5.50**.

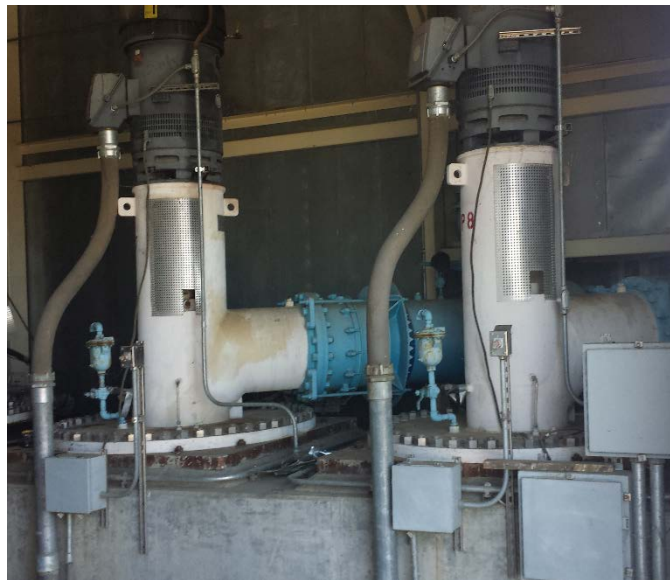
Figure 5.51: Backwash Supply Pumps

The backwash supply pumps are grouped together with the treated water pumps in a building located south east of the property, see [Figure 5.51](#) for a general view. The pumps are 300 HP Flowserve vertical turbine pumps and are identified by tags 5-P-07 and 5-P-08. The pumps operate at 13,500 GPM at 59 feet of TDH, with an operating speed of 898 RPM.

Neither pump was operating at the time of observation. The pumps appear to be in overall good condition.

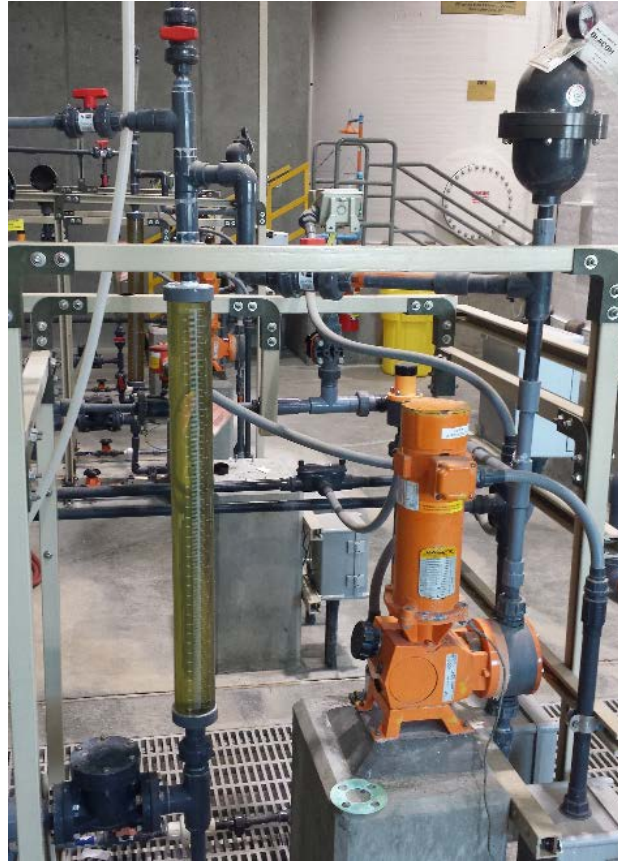
Figure 5.56: Sodium Hypochlorite Feed Pump

Pump skid 6-FD-82 was not installed at the time of observation. Both pumps 6-FD-81 and 6-FD-83 were not in operation at the time of the field investigation. The pumps exhibit signs of leaking throughout various fittings and connections, and some paint chipping of pump housing. The pumps appear to be in overall good condition, see **Figure 5.56**.

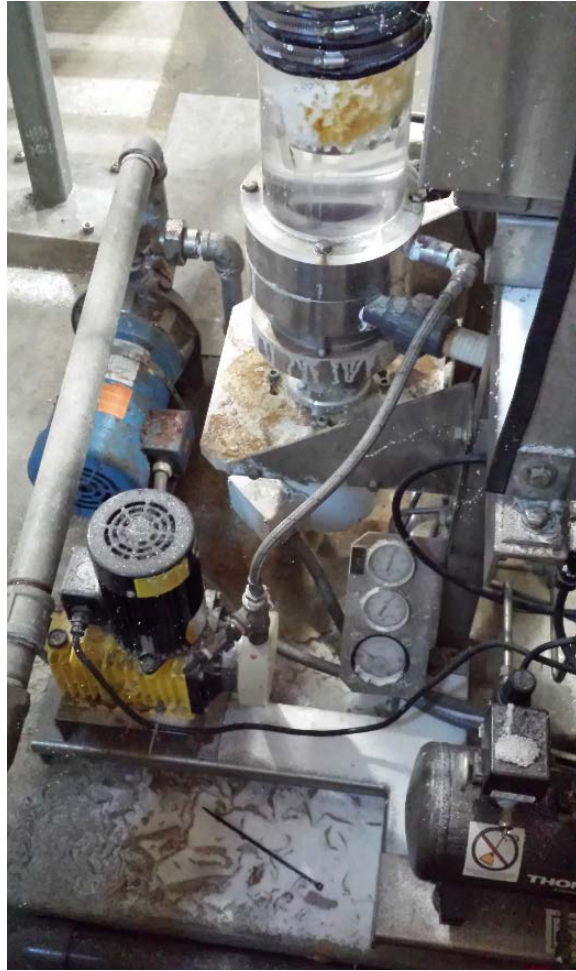
Figure 5.57: Polymer Batching System

There is significant chemical build-up and scaling around the system framing as showed in **Figure 5.57**. There is corrosion on the motor housing and pumps, as well all signs of leaking and spills.

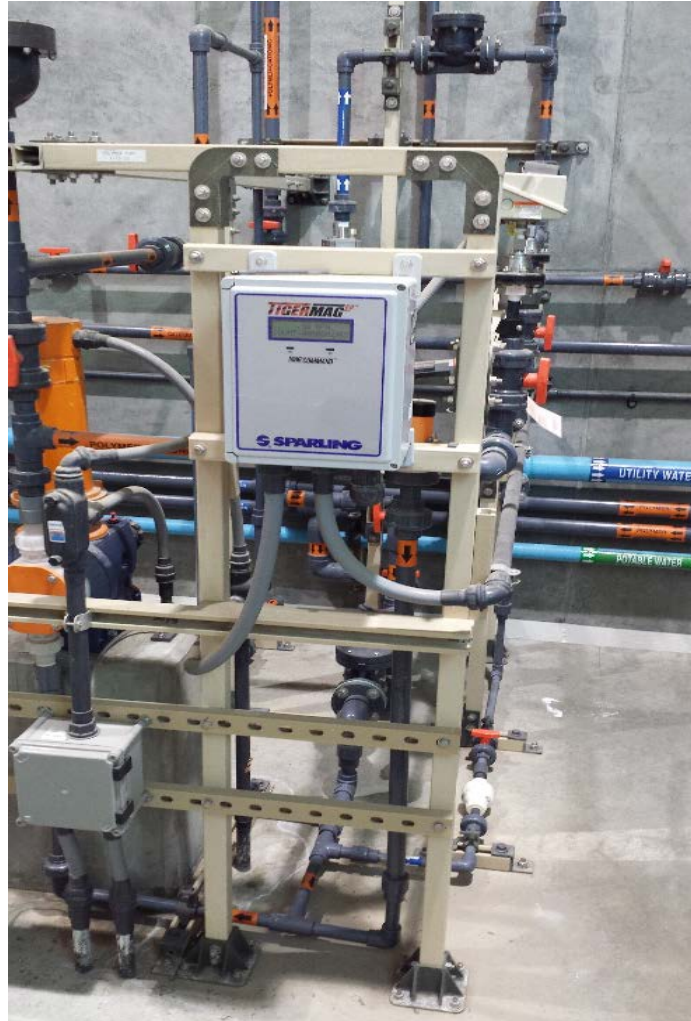
Figure 5.59: Cationic Polymer Feed Pump System

All components, fittings and connections appear to be in good condition as showed in [Figure 5.59](#). The pumps were not in operation at the time of observation. There are spill stains on the floor beneath pumps 6-FD-71 and 6-FD-72.

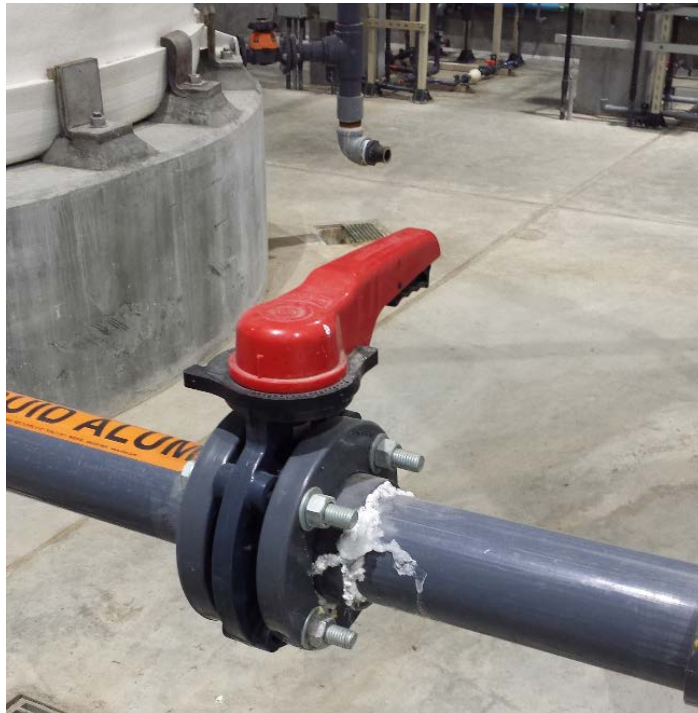
Figure 5.60: Build-up on Alum/Ferric Storage Piping

The tanks, components, connections, and fittings all appear to be in good condition. Both tanks show signs of some stains, possibly due to a minor spill. There is some build-up on some pipe fittings as shown in **Figure 5.60**.

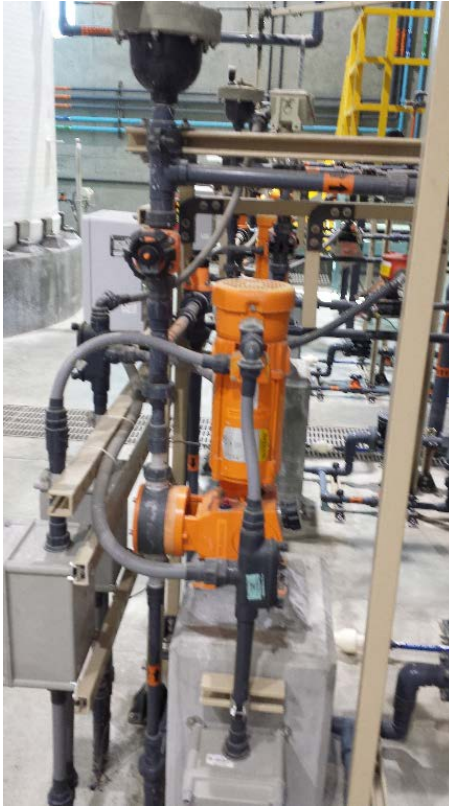
Figure 5.62: Alum/Ferric Feed Pump System

There are some minor signs of build up around the fittings and some stains are visible around the pump, overall the pumps appear to be in good condition. **Figure 5.62** shows the overall alum/ferric feed pump system.

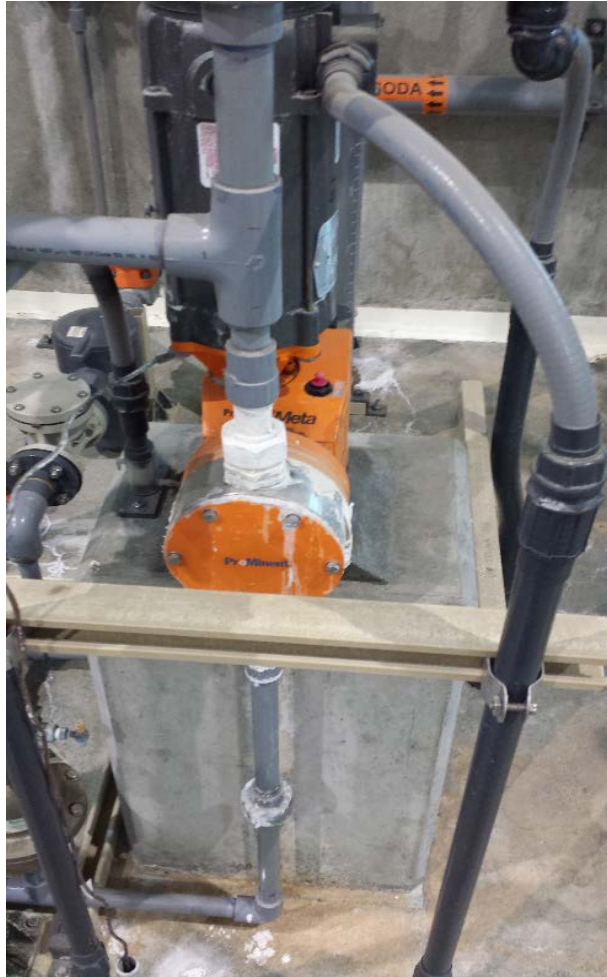
Figure 5.66: Feed pump caustic system

The system 6-FD-21 showed signs of leaking around fittings throughout the system, with several areas of caustic build-up, as shown in **Figure 5.66**. This feed system was not in operation at the time of observation. Feed system 6-FD-22 showed only very few signs of leaks and some staining at the pump base.

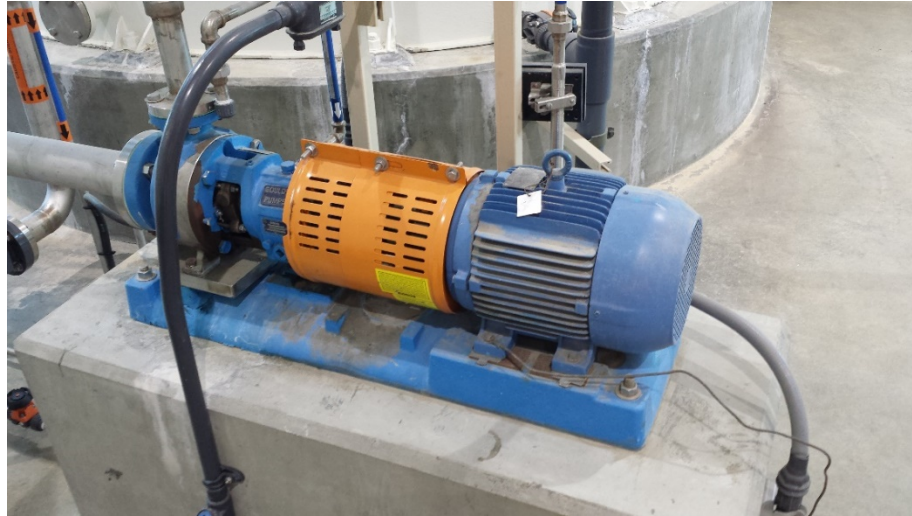
Figure 5.68: Caustic System Mixing Pump

The pump was not in operation at the time of observation. Some signs of corrosion were observed. The pump appeared to be in overall good condition as shown in Figure 5.68.
