Drinking Water Infrastructure Renewal and Replacement Plan

**AUGUST 2019
FINAL**

AKEL
ENGINEERING GROUP, INC.

CITY OF FRESNO

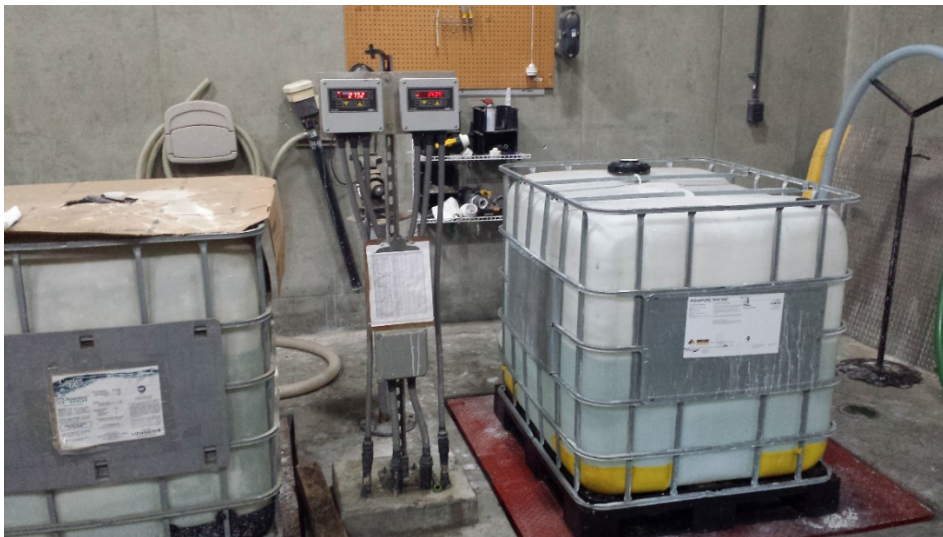
Figure 5.69: Weigh Scales for Polyphosphate

There are two weight scales for polyphosphate located in the adjacent room to the chemical building. The weight scales were not identified by a field tag number, however on the record drawings they are tagged as 6-WS-31 and 6-WS-91. **Figure 5.69** shows a general view of the scales.

The scales were functional and appeared to be in good condition at the time of the field investigation. It is recommended the weigh scales be refurbished.

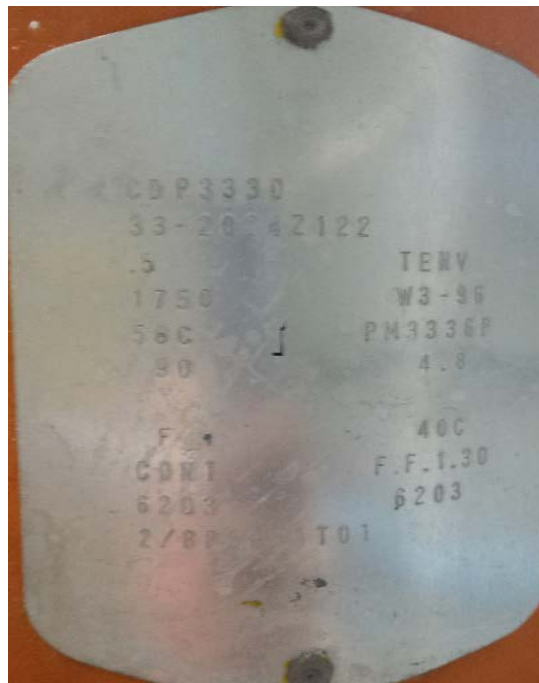
Figure 5.70: Polyphosphate Pump Motor Nameplate

One feed pump is assigned for polyphosphate addition. The feed system and pump skid are located in the chemical building. The pump skid was identified by the field tag 6-FD-31. The pump is manufactured by ProMinent Fluid Controls, Inc. and is driven by a 0.5 HP Baldor Electric Co. motor. **Figure 5.70** shows the motor nameplate.

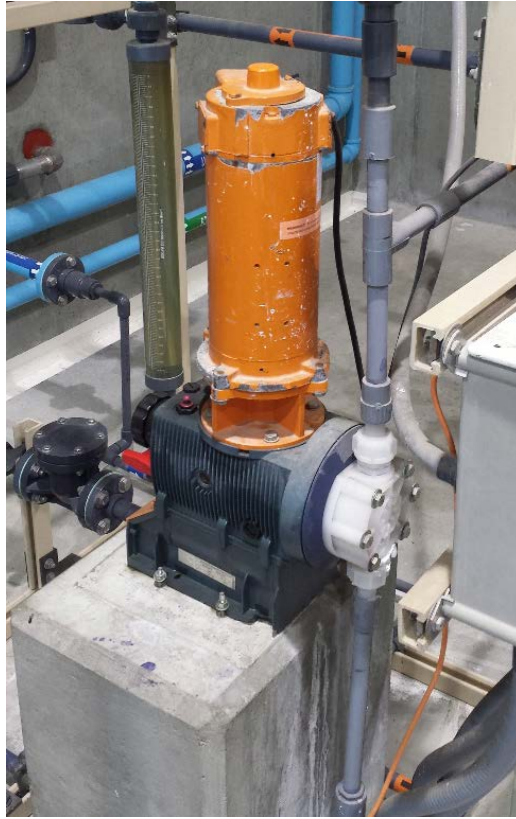
Figure 5.71: Polyphosphate Feed Pump

The system has build-up in various places, with stains around the pump base and signs of leaking around the piping and floor. There is some paint chipping of the pump motor as shown in **Figure 5.71**.

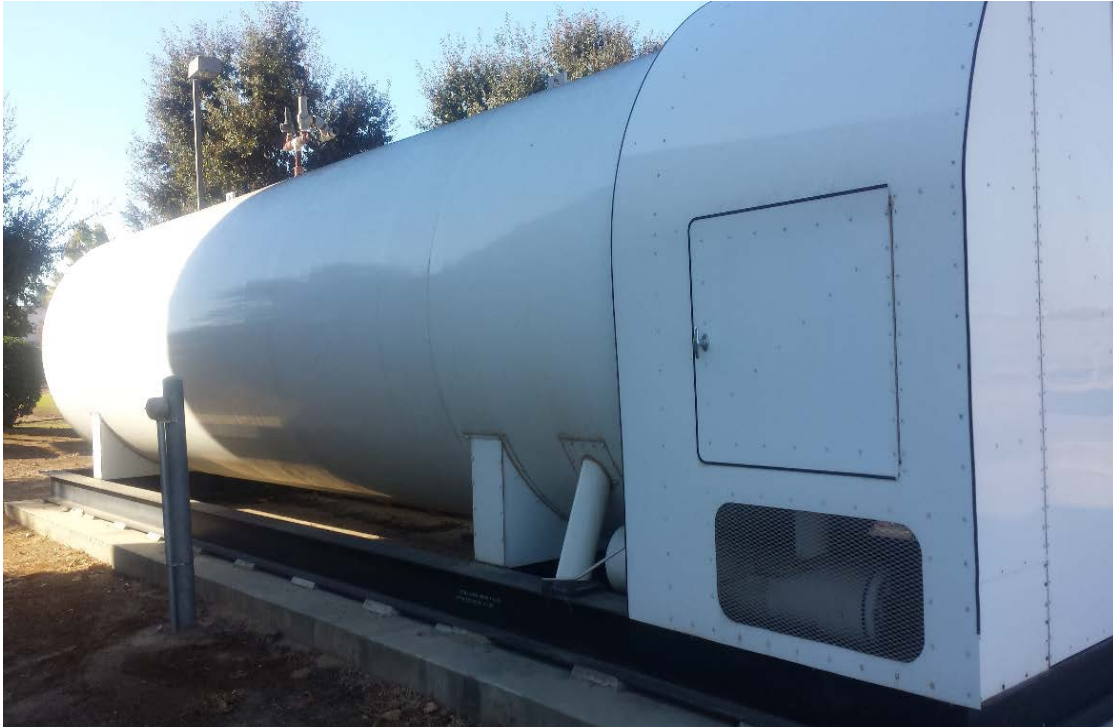
Figure 5.72: Carbon Dioxide Storage Tank

The storage tank for carbon dioxide is located outside and north of the chemical building. The tag number per the record drawings is 6-T-41, however a field tag number was not found. The tank was manufactured by Linde. A nameplate for the tank was not found. **Figure 5.72** shows a general view of the tank.

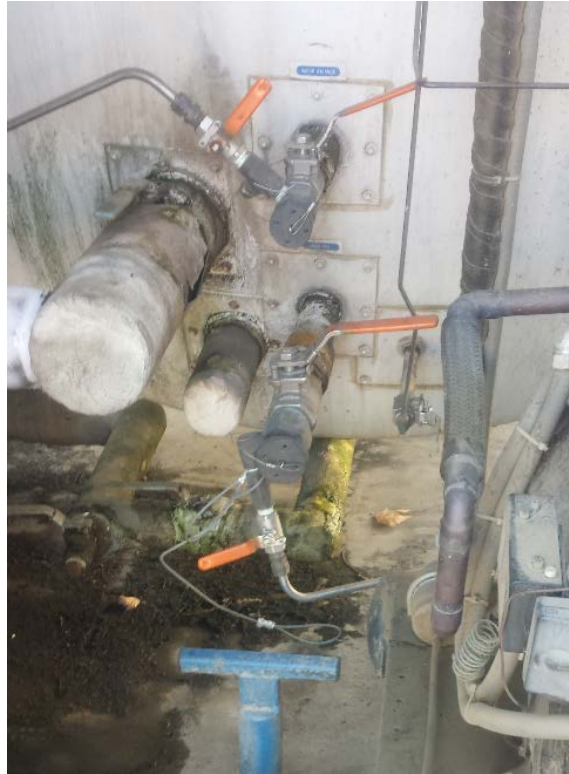
Figure 5.73: Carbon Dioxide Tank Instruments and Equipment

The tank appears to be in overall good physical condition. There is some minor corrosion and build-up around the equipment and instrument connections at the front of the tank. [Figure 5.73](#) shows various instruments and equipment installed on the tank.

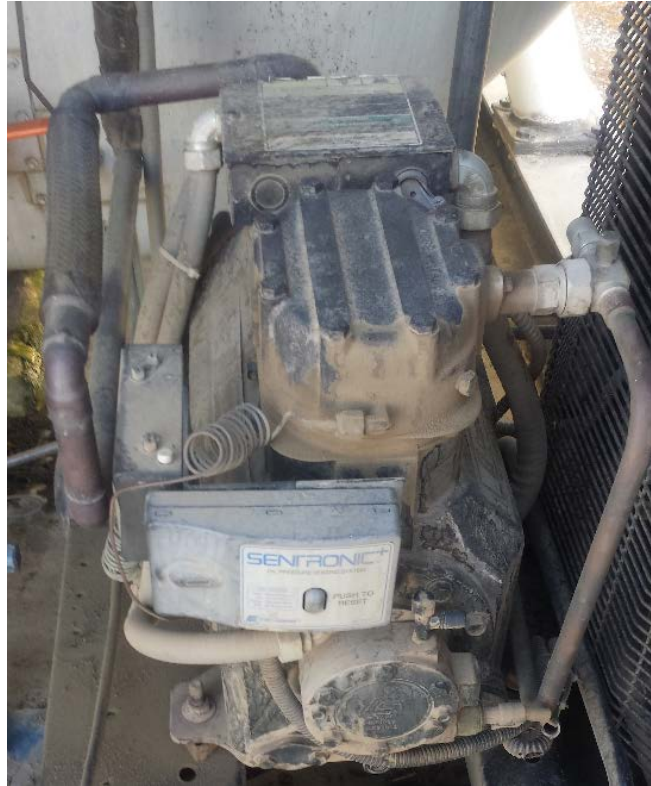
Figure 5.74: Vaporizer Compressor

The equipment appears to be in overall fair condition, with some observed buildup around connection ports and appurtenances. **Figure 5.74** shows the compressor of the vaporizer. It is recommended the system be refurbished.

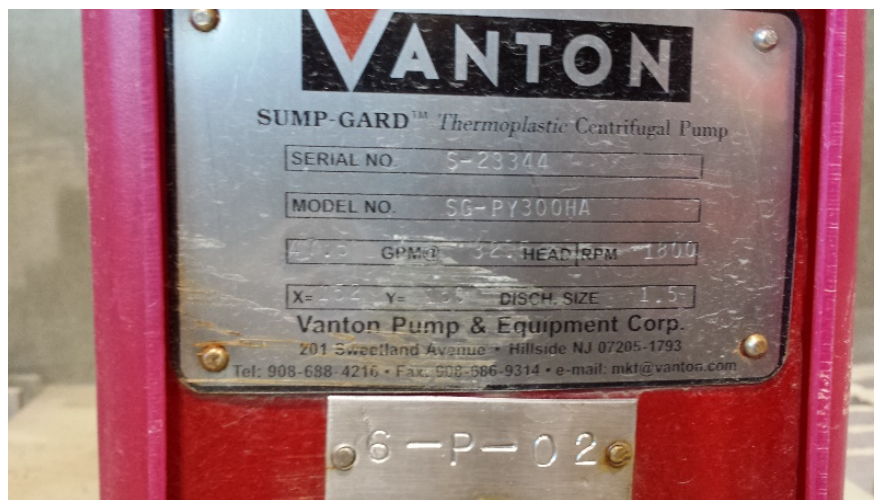
Figure 5.76: Chemical Sump Pump 6-P-02 Nameplate

Only two out of four Chemical sump pumps were identified in the field and both are located in the chemical building in the northern and southern corner of the building, respectively. The other two chemical sump pumps are located in a vault placed outside, in between the chemical and the maintenance buildings. The chemical sump pumps were identified by the field tags 6-P-01 and 6-P-02. The pumps are centrifugal pumps manufactured by Vanton Pump & Equipment Corp with a capacity of 47.5 GPM at 32 feet of TDH. The pumps are driven by a 2 HP motor manufactured by WEG. **Figure 5.76** shows pump 6-P-02 nameplate.

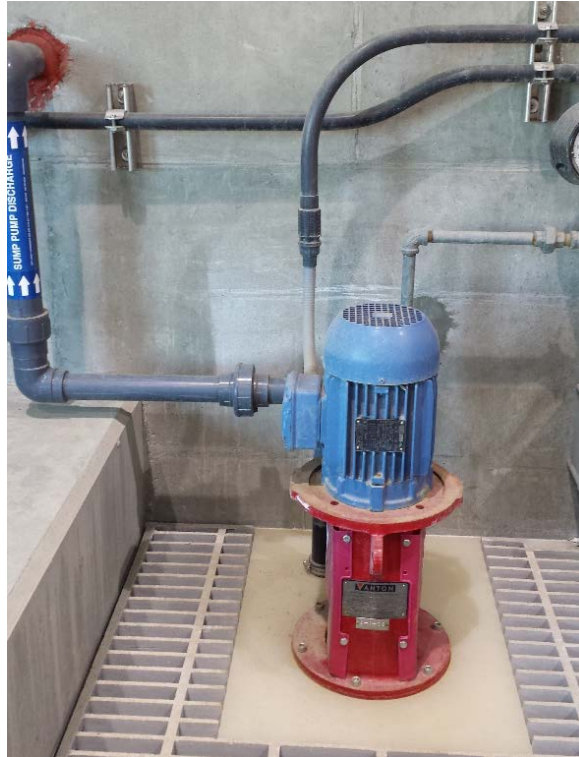
Figure 5.77: Typical Chemical Sump Pump

There were no observed signs of corrosion or leaking. The pumps were not operating at the time of the site visit. The pumps appear to be in overall in good condition as shown in **Figure 5.77**.

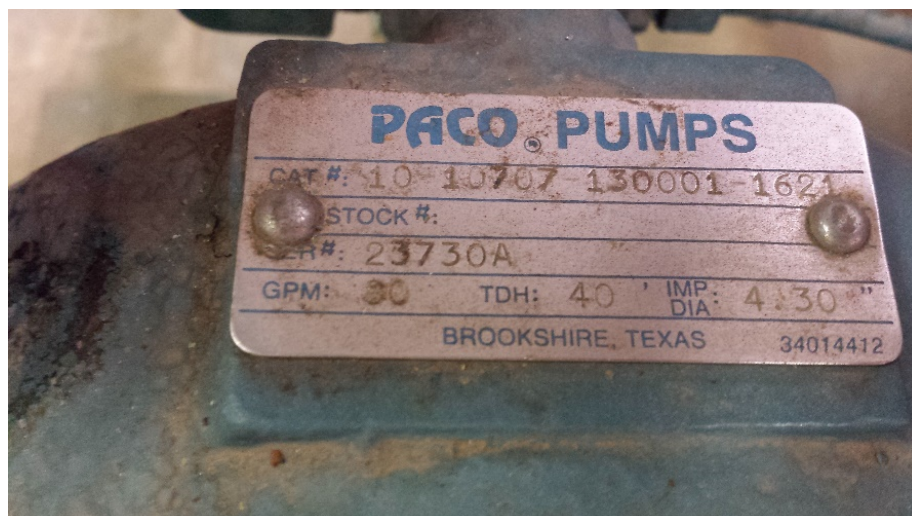
Figure 5.78: Potable Water Booster Pump Nameplate

There are two potable water booster pumps located in a room in the maintenance building. The pumps were not identified by a field tag, however, per the record drawings, they are reported as 6-P-91 and 6-P-92. The pumps were manufactured by Paco Pumps and have a capacity of 80 GPM at 40 feet of TDH. The pumps are powered by a 3 HP Baldor industrial electric motor. **Figure 5.78** shows the pump nameplate.

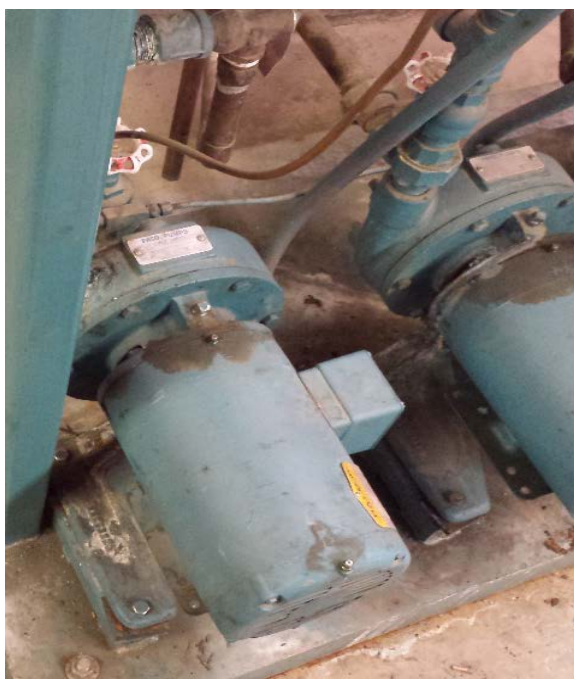
Figure 5.79: Potable Water Booster Pump

There were some oil stains around and on top of the pumps, but they otherwise appear to be in overall good condition as shown in [Figure 5.79](#).

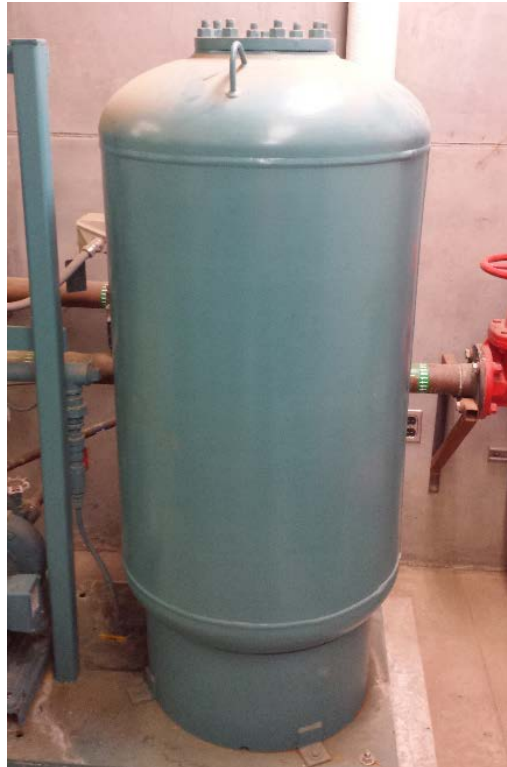
Figure 5.80: Pressure Vessel

The pressure vessel is located close to the potable water booster pumps. No nameplate or pertinent information regarding the pressure vessel was found in-field. **Figure 5.80** shows the pressure vessel.

Equipment appears to be in overall in good condition.

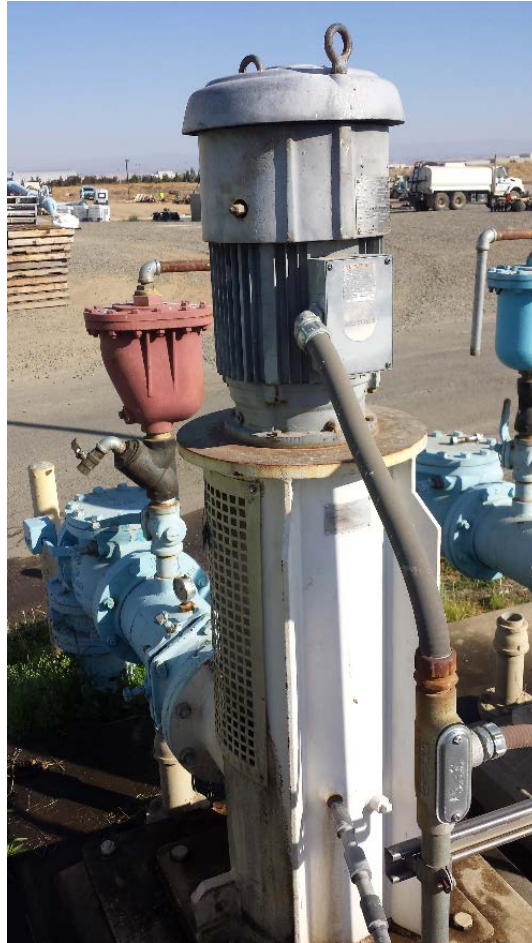
Figure 5.83: Oil Stains Around Washwater Pump and Motor

Plant staff reported issues with leaking around the pump packing.

There is minor corrosion and chipping paint on the pump and motor housing, and some oil stains as shown in Figure 5.83. Neither pump was operating at the time of observation.

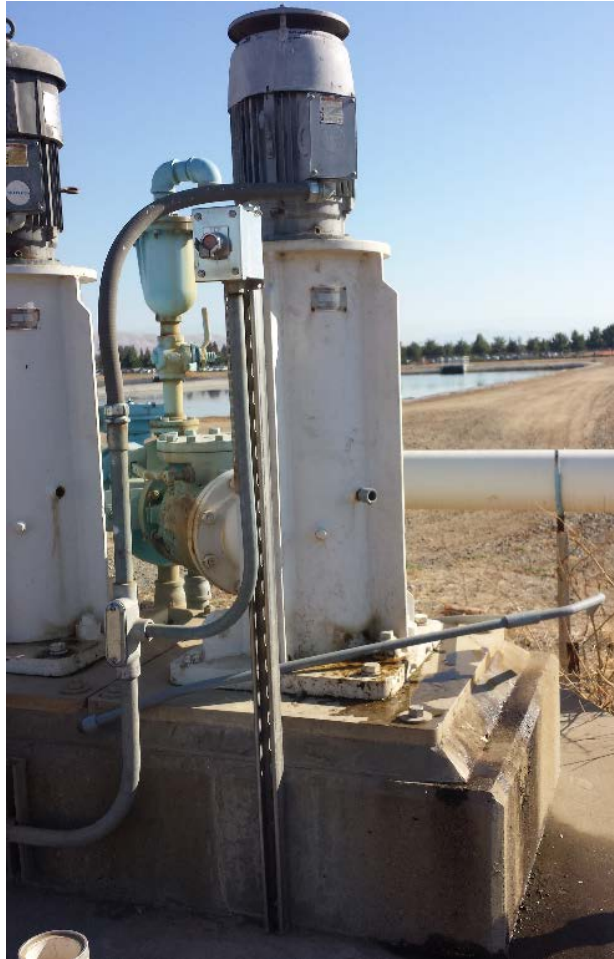
Figure 5.85: Decant Pump 7-P-31 and Electric Motor

The pumps appear to be in good condition as shown in [Figure 5.85](#). Pump 7-P-31 exhibited oil residue at the pump pedestal.

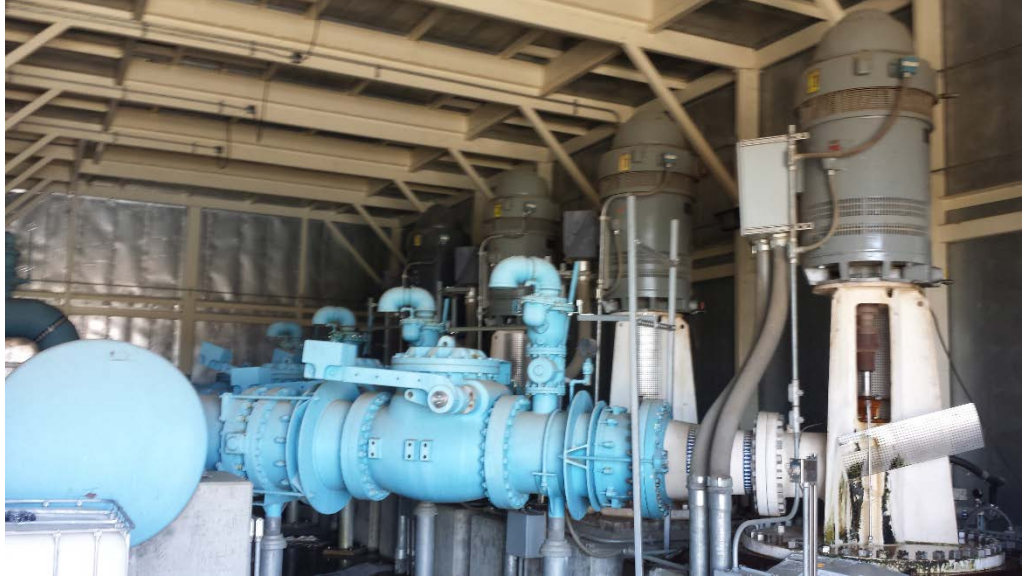
Figure 5.88: Treated Water Pumps

Pump 9-P-01 requires packing since it is leaking from the shaft. All other pumps work properly. Motors were refurbished in 2014.

Pumps 9-P-01 and 9-P-03 were operating during the field inspection. Pump 9-P-01 was leaking from the shaft. All pumps appear to be in overall good condition as shown in Figure 5.88.

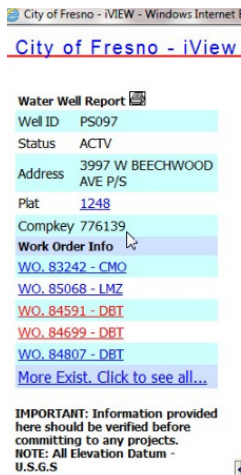
iView presents location and status data along with a list of Work Orders from Hansen for the selected well.

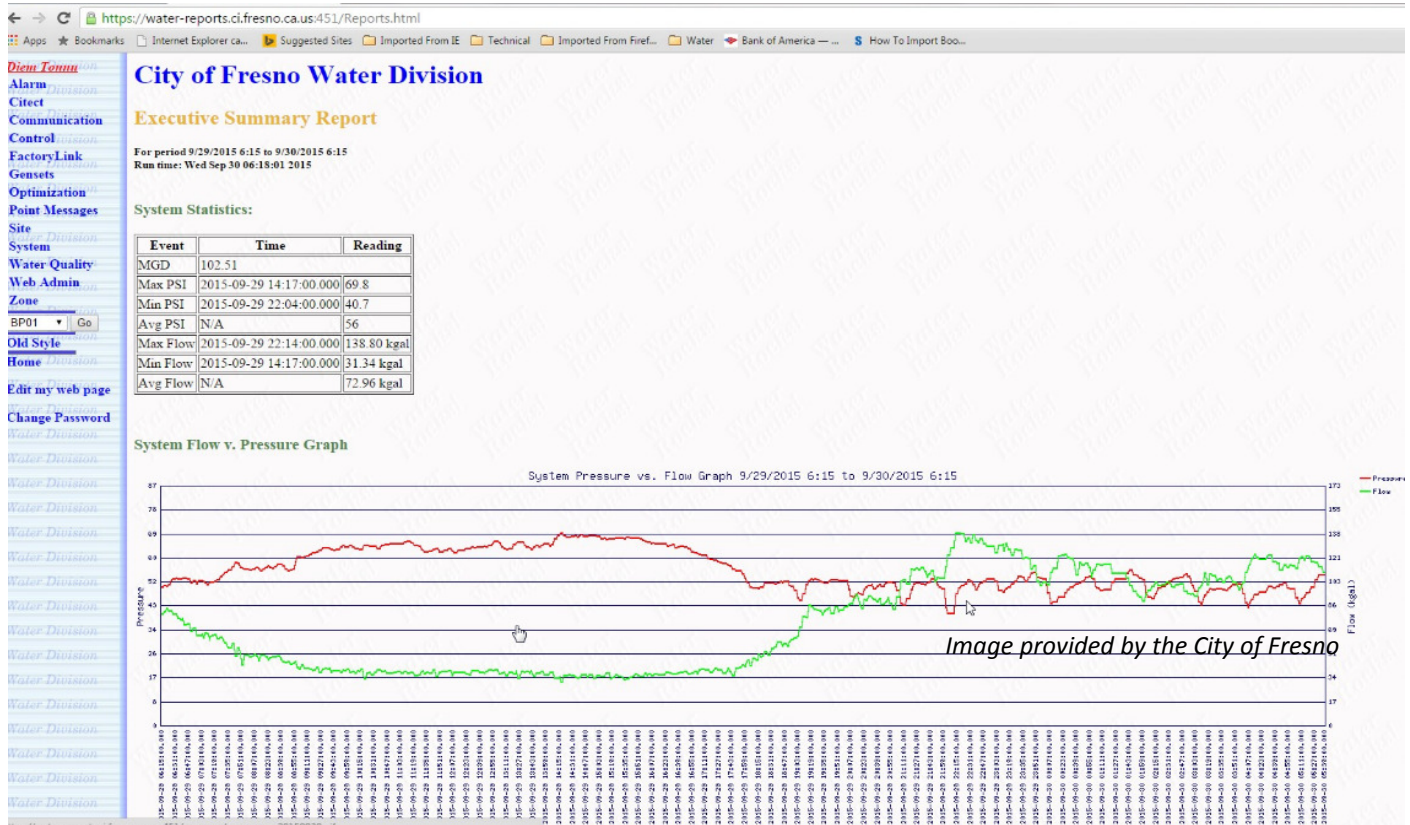
A SCADA graph showing system pressure (red) vs Flow (green) over a twenty-four hour period
This is just one of many data views available through SCADA

The City’s SCADA system provides real time and historical data in terms of flow, run time, power consumption, pumping levels and other data as required to monitor the operational characteristics, specific capacity (SC) and Overall Plant Efficiency (OPE) for each well. Historical data stored in the SCADA database can be retrieved for a period of over ten years.

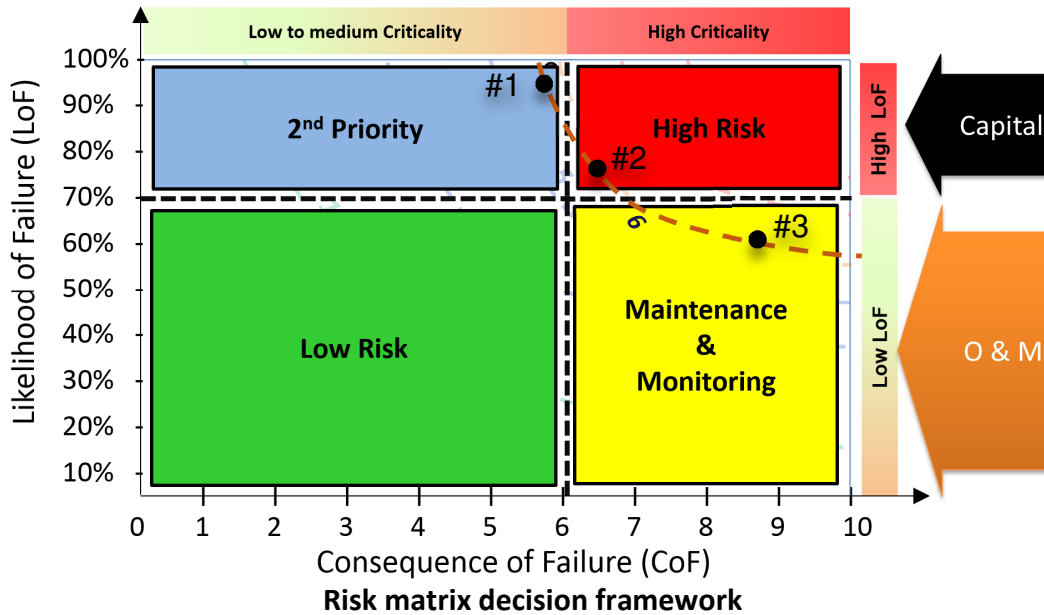
In the graphic above we introduce the term “Criticality” as it relates to assets with a high CoF value (see definition of “Critical Assets” on previous page). The straight dashed black lines represent threshold values for LoF and CoF. These lines are used to distinguish high and low LoF and CoF values. The 3 black dots represent 3 assets with the same Risk score, but the decision how to address each asset varies because of the differences in LoF and CoF values. In this case asset #2 would receive priority treatment because it is the only one that falls in the high risk quadrant. The next diagram illustrates what types of decision may be made based on where the asset falls in the Risk matrix.

Plotting the three assets that share a common Risk score on the Risk matrix illustrates how three different management strategies would be applied. Asset #2 will be rehabilitated or replaced soon because it is more critical than asset #1 even though asset #1 is more likely to fail. Asset #3 is more critical than #2 but it is less likely to fail so it will receive an aggressive monitoring and maintenance schedule to keep it from moving into the high Risk area as long as practical (it will move into high Risk eventually). It is rare for an asset to become more critical with age, so it is unlikely that #1 will ever be a high Risk asset, but since its LoF is high, the organization should make sure there is budget available to replace it. As a 2nd priority the organization may decide to run the asset to failure but more likely it will be replaced or rehabilitated after the organization has funded projects that fall in the high risk quadrant.
