Geotechnical Study

May 20, 2021
Kleinfelder Project No. 20212905.001A

**SUBJECT: Geotechnical Study
Proposed Costco Wholesale Warehouse and Fuel Facility
NE Corner of West Herndon Avenue and North Riverside Drive
Fresno, California 93722
CW# 20-0569**

**GEOTECHNICAL STUDY
PROPOSED COSTCO WHOLESALE WAREHOUSE
AND FUEL FACILITY
NE CORNER OF WEST HERNDON AVENUE AND
NORTH RIVERSIDE DRIVE
FRESNO, CALIFORNIA 93722
CW# 20-0569
KLEINFELDER PROJECT NO. 20212905.001A**

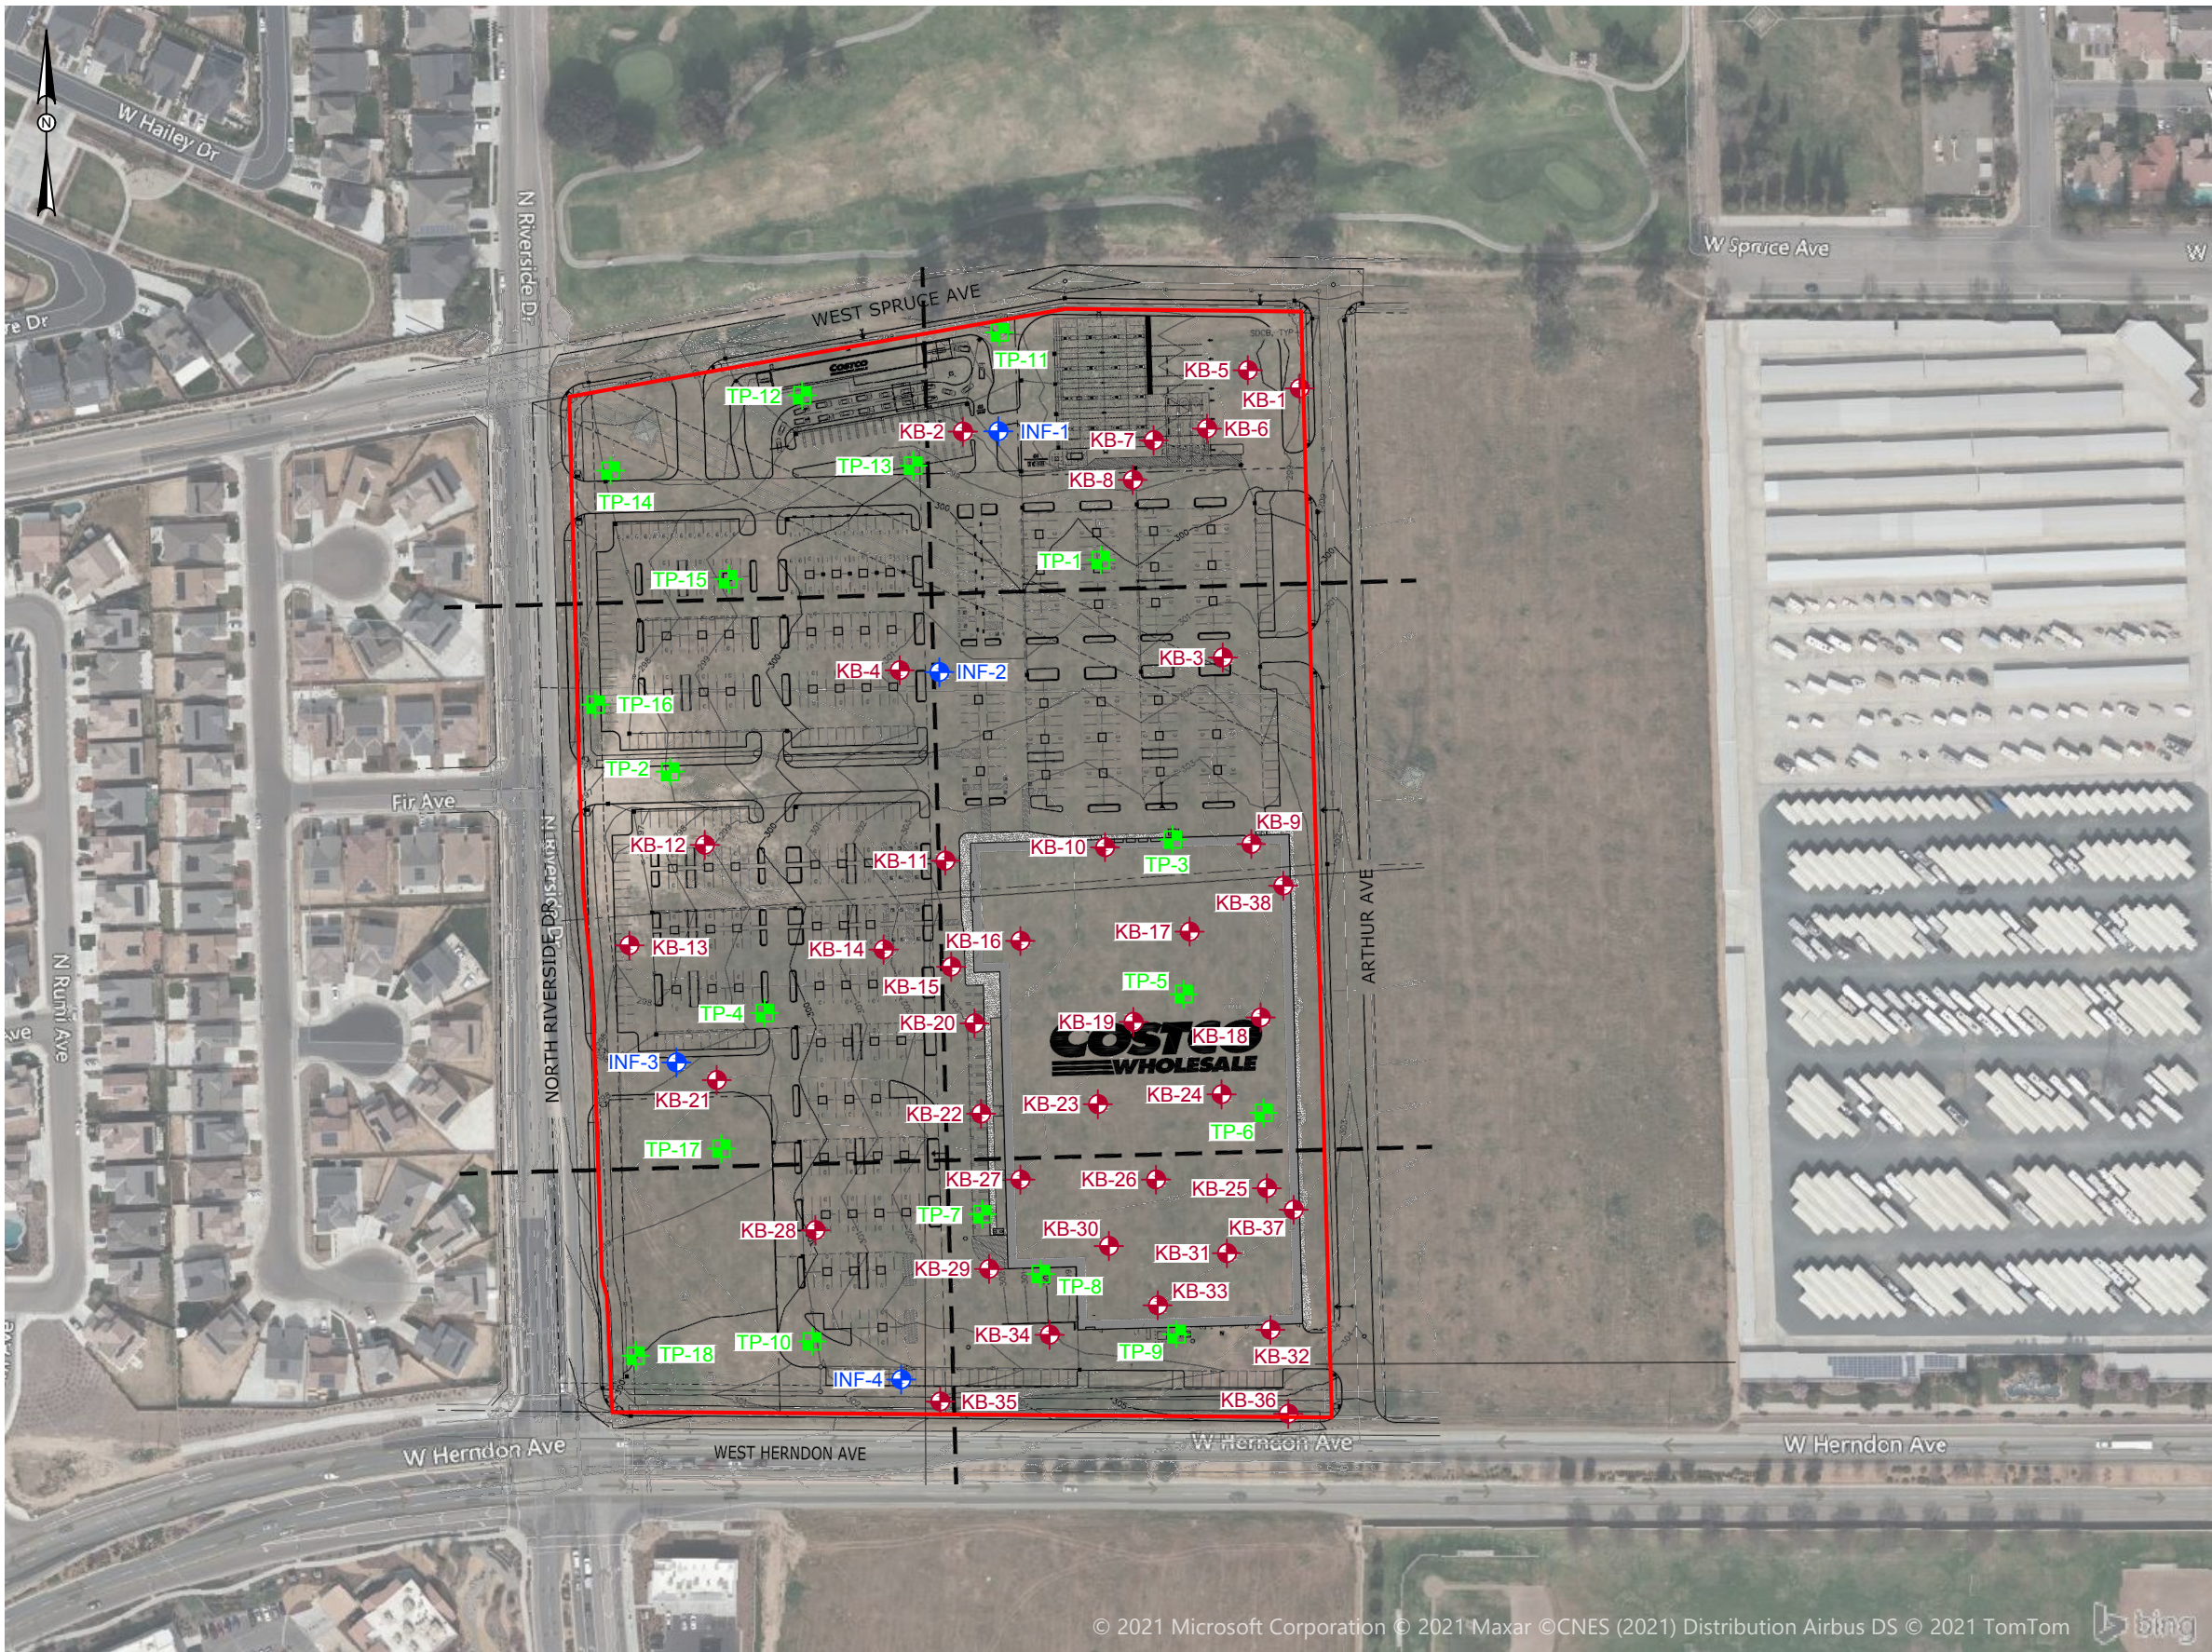
EXPLORATION LOCATION MAP
COSTCO FRESNO NEW WAREHOUSE NEC OF W. HERNDON AVE. &N. RIVERSIDE DR. FRESNO, CALIFORNIA 93722

Subsurface conditions at the site were explored by drilling 38 borings and excavating 18 test pits. A total of 21 borings and 6 test pits were drilled/excavated in the building area; 13 borings and 5 test pits were drilled/excavated in the parking and drive areas; 4 borings and 1 test pit were

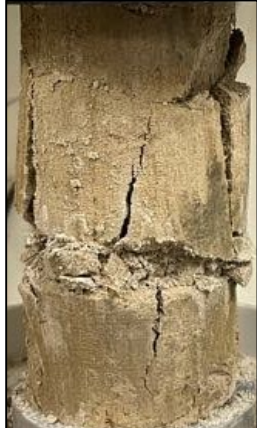
Specimen Failure Picture		Specimen No.		1

Initial	Diameter, in	D _O	2.40
		Height, in	H _O	5.29
		Height to Diameter Ratio		2.21
		Water Content, %	ω _O	9.6
		Dry Density, lbs/ft ³	γ _{dO}	93.1
		Saturation, %	S _O	32.0
		Void Ratio	e _O	0.810
	Time to Failure, min.		t _f	5.8
	Unconfined Compressive Strength, psi		q _u	5.18
	Shear Strength, psi		s _u	2.59
Strain at Failure, %		ε _f	5.7	
Average Rate of Strain to Failure, %/min		ε	1.0

Description of Specimen: Light Brownish Gray SILT				
Amount of Material Finer than the No. 200, %: nm				
LL: nm	PL: nm	PI: nm	G _s : 2.70 Assumed	Specimen Type: Intact Test Method: ASTM D2166
Boring: KB-8	Remarks: nm= not measured, na = not applicable			
Sample: S8				
Depth, ft: 16.0				
Test Date: 3/11/21

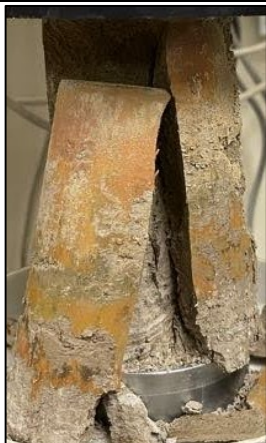
Specimen Failure Picture		Specimen No.		1

Initial	Diameter, in	D _O	2.41
		Height, in	H _O	5.03
		Height to Diameter Ratio		2.08
		Water Content, %	ω _O	21.7
		Dry Density, lbs/ft ³	γ _{dO}	100.8
		Saturation, %	S _O	87.4
		Void Ratio	e _O	0.672
	Time to Failure, min.		t _f	5.6
	Unconfined Compressive Strength, tsf		q _u	3.66
	Shear Strength, tsf		s _u	1.83
Strain at Failure, %		ε _f	2.8	
Average Rate of Strain to Failure, %/min		ε	0.5

Description of Specimen: Light Brownish Gray SILT						
Amount of Material Finer than the No. 200, %:				nm		
LL:	nm	PL:	nm	PI:	nm	G _s : 2.70 Assumed
				Specimen Type: Intact		Test Method: ASTM D2166
Boring:		KB-7		Remarks: nm= not measured, na = not applicable		
Sample:		S7				
Depth, ft:		13.5				
Test Date:		3/11/21
