REPORT TO THE HISTORIC PRESERVATION COMMISSION

SUBJECT: CONSIDERATION OF APPROVAL OF REQUEST BY THE PROPERTY OWNER TO RESCIND THE DESIGNATION OF THE DR. FLOYD L.R. BURKS HOME (HR#006, 1913) LOCATED AT 2221-2223 STREET AS A HERITAGE PROPERTY AND ADOPTION OF FINDINGS NECESSARY TO SUPPORT RESCINDING THE DESIGNATION, PURSUANT TO 12-1612.

Dr. Floyd L. R. Burks Home, De-listing as a Heritage Property, June 28, 2010

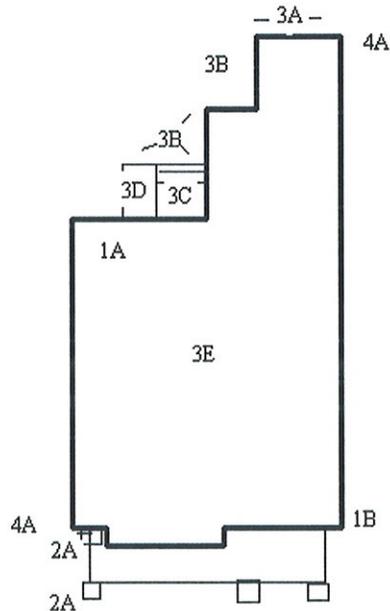
Subterranean Termites <input checked="" type="checkbox"/> Drywood Termites <input checked="" type="checkbox"/> Fungus/Dryrot <input checked="" type="checkbox"/> Other Findings <input checked="" type="checkbox"/> Further Inspection <input type="checkbox"/>			
If any of above boxes are checked, it indicates that there were visible problems in accessible areas. Read the report for details on checked items.
