BROOKS-RANSOM ASSOCIATES

15 September 2016

Subject: Schematic Condition Assessment – 450 E. Belmont Avenue, Fresno CA
North and South Buildings

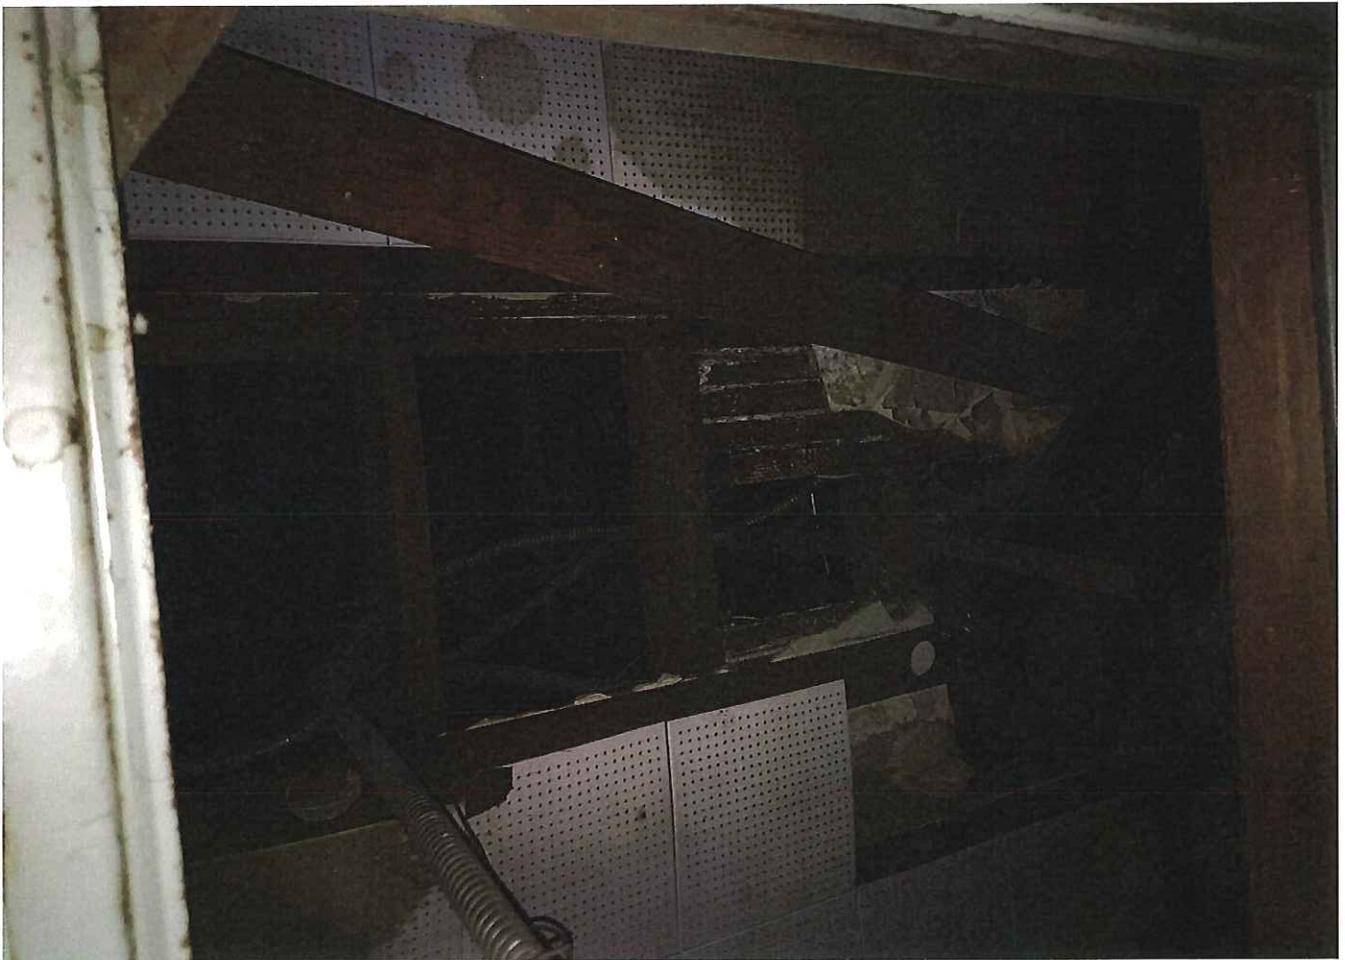
N
26

- Unreinforced Red Brick Walls (Photo S7)
- Nominally reinforced CMU walls (Photo S2)
- Straight board roof sheeting with water damage and rot. (Photo S6)
- Severe water damage to roof framing (Photos S5 & S6)
- Significant impact damage to the west wall. (Photo S7)
- Step cracking in the east wall near the north corner. (Photo S1)
- Deteriorated ceiling sheeting at the east side of the building. (Photo S3)
- No wall ties from perimeter walls to the roof framing. (Photo S5)
- Roof joist embedded directly in the masonry wall. (Photo S5)
- No shear transfer from the roof "diaphragm" to the shear walls. (Photos S5 & S6)
