**REPORT TO THE HISTORIC
PRESERVATION COMMISSION**

SUBJECT: CONSIDERATION OF APPROVAL OF REQUEST BY THE PROPERTY OWNER TO RESCIND THE DESIGNATION OF THE JUDGE WILLIAM D. CRICHTON HOME (HR#005, 1906) LOCATED AT 1718 L STREET AS A HERITAGE PROPERTY AND ADOPTION OF FINDINGS NECESSARY TO SUPPORT RESCINDING THE DESIGNATION, PURSUANT TO FMC 12-1612

Request to De-list the Judge Crichton Home as a Heritage Property, July 12, 2010

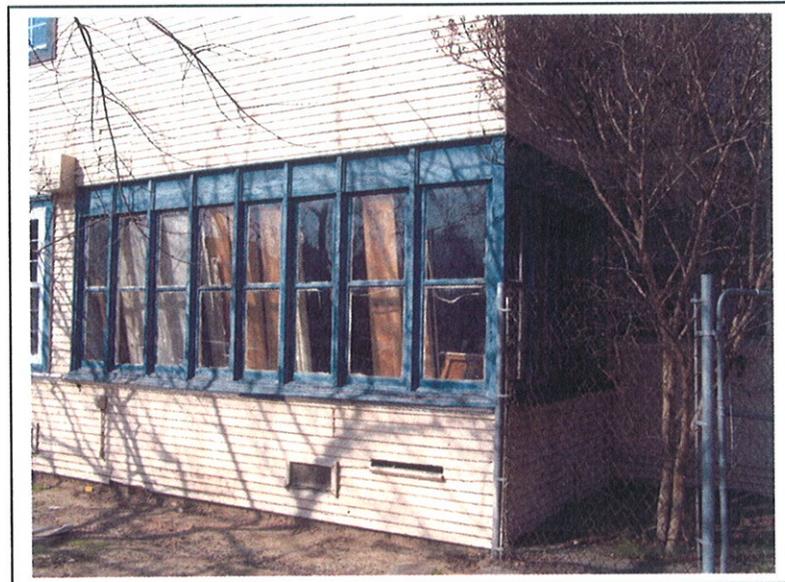
Southeast Corner with Ribbon Windows/Sun Porch

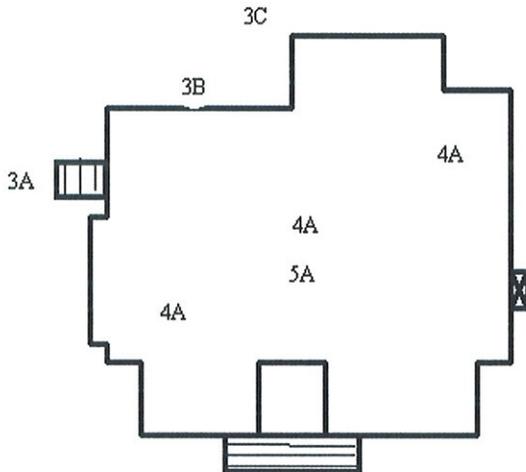
Firm Registration No. PR 3504	Report No. 7313	Escrow No.	
Ordered By: Granville Homes 1396 W. Herndon #104 Fresno, CA 93711	Property Owner/Party of Interest Granville Homes 1396 W. Herndon #104 Fresno, CA 93711	Report Sent To: Granville Homes 1396 W. Herndon #104 Fresno, CA 93711	
COMPLETE REPORT <input checked="" type="checkbox"/> LIMITED REPORT <input type="checkbox"/> SUPPLEMENTAL REPORT <input type="checkbox"/> REINSPECTION REPORT <input type="checkbox"/>			
General Description: Two story, framed, stucco and wood sided residence vacant and unoccupied, comp shingle roof on a raised foundation		Inspection Tag Posted: Subarea	
		Other Inspection Tags: NONE	
An inspection has been made to the structure(s) shown on the diagram in accordance with the Structural Pest Control Act. Detached porches, detached steps, detached decks and any other structures not on the diagram were not inspected.

Subterranean Termites <input type="checkbox"/> Drywood Termites <input type="checkbox"/> Fungus/Dryrot <input checked="" type="checkbox"/> Other Findings <input checked="" type="checkbox"/> Further Inspection <input type="checkbox"/>			
If any of above boxes are checked, it indicates that there were visible problems in accessible areas. Read the report for details on checked items.
