Fulton Mall Reconstruction Project

Visual Impact Assessment

Fulton Mall, City of Fresno
Fresno County, California

Federal Project # TCSPL-5060(263)

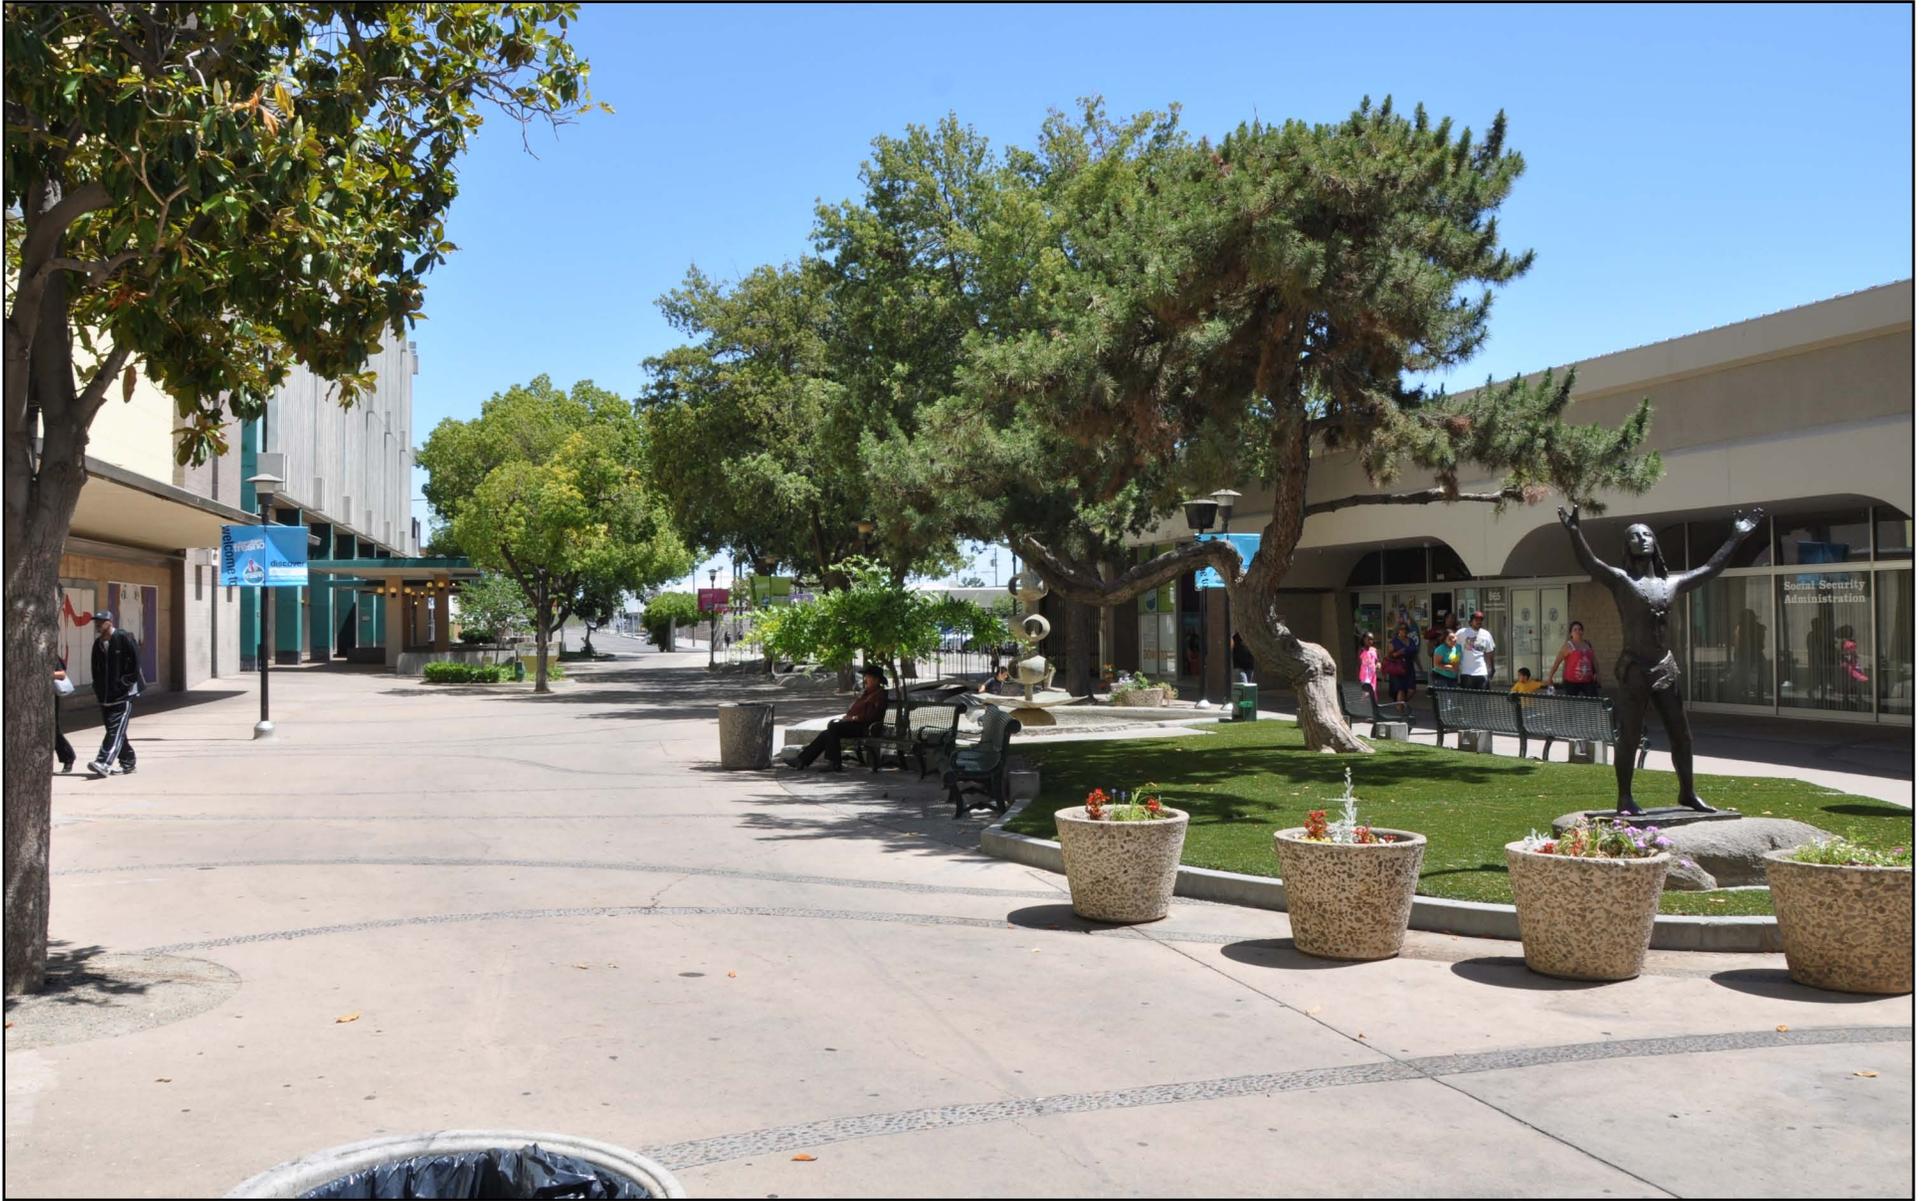
Figure 4
Existing View at Key Observation Point 1

The existing southern view of Fulton Mall south of Kern Mall is primarily limited to foreground and middle ground views of various visual resources (Figure 4). These resources include mature trees, patterned pavement, artwork, benches, light stands, and flower pots. The landform from this viewpoint is considered to have moderately low vividness due to its relatively flat terrain; however, the irregularly shaped ornamental pine tree in the foreground is considered to have a moderately high vividness due to its unique trunk structure.

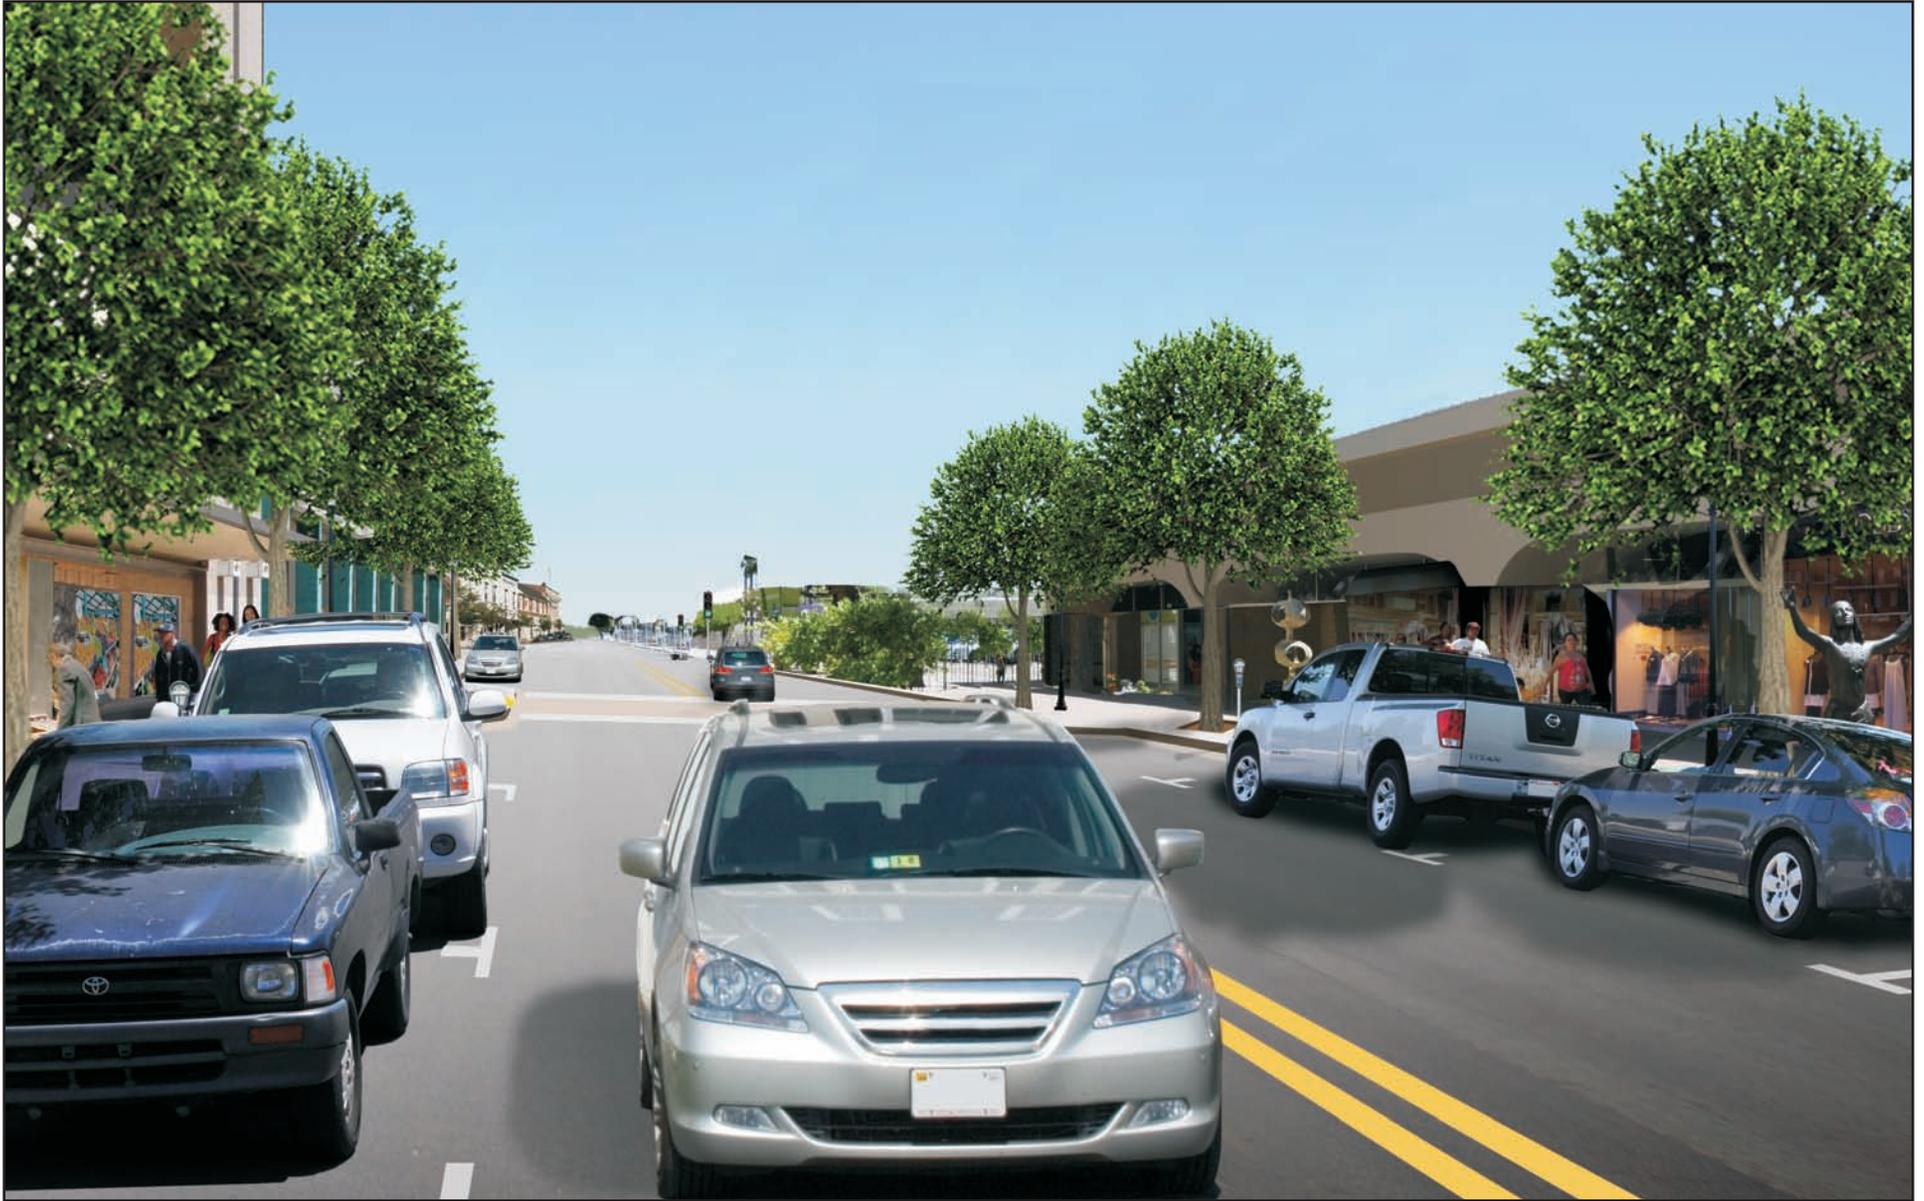
Figure 5
Visual Simulation at Key Observation Point 1 for Alternative 1

This alternative includes construction of a two-lane street with parallel parking on both sides of the street, and includes approximately 20-foot wide sidewalks with various features (Figure 5). From this viewpoint, the visual features within the sidewalk area would include benches, artwork, trees, and patterned pavement. This viewpoint also illustrates a mid-block crosswalk. This proposed view provides foreground, middle ground, and background views.

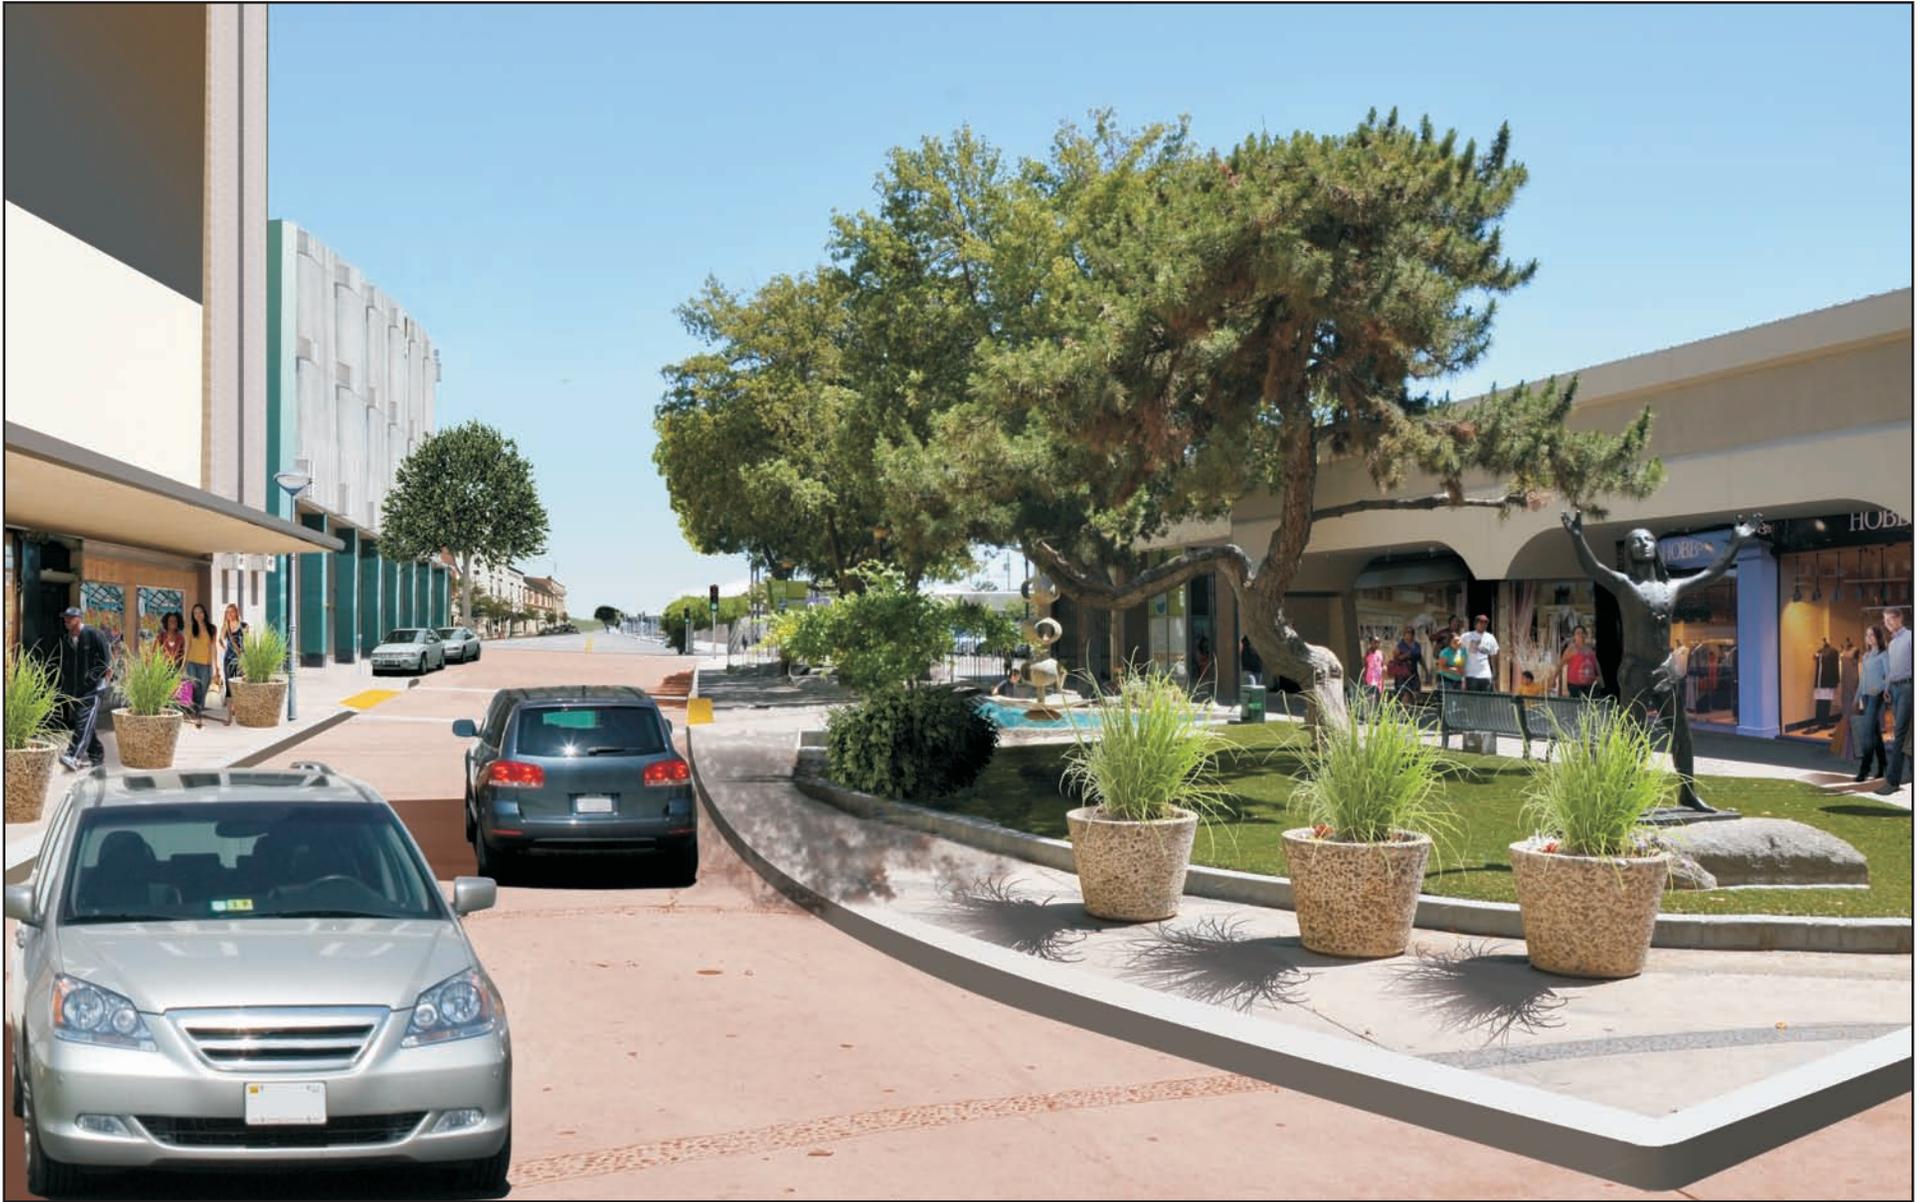
31680017 • 07/2013 | 6_visual_sim_KOP1_for_alt2.cdr

The unity between natural (trees and vegetation) and manmade is considered to be moderately high and the overall unity is also considered to be moderately high due to the coherent visual pattern that is established with the proposed improvements.

Overall, the visual quality that this view provides is moderately high. Table 3 provides the quantitative comparison between the existing condition and Alternative 2.

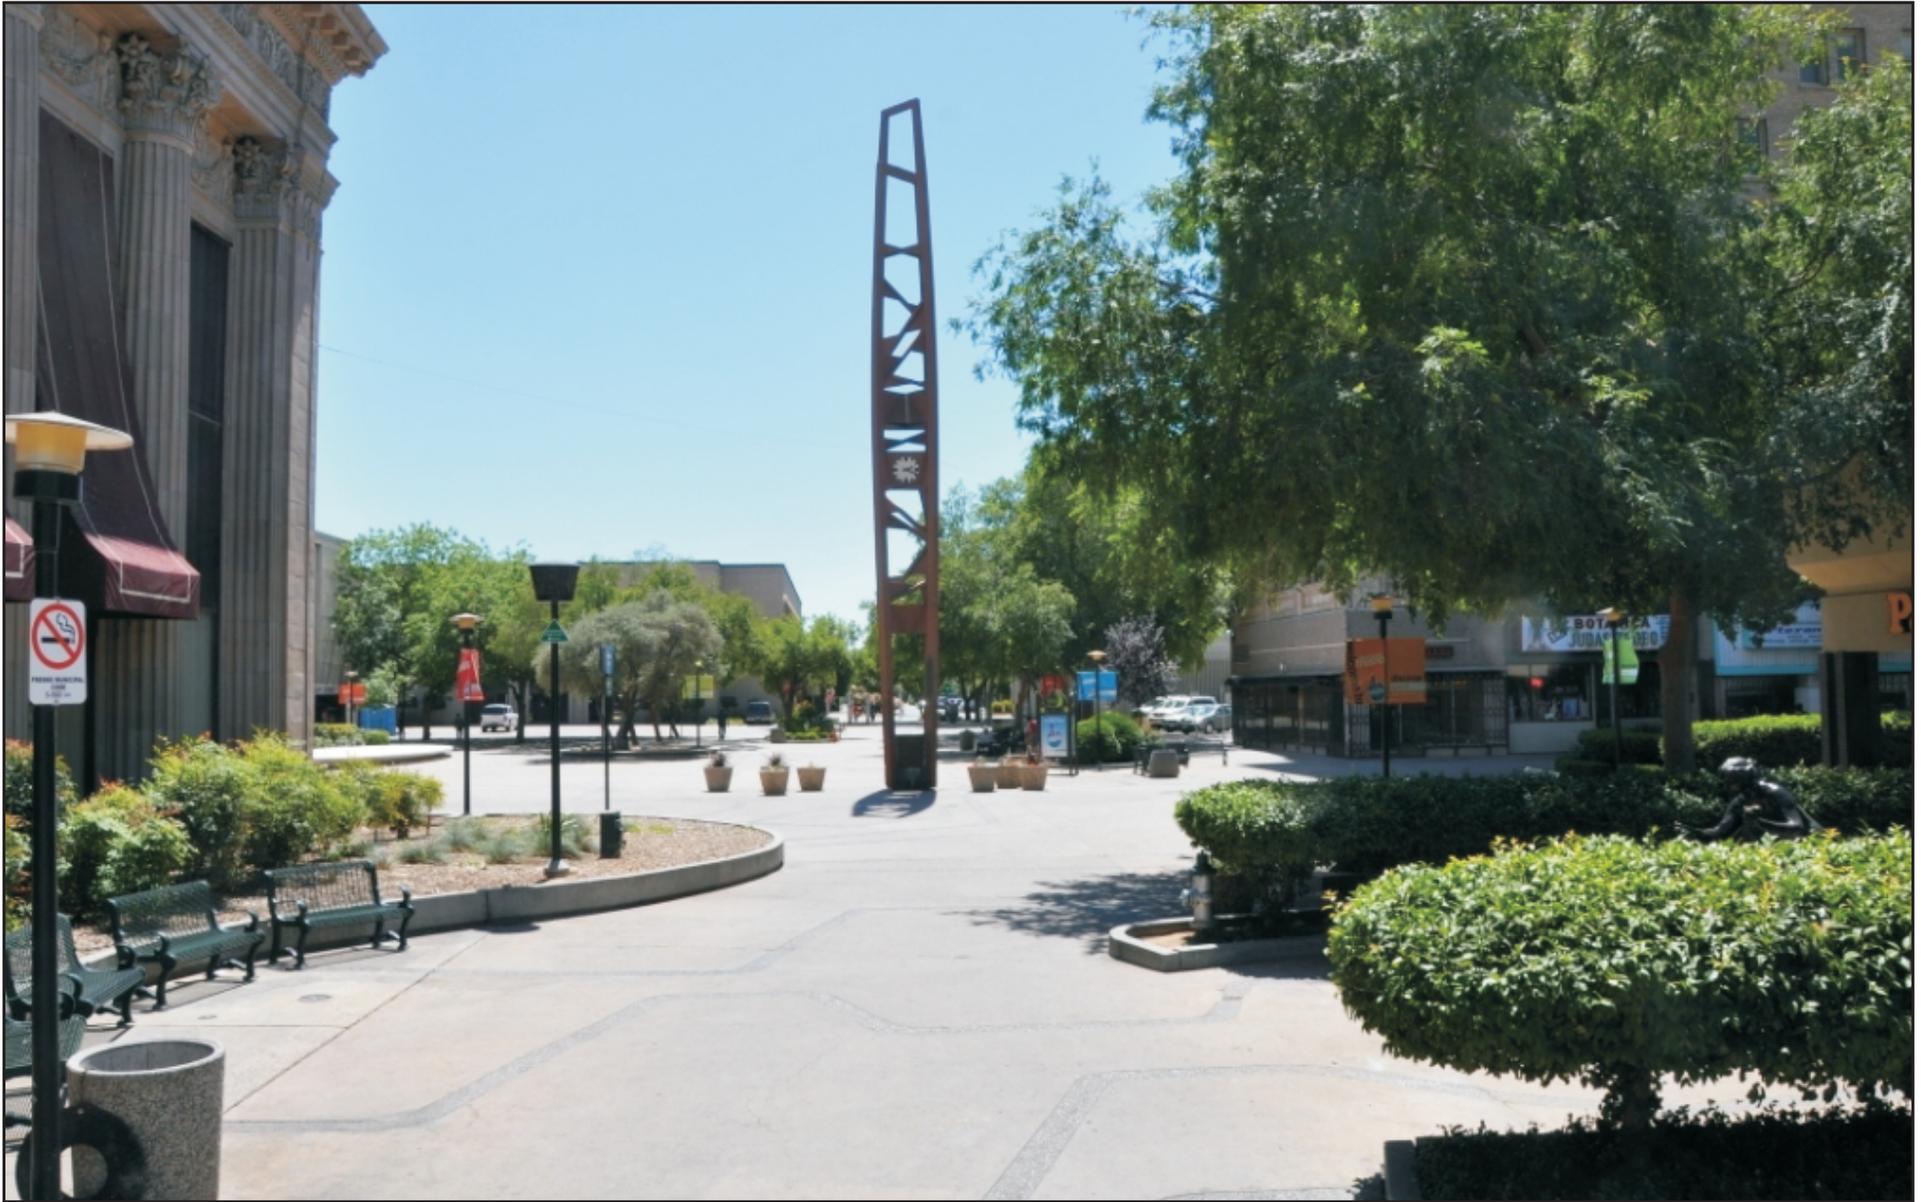
Figure 7
Existing View at Key Observation Point 2

The existing western view of the intersection of the Fulton Mall and Mariposa Mall from east of Fulton Mall is dominated by the 60-foot “Clock Tower” (Figure 7). The resources included in this view are mature trees, patterned pavement, a bronze sculpture “La Grand Laveuse (Washer Woman)” by world renown Pierre Auguste Renoir, benches, light stands, and flower pots. The landform from this viewpoint is considered moderately low vividness due to its relatively flat terrain.

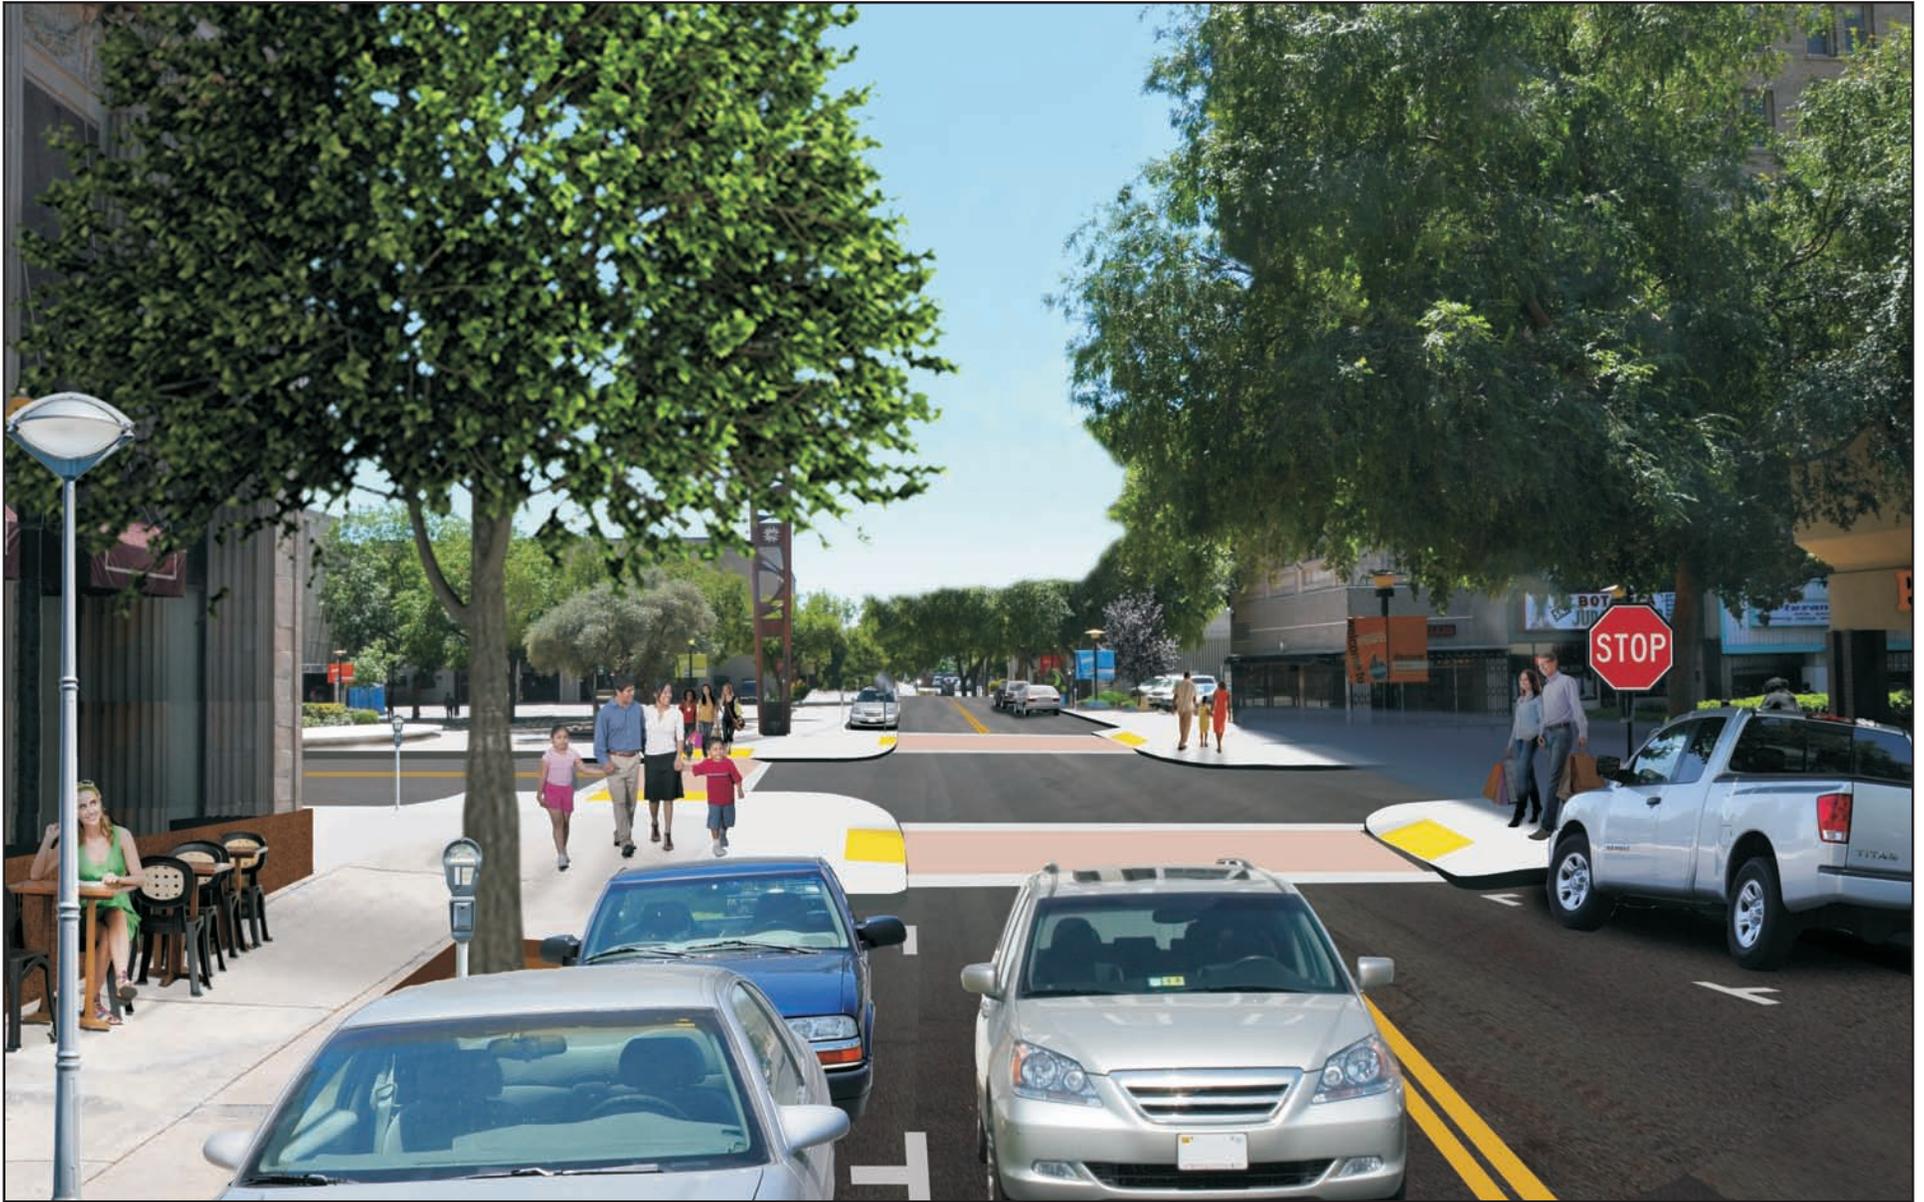
31680017 • 07/2013 | 8_visual_sim_KOP2_alt1.cdr

This view has few visual encroachments or eyesores. These eyesores include the contrast of the pavement and the crosswalk as well as the marked parallel parking spaces along Fulton Street and Mariposa Street. The overall intactness from this view is moderately high.

The unity between natural (trees and vegetation) and manmade features is considered to be high within the right-of-way due to the visual integrity of the view and average outside of the right-of-way. The overall unity from this viewpoint is moderately high. Based on the above evaluation, the overall visual quality that this view provides is average. Table 4 provides the quantitative comparison between the existing condition and Alternative 1.

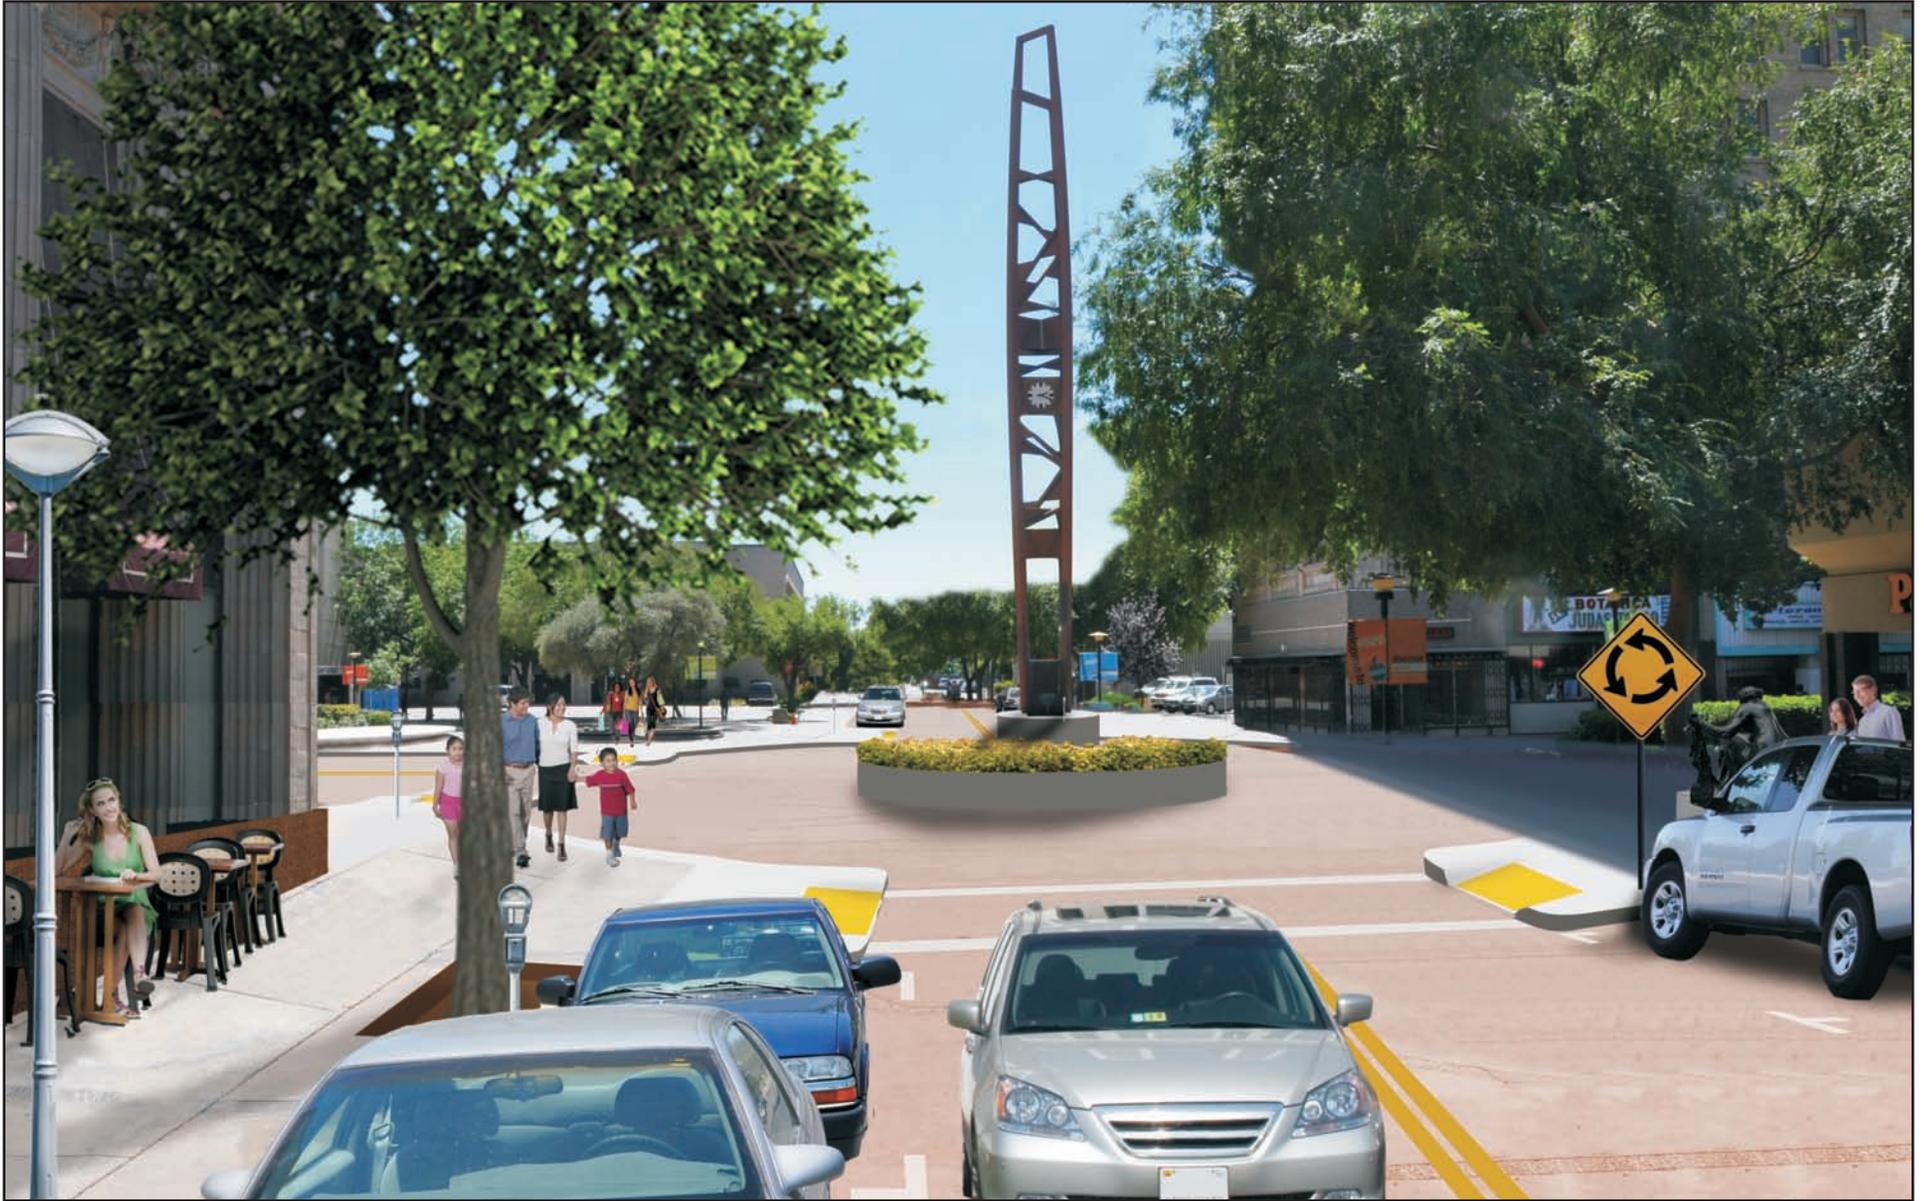
Figure 9
Visual Simulation at Key Observation Point 2 for Alternative 2

This alternative includes construction of two lane streets that converge into a roundabout at the intersection of Fulton Street and Mariposa Street (Figure 9). The intersection will include pedestrian bulb-outs and crosswalks at each of the four corners. Parallel parking on both sides of Fulton Street and Mariposa Street will be provided. The “Clock Tower” will remain at the center of the roundabout making it a visual focus for pedestrians and motorists. The “Clock Tower” is planned to be raised approximately 2 to 3 feet in height onto a base that includes a planter. Sidewalks will be approximately 20 feet wide with trees, artwork, and patterned pavement.

As shown in Table 5, the overall existing visual quality at the Key Observation Point 2 would increase with the development of Alternative 2. This increase in visual quality would primarily occur due to the increase in intactness and unity by improving the visual integrity and harmony of the view.

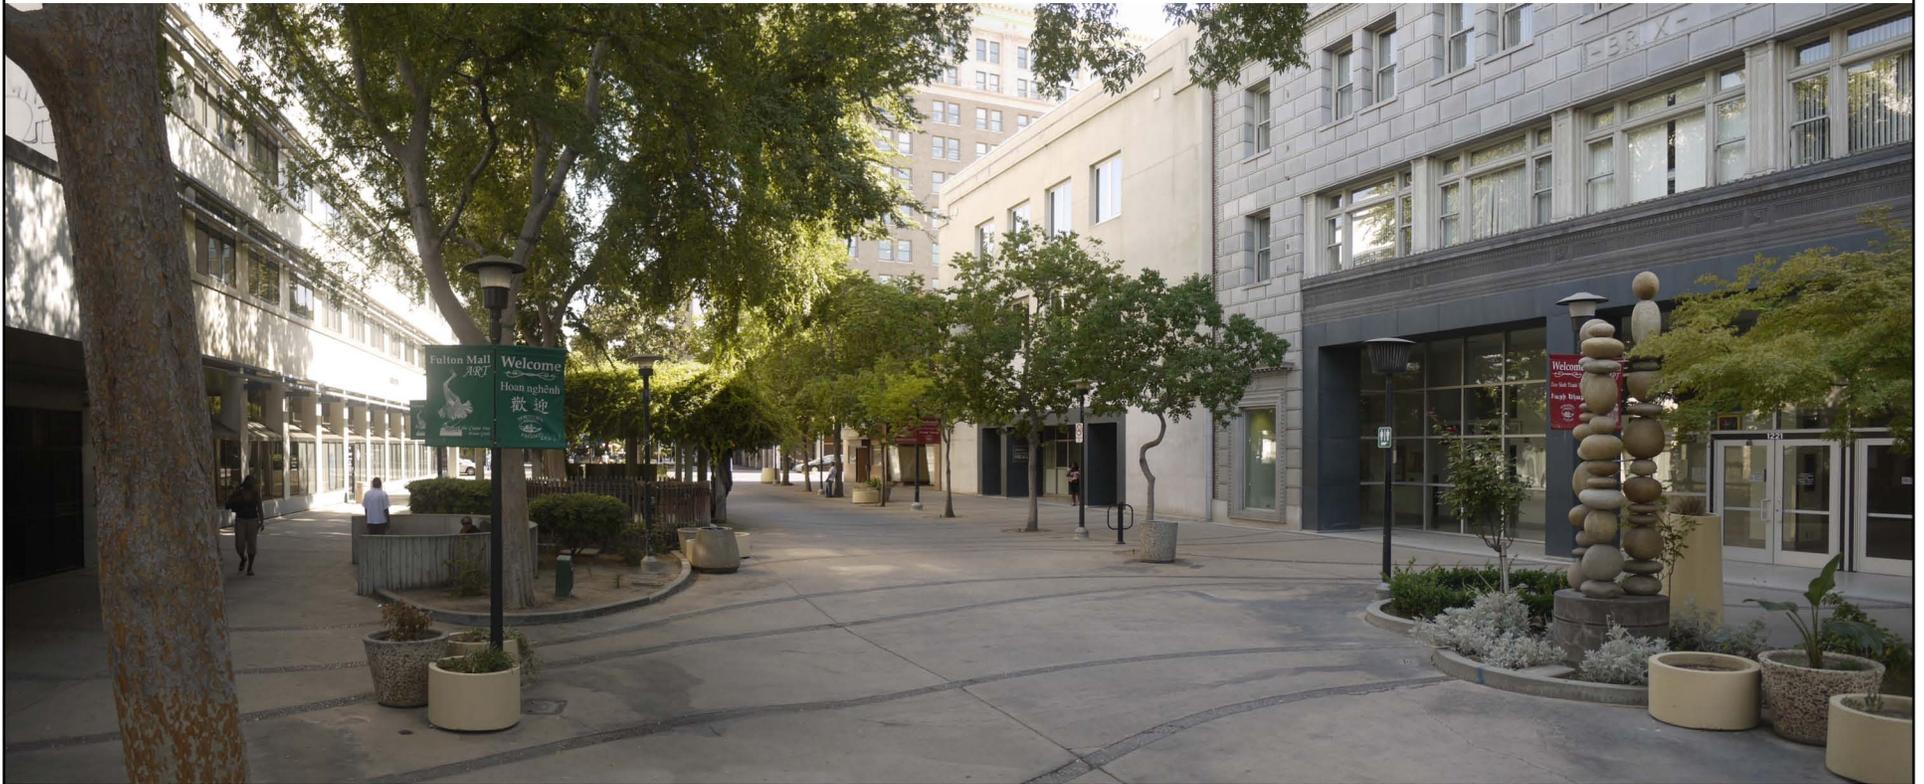
31680017 • 07/2013 | 10_existing_view_KOP3.cdr

This view has several visual encroachments or eyesores that include posters on light poles, dirty and cracked pavement and benches and has moderately low intactness. Outside of the right-of-way, there are some visual encroachments from this viewpoint including the dirty and cracked pavement, benches and planters. This view is considered to have a moderately high intactness. Overall, the intactness of this view is average.

The unity between natural (trees and vegetation) and manmade features is considered moderately low because the features within the mall from this viewpoint do not appear to be well maintained. There is little visual harmony of this view.

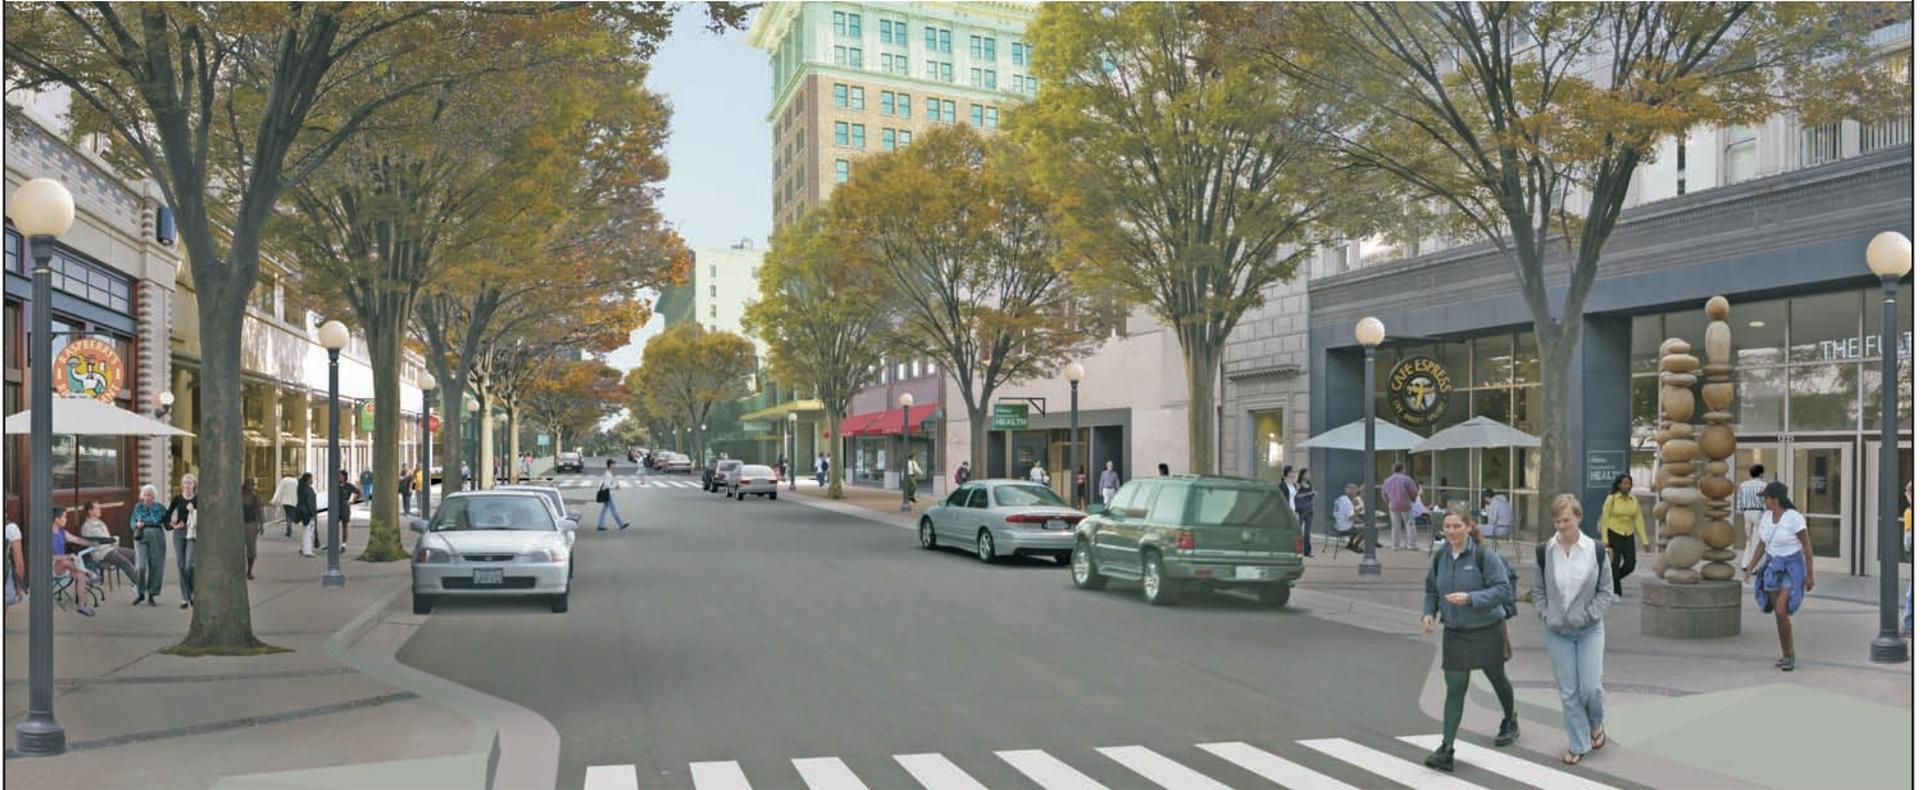
31680017 • 07/2013 | 11_visual_sim_KOP3_alt1.cdr

This view has few visual encroachments or eyesores. These eyesores include the contrast of the pavement and the mid-block crosswalk along Fulton Street. The overall intactness from this view is high. The unity between natural (trees and vegetation) and manmade is considered to be moderately high while the overall unity is also considered to be moderately high due to the visual pattern and harmony that is created under this alternative.

Overall, the visual quality that this view provides is moderately high. Table 6 provides the quantitative comparison between the existing condition and Alternative 1.

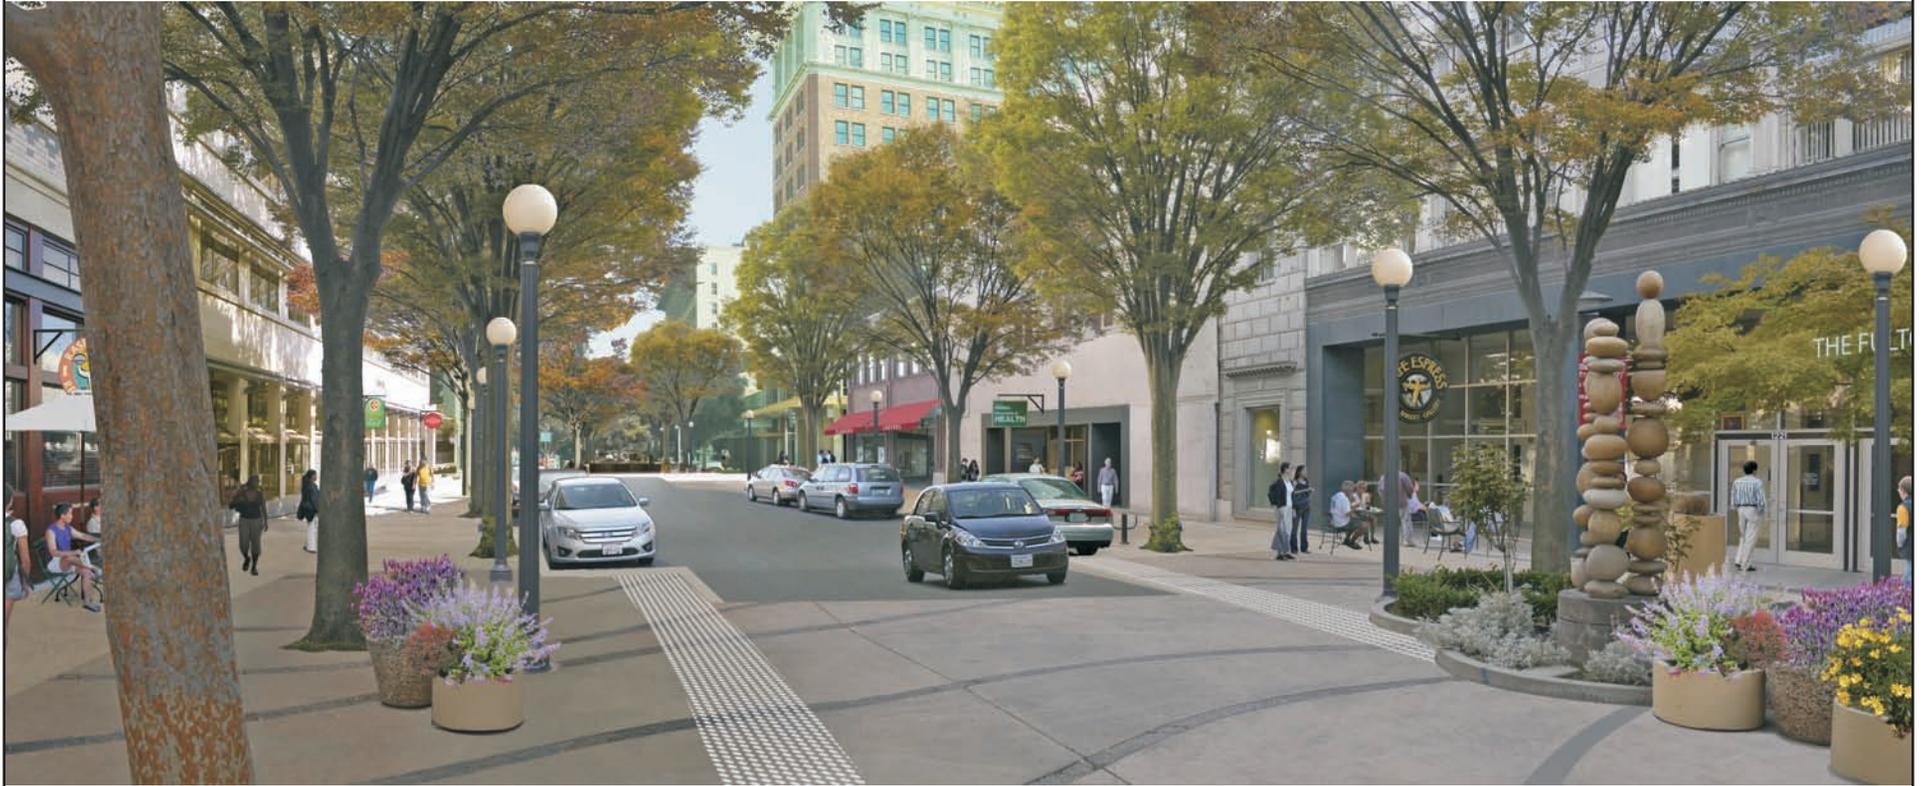
Figure 12
Visual Simulation at Key Observation Point 3 for Alternative 2

This alternative includes construction of a two-lane street with vignettes. At this location, the vignette includes the roadway in the middle of the right-of-way and no parallel parking in the vignette area, but parallel parking is provided outside of the vignette area (Figure 12). The vignette allows for a larger area for sidewalks, vegetation, and artwork. From this viewpoint, the visual features within the sidewalk area includes light poles, artwork, trees, potted plants, and patterned pavement.

This proposed view provides foreground, middle ground, and limited and confined background views. The landform from this viewpoint is considered to be low vividness due to its relatively flat terrain; however, the ornamental trees that are proposed along the road are considered to have moderately high vividness due to their visual pattern. The features proposed within the pedestrian mall provided in this view are considered to have high vividness due to the clean pavement and maintained street, sidewalk, lighting fixtures, and artwork. The view outside of the right-of-way includes the structures that are adjacent to the mall. An expected result of opening the mall to vehicular traffic is an increase in customers and retail sales. With an increase in sales, building owners or renters, may use the additional income to improve building exteriors, which would provide the opportunity for the storefronts to have a higher vividness. Overall, the view from this viewpoint of inside and outside of the right-of-way provides high vividness.

This view has few visual encroachments or eyesores under Alternative 2. One eyesore includes the contrast of the patterned pavement and the white stripes that illustrate the separation between the sidewalk and the roadway along Fulton Street (Figure 12). The intactness of the view outside of the right-of-way which includes the buildings is considered very high. The overall intactness from this view is high.
