**Appendix 3:
Visual Impact Assessment**

Visual Impact Assessment Fulton Mall Reconstruction Project City of Fresno, California

Report Date: November 20, 2013

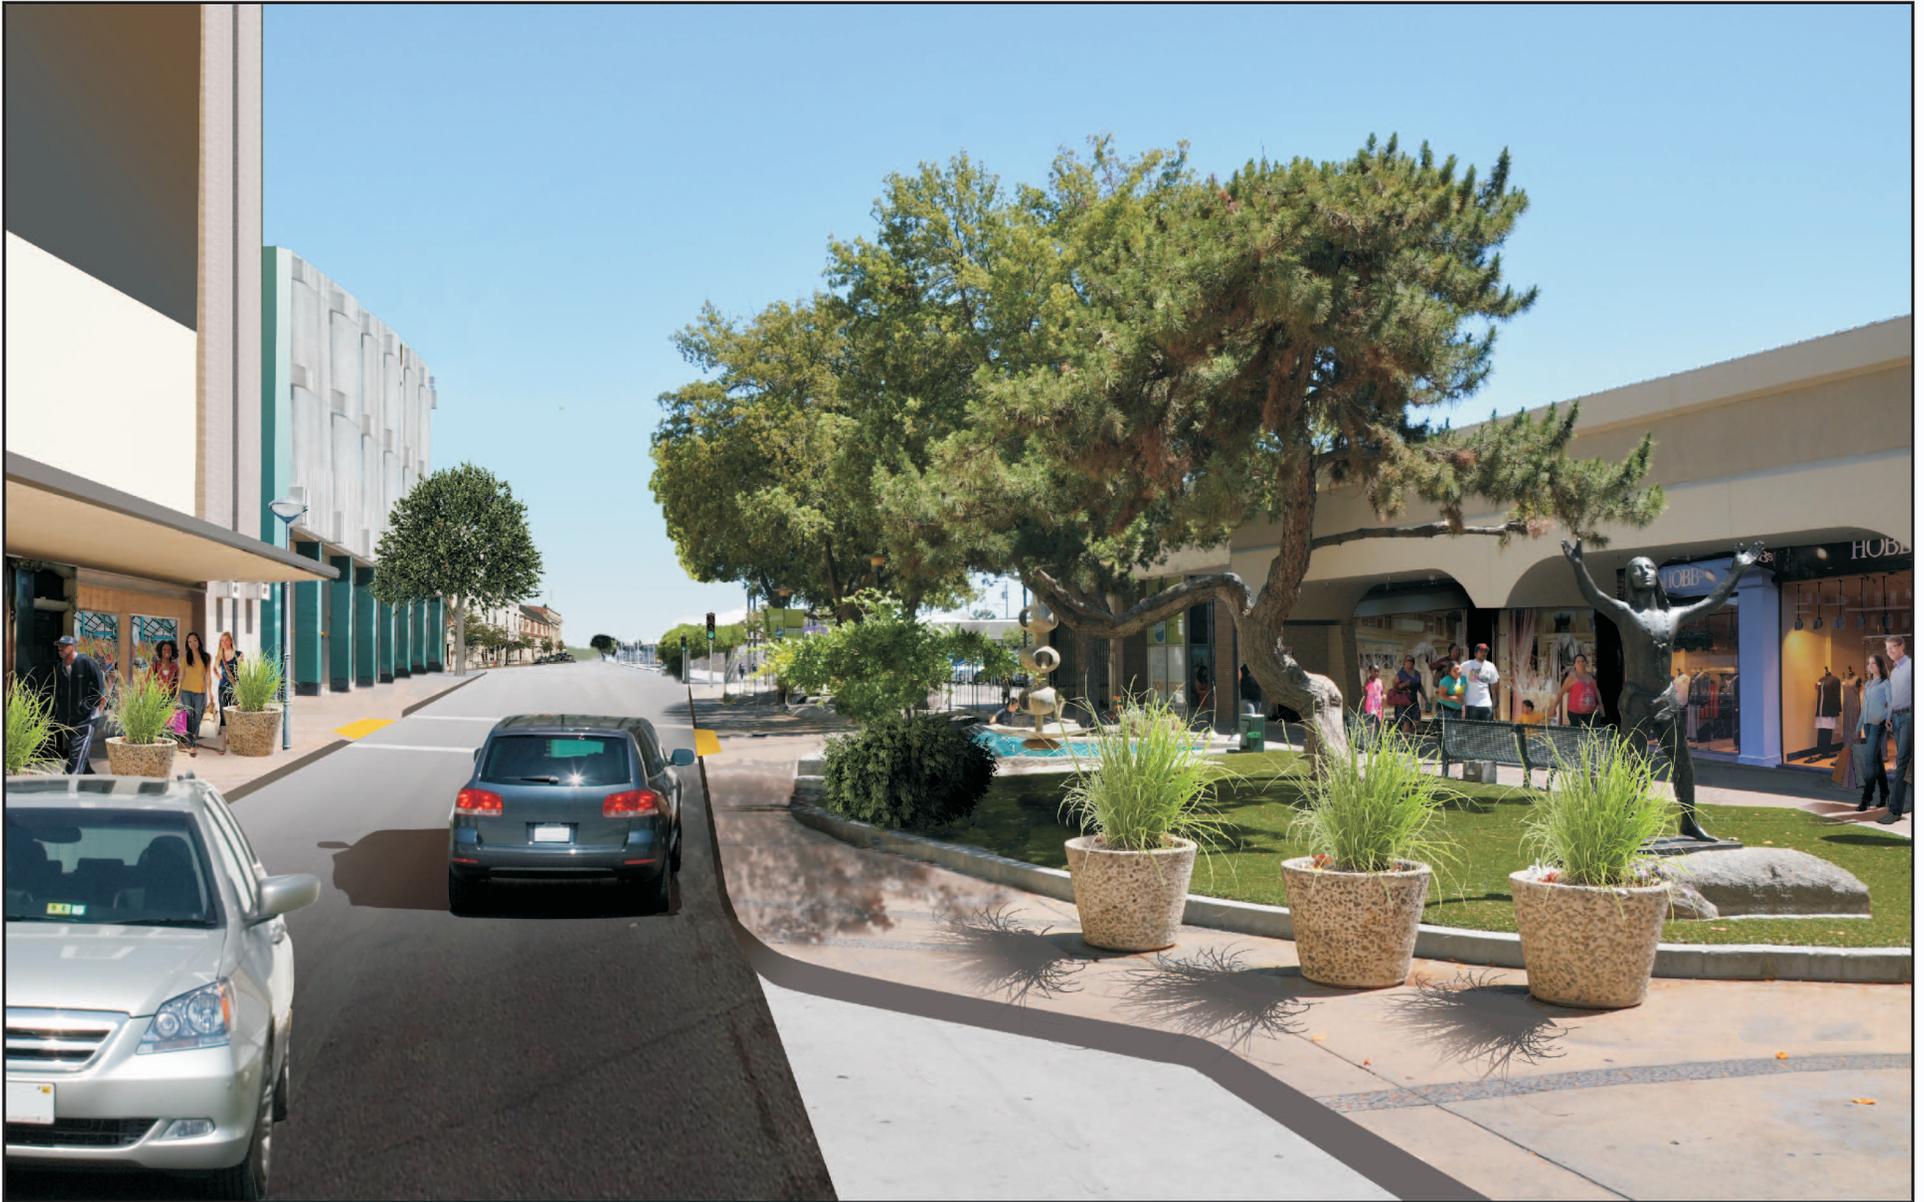
31680017 • 11/2013 | 6_visual_sim_KOP1_for_alt2.cdr

The unity between natural (trees and vegetation) and manmade is considered to be moderately high and the overall unity is also considered to be moderately high due to the coherent visual pattern that is established with the proposed improvements.
