**Phase I Environmental Site Assessment**

**735, 739, and 741 H Street  
Fresno, California**

August 30, 2022

Stantec Consulting Services Inc.  
3875 Atherton Road  
Rocklin, California 95765

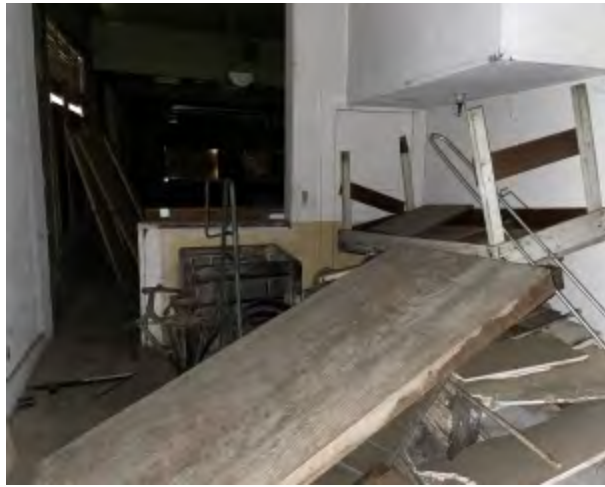
**Photo 13**

**Comments:** Small room near southeast corner of building. 5 gal bucket leaking oil.

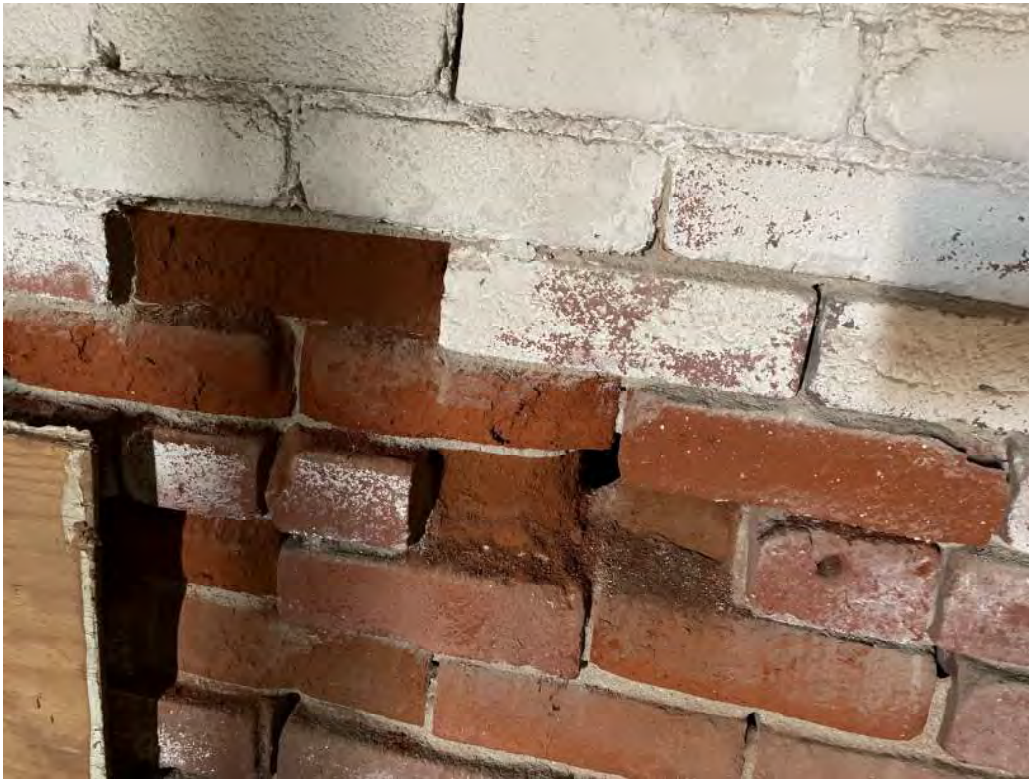
PHOTO #  
6

COMMENTS : View of south exterior wall, looking east. Note the number of openings closed up with plywood. This wall has very minimal seismic shear resistance. Note the headers inlaid to the brick piers.

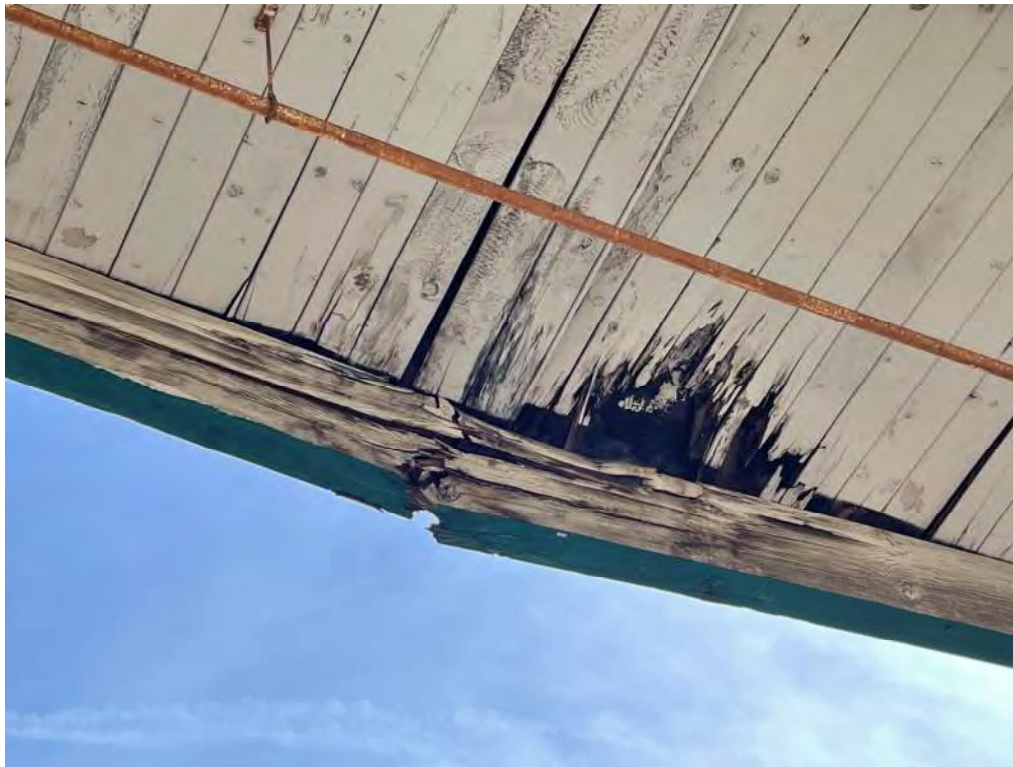
PHOTO #  
13

COMMENTS : View of the underneath of the east roof deck over the loading dock. Staining and peeling of the paint is due to moisture infiltration to the roof structure.

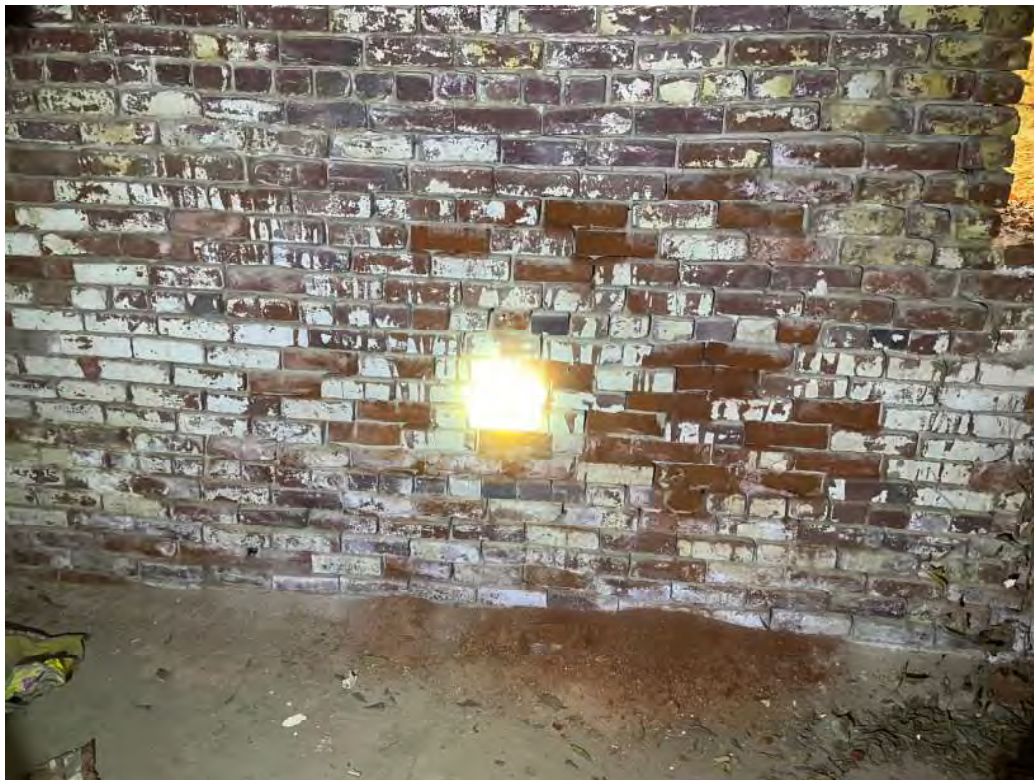
PHOTO #  
15

COMMENTS : View of the bottom of a portion of the basement wall. Extreme brick and mortar deterioration.

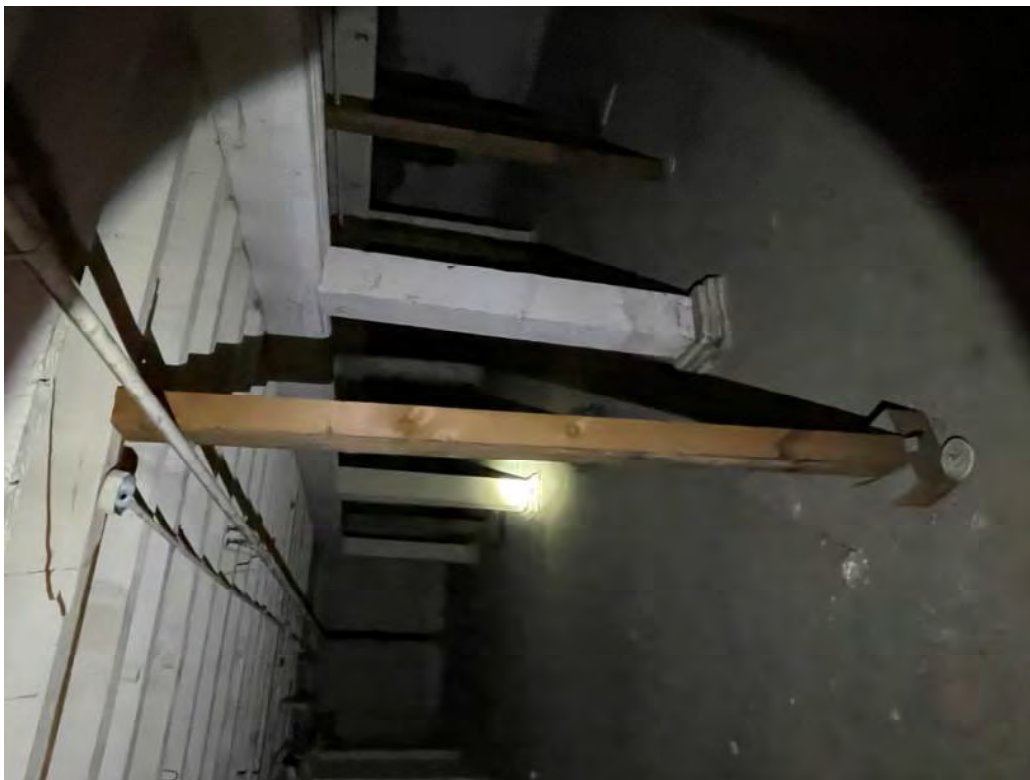
COMMENTS : A beam and post repair effort for broken floor joists.

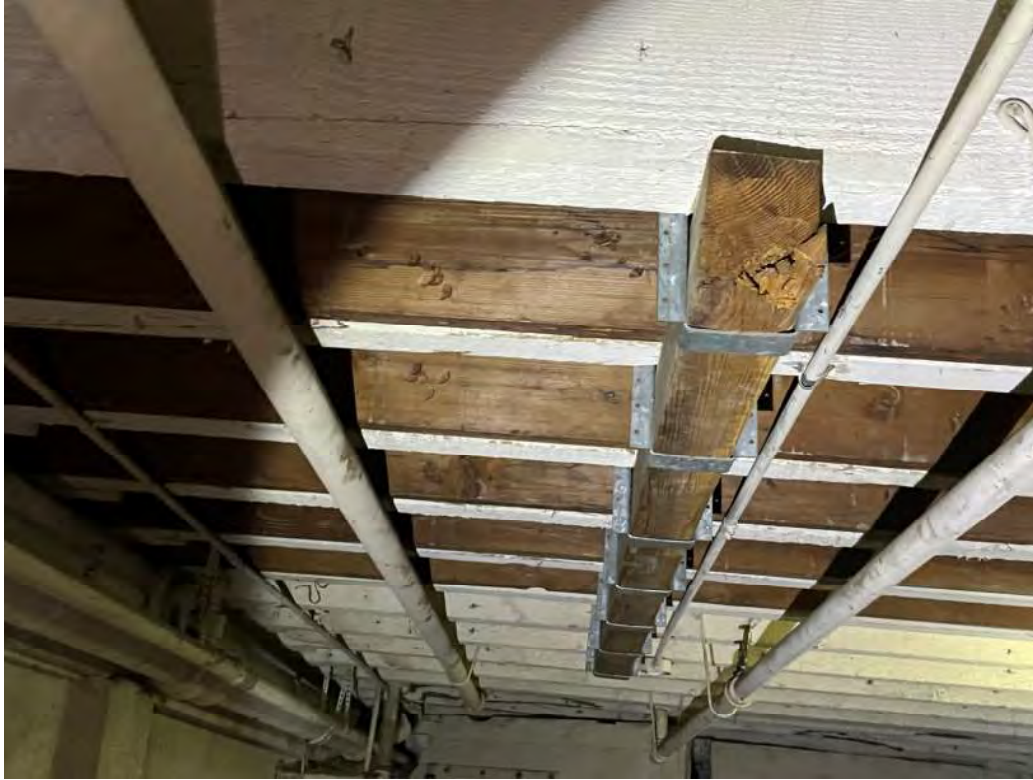
PHOTO #  
26

COMMENTS : An added post at a broken floor joist.

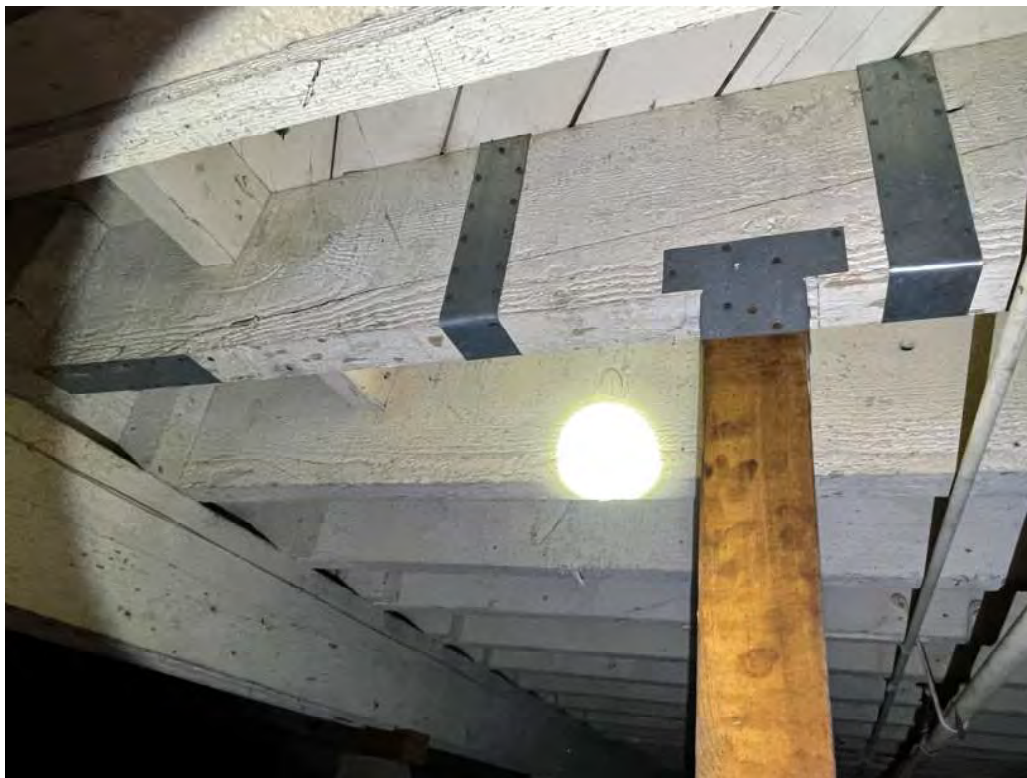
PHOTO #  
27

COMMENTS : An added 'strongback' with doubled joists to spread the load from broken joists to unbroken joists.

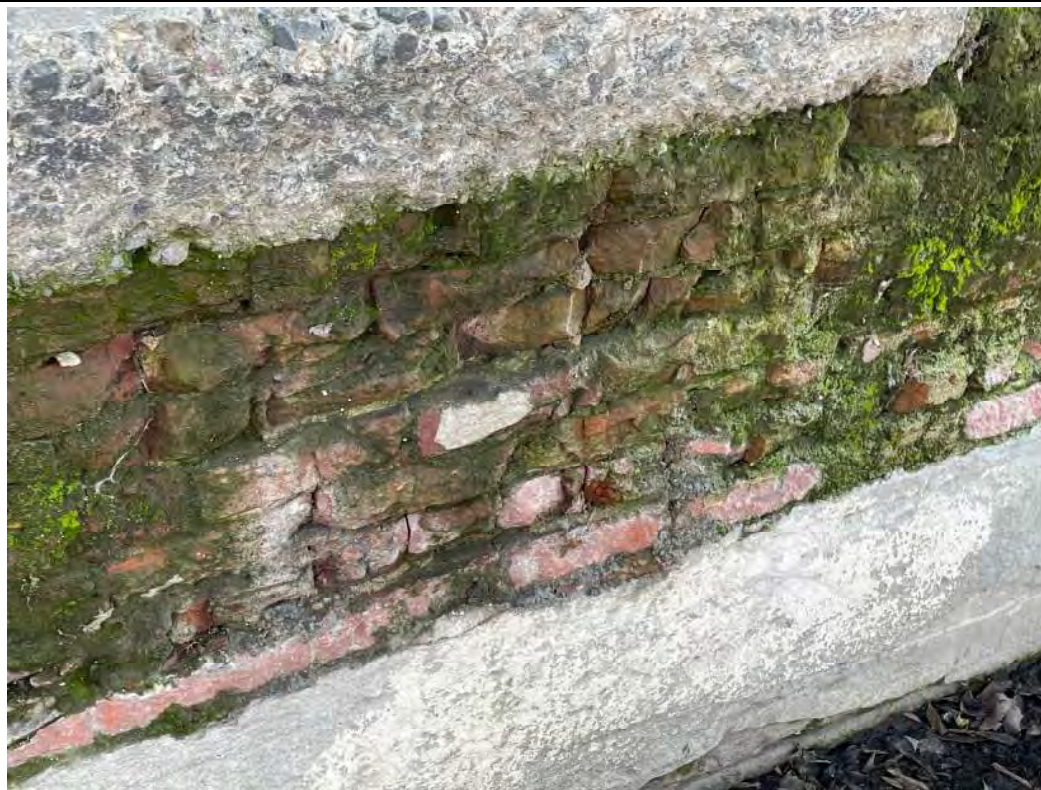
PHOTO #  
29

COMMENTS : A typical view of the face of the loading dock retainment wall. The cement coating, which was probably applied to protect the brick from further deterioration, has fallen apart. Brick is behind the green moss.

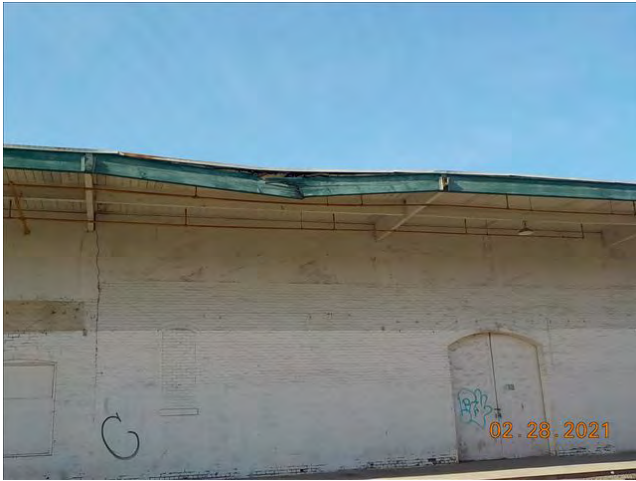
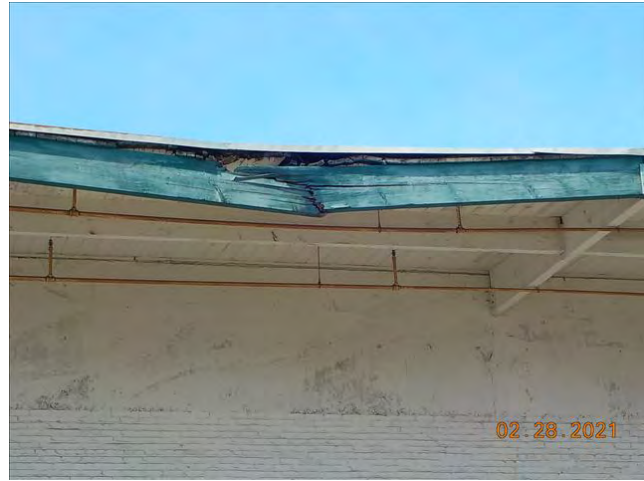
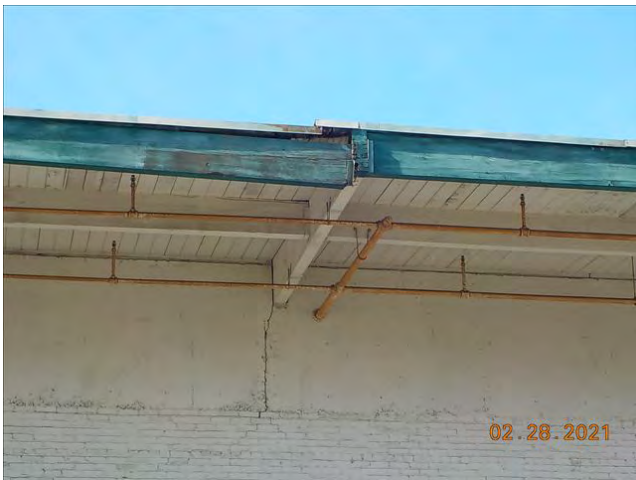
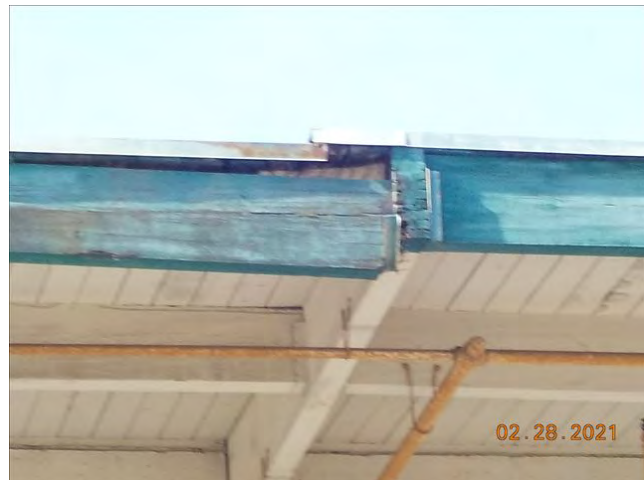
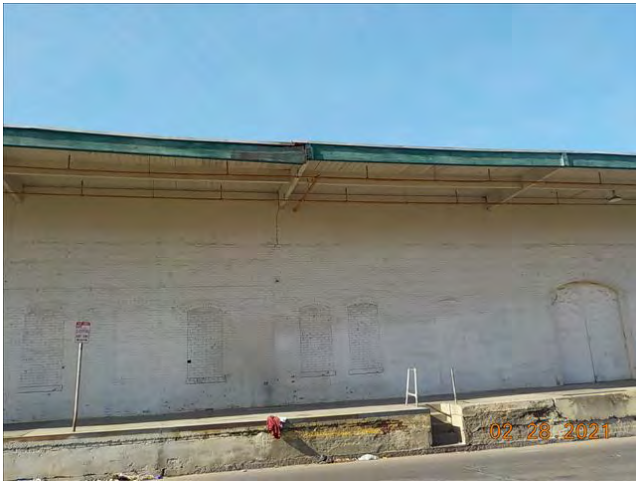
Date: 2/28/2021 9:34:56 AM  
DAMAGED ROOF AND FASCIA ON H ST. SIDE OF STRUCTURE

Date: 2/28/2021 9:35:01 AM  
DAMAGED ROOF AND FASCIA ON H ST. SIDE OF STRUCTURE

Date: 2/28/2021 9:35:15 AM  
DAMAGED ROOF AND FASCIA ON H ST. SIDE OF STRUCTURE

Date: 2/28/2021 9:35:20 AM  
DAMAGED ROOF AND FASCIA ON H ST. SIDE OF STRUCTURE

Date: 2/28/2021 9:35:31 AM  
 DAMAGED ROOF AND FASCIA ON H ST. SIDE OF STRUCTURE

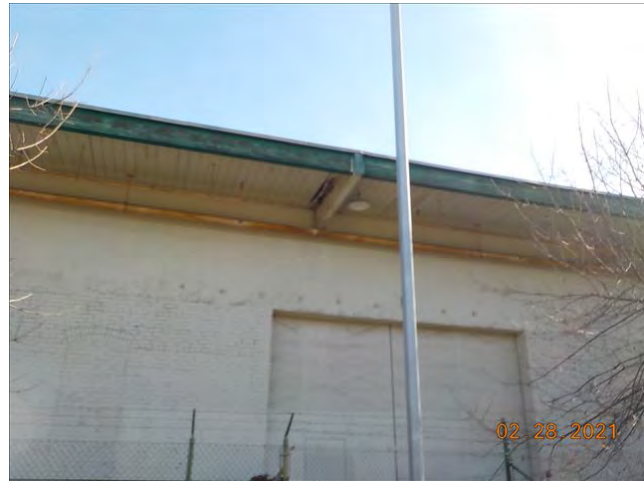
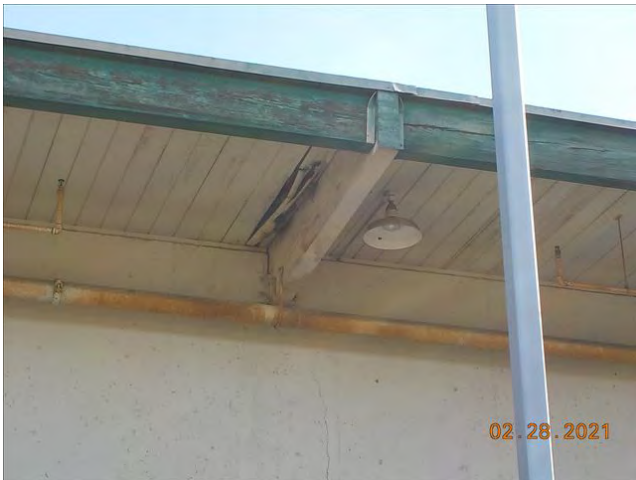
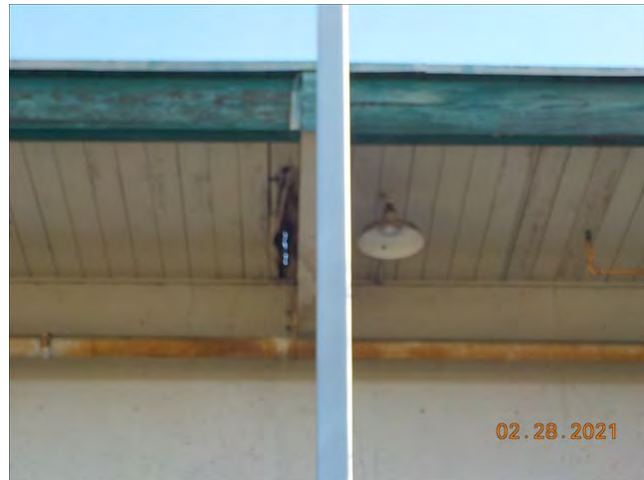
Date: 2/28/2021 9:36:30 AM  
 DAMAGED ROOF ON PARKING LOT SIDE OF STRUCTURE

Date: 2/28/2021 9:36:35 AM  
 DAMAGED ROOF ON PARKING LOT SIDE OF STRUCTURE

Date: 2/28/2021 9:36:50 AM  
 DAMAGED ROOF ON PARKING LOT SIDE OF STRUCTURE
